# STREAM BIOLOGICAL CONDITIONS ENVIRONMENTAL AUDITOR REPORT

<b>Stream ID:</b> S-CC11	<b>Crossing Start Date:</b> 11/08/2023	<b>Crossing Completion Date:</b> 11/10/2023
<b>Milepost:</b> 294.8	<b>Pre-Con Assessment Date:</b> 11/04/2023	<b>Post-Con Assessment Date:</b> 11/11/2023
<b>Station:</b> 15573+81	<b>Stream Classification:</b> Perennial (Perennial, Intermittent, Ephemeral)	<b>Bankfull Width (ft.):</b> 8
<b>County:</b> Pittsylvania	<b>303(d) Impairment Listing:</b> Not Impaired	<b>Riffle:Pool Complexes Present?</b> No

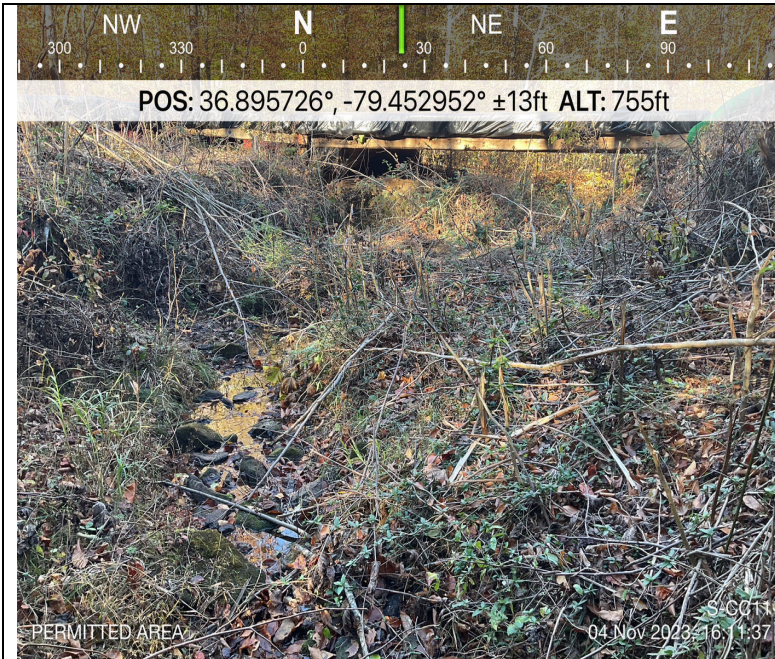
16.	<b>Channel Conditions:</b> <b>Rating:</b> 1-Optimal (80-100% stable banks), 2-Sub-optimal (60-80% stable banks), 3-Marginal (40-60% stable banks), 4-Poor (20-40% stable banks), 5-Severe (0-20% stable banks, highly eroded or unvegetated banks)	3 - Marginal	1 - Optimal

**Photo Description:** Downstream view of permitted impact area during pre-construction assessment.

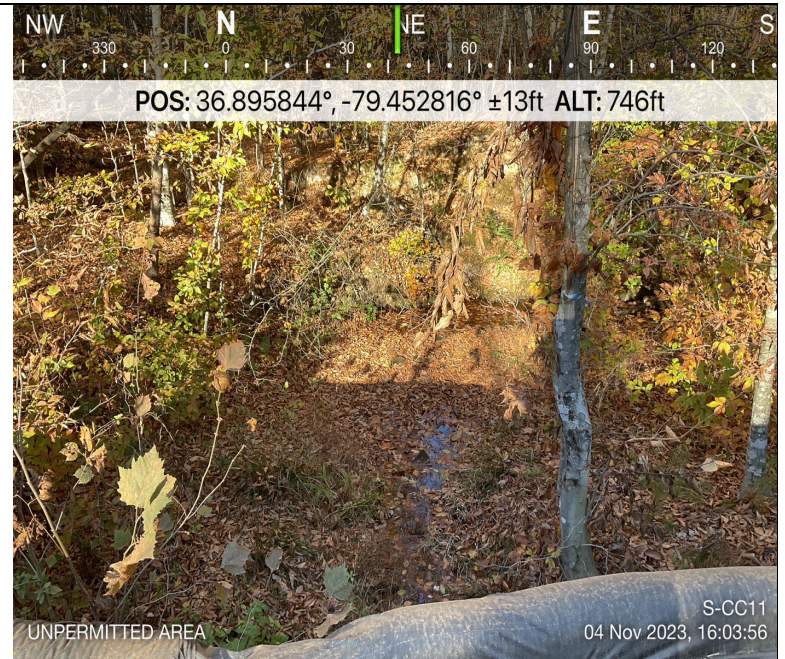
**Photo Description:** Conditions of the downstream area outside the ROW during pre-construction assessment.

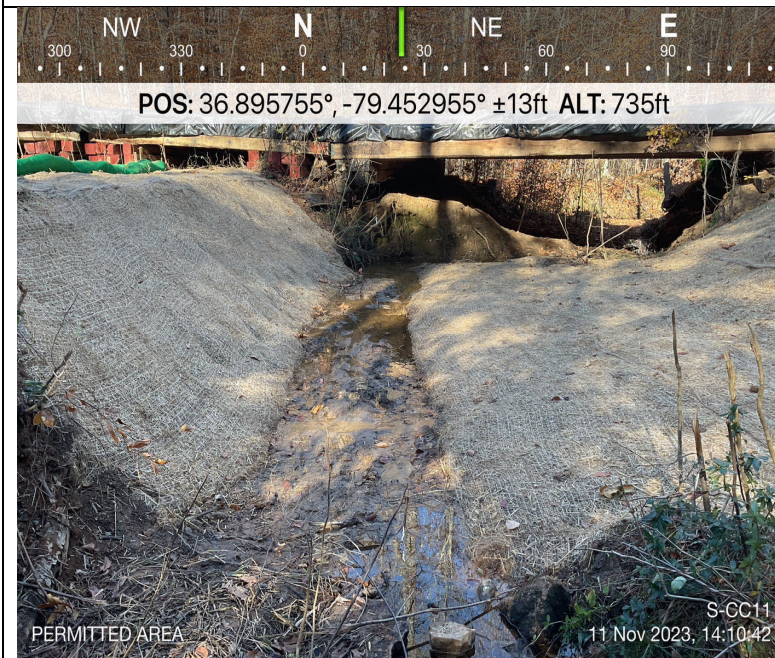
No impacts to biological conditions or unauthorized discharges were observed during the crossing activities.

**Photo Description:** Downstream view of permitted impact area during post-construction assessment.

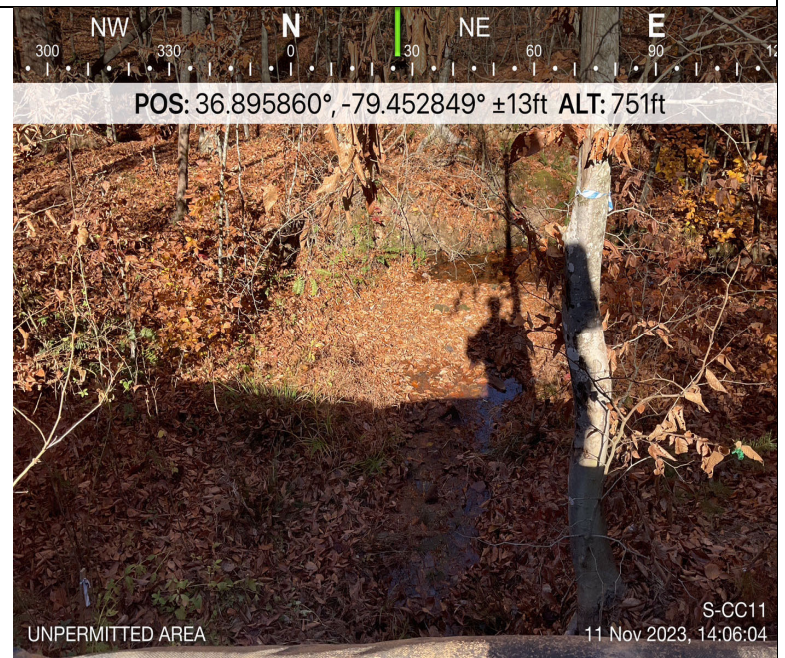
**Photo Description:** Conditions of the downstream area outside the ROW during post-construction assessment.

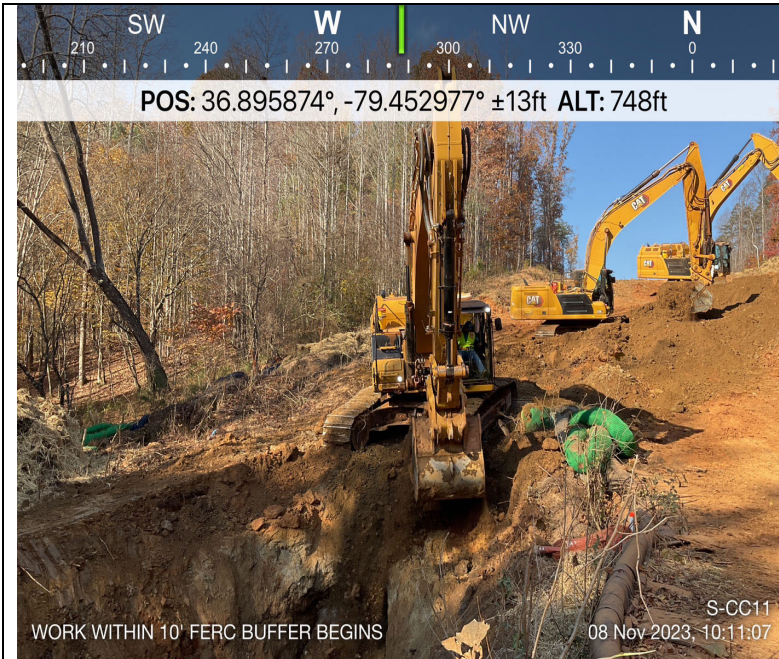
**Photo Description:** Crossing construction begins within 10' FERC buffer.

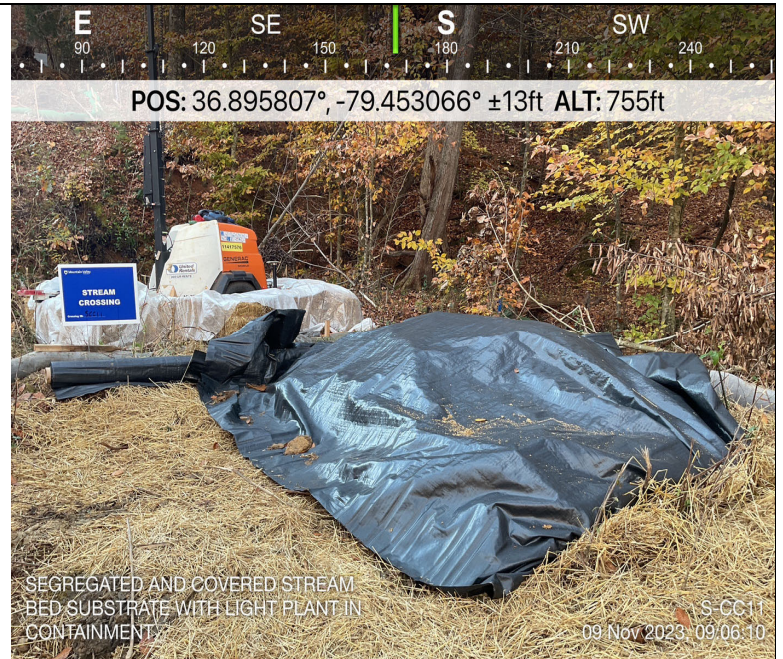
**Photo Description:** Segregated and covered stream bed substrate.

11-08-2023: Fish removal commenced ahead of provided schedule. Upon arrival, two fish had been relocated downstream. Sandbags with Visqueen dam and pump and energy dissipation system installed. Dewatering of stream bed channel. Top 12" of substrate segregated & covered with geotextile filter fabric. Top 10" topsoil segregated from buffer zones. Trench excavated, sandbags installed in trench, and pipe section lowered in. Tie-in weld completed on GAS. X-ray and further prep to follow on 11-09-23. No impacts to the unpermitted areas of the resource or biological conditions. -K. Douglas

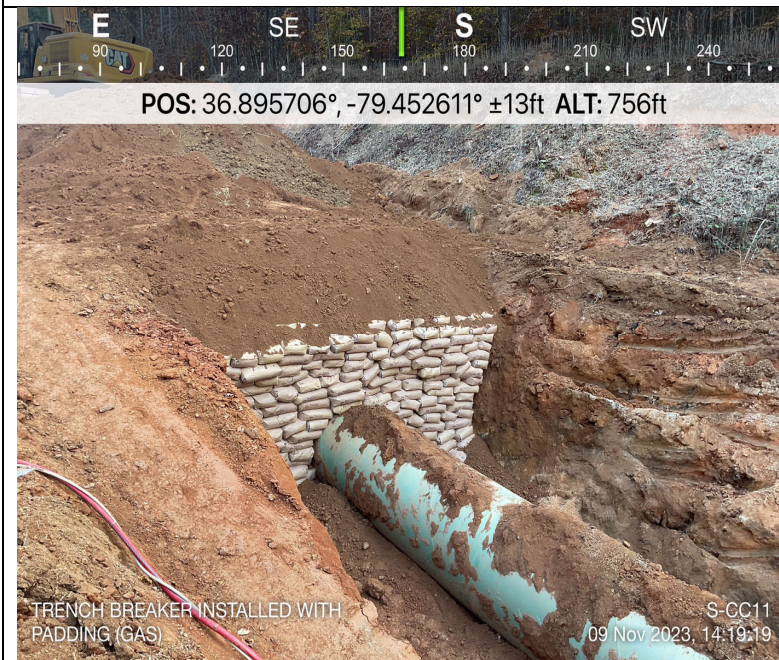
**Photo Description:** Trench breaker installed (GAS).

11-09-2023: Blasting and coating of tie-in weld (CIS). 2nd and final tie-in weld completed, sandblasted and coated (GAS). Trench breaker installed and padded (GAS). Backfill of trench completed. Survey crew on site to begin restoration of bank contours and stream channel. Spreading of segregated, clean, native substrate in stream channel and of topsoil on banks. Banks seeded and stabilized with erosion control matting. Dam and pump removed, stream flow in the channel restored. Re-establishment of 50' buffer and installation of final trench breaker (CIS) expected on Fri 11-10. -K. Douglas

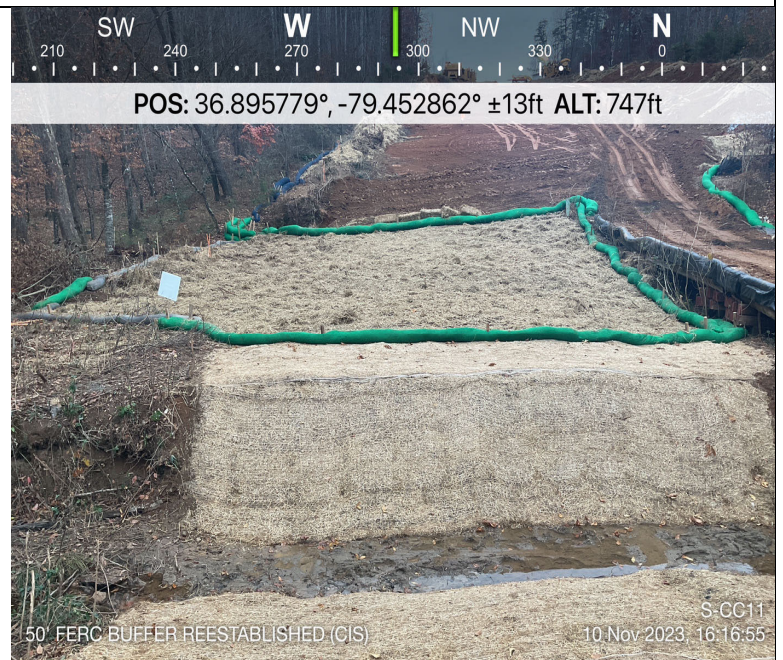
**Photo Description:** 50' FERC Buffer zones reestablished.

11-10-2023: Trench breaker, padding and backfill completed (CIS). 50' FERC aquatic resource buffer reestablished, stabilized and enclosed with 12" filter sock (CIS). -K. Douglas
