STREAM BIOLOGICAL CONDITIONS ENVIRONMENTAL AUDITOR REPORT

Stream ID: S-CC9	Crossing Start Date: 11/11/2023	Crossing Completion Date: 11/15/2023
Milepost: 294.5	Pre-Con Assessment Date: 11/04/2023	Post-Con Assessment Date: 11/16/2023
Station: 15556+96	Stream Classification: Ephemeral (Perennial, Intermittent, Ephemeral)	Bankfull Width (ft.): 5.5
County: Pittsylvania	303(d) Impairment Listing: Not Impaired	Riffle:Pool Complexes Present? No

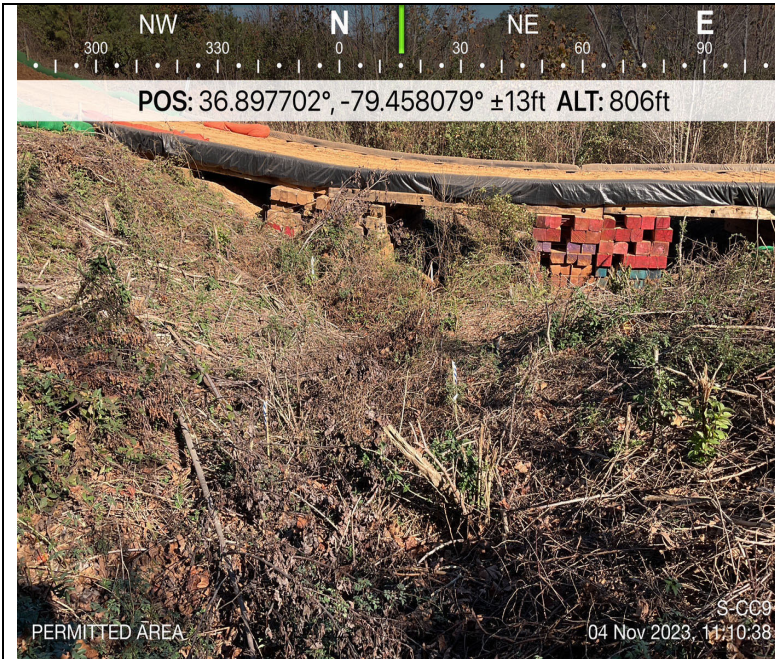
Photo Description: Downstream view of permitted impact area during pre-construction assessment.

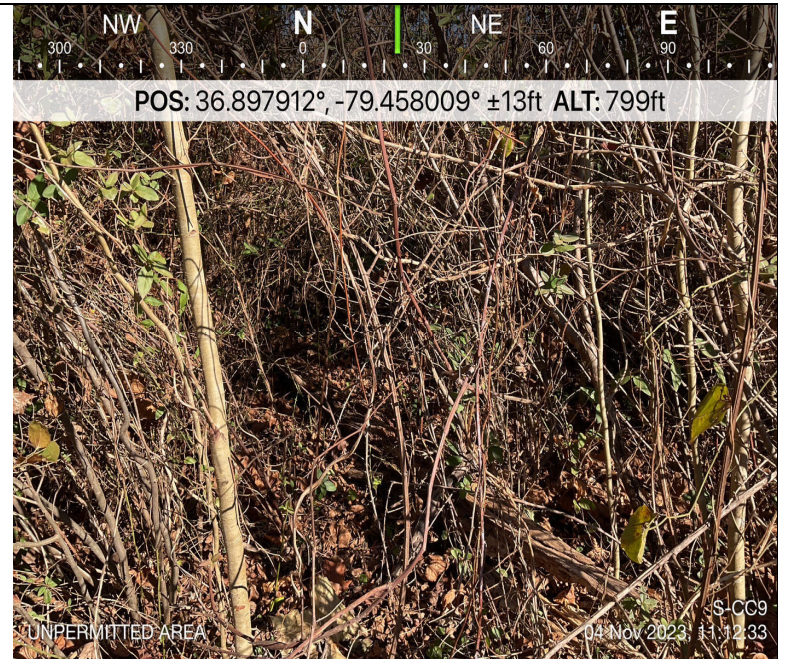
Photo Description: Conditions of the downstream area outside the ROW during pre-construction assessment.

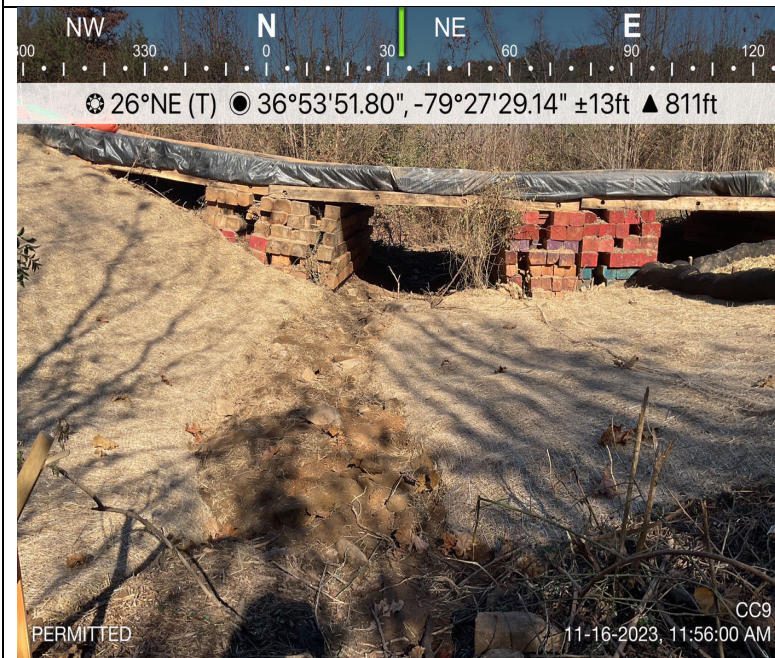
Photo Description: Downstream view of permitted impact area during post-construction assessment.

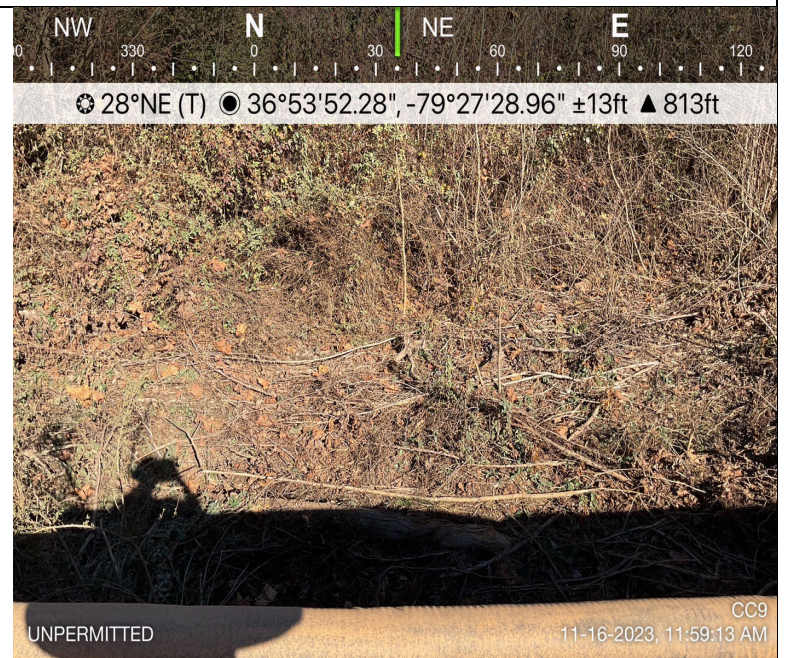
Photo Description: Conditions of the downstream area outside the ROW during post-construction assessment.

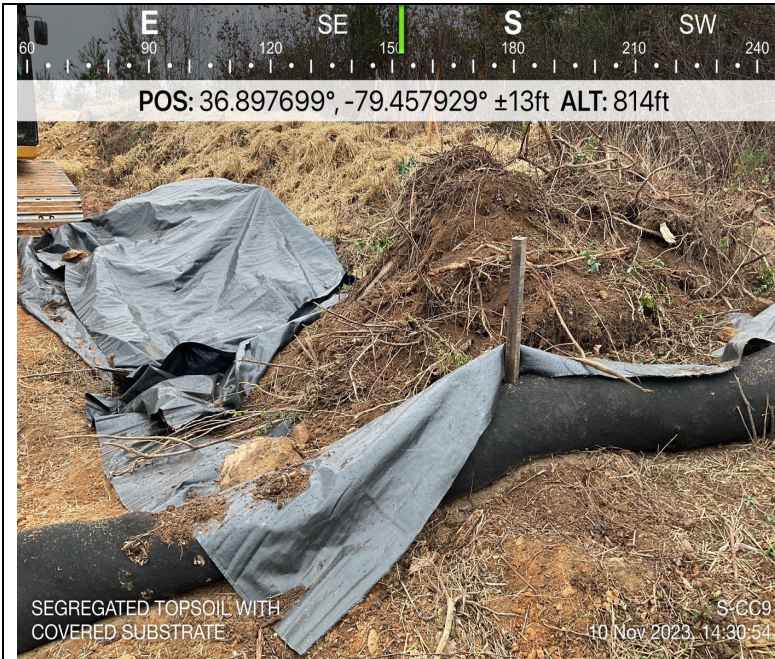
Photo Description: Segregated topsoil and stream bed substrate enclosed in geotextile fabric.

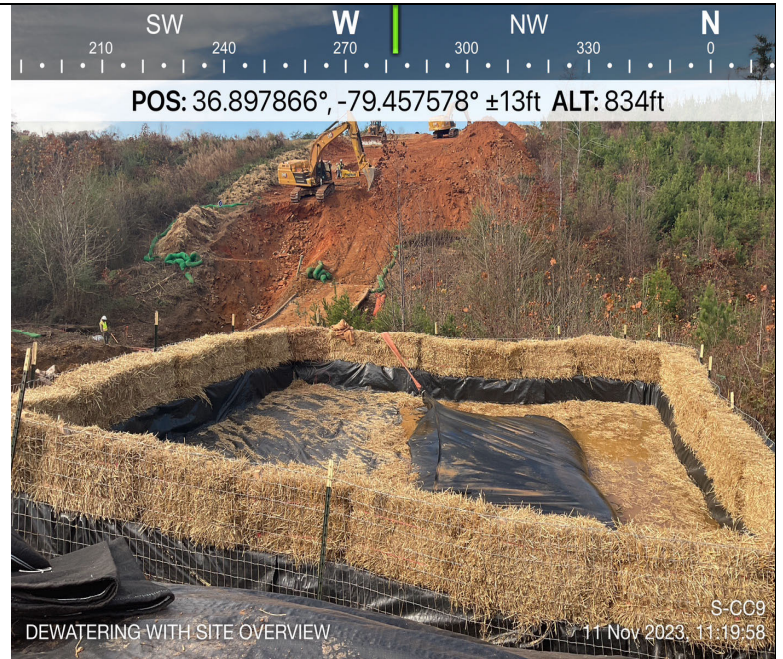
Photo Description: An overview of the dewatering structure installed on the GAS.

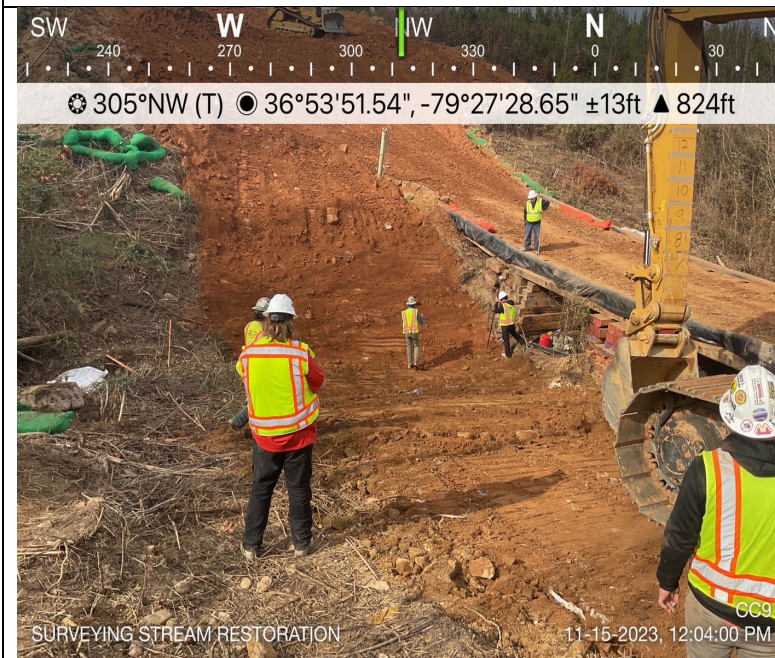
Photo Description: Survey conducted for the stream restoration.

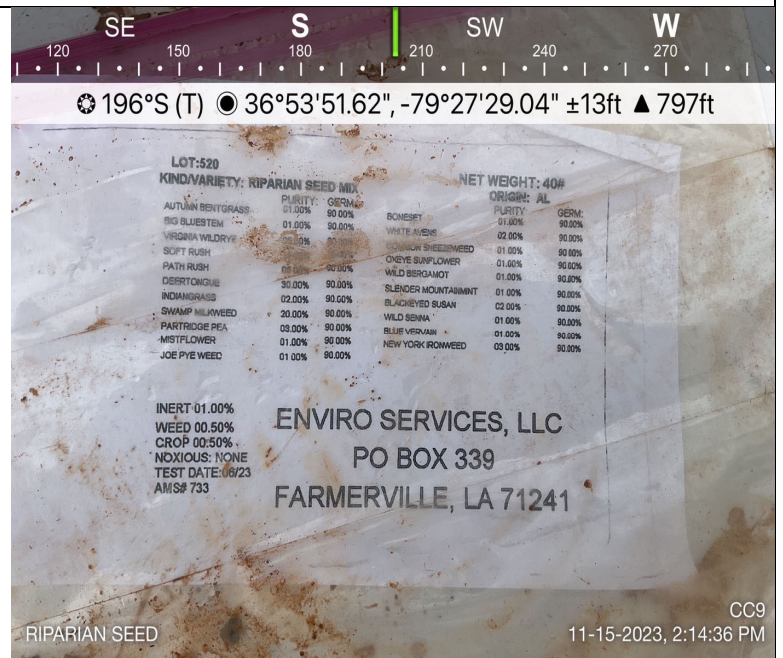
Photo Description: Riparian seed mix installed during restoration.
