# Stream Biological Conditions EA Report

<b>Project Name</b>	H-600 Pipeline Spread F	<b>AFE</b>	124300135	<b>Spread</b>	H-600 Pipeline Spread F
<b>Contractor</b>	Price Gregory	<b>Report #</b>	411		
<b>Environmental Auditor</b>	O'Brien Jonathon	<b>Date/Time</b>	11/22/2023 1:31 PM		
<b>Stream ID</b>	S-D31	<b>Crossing Start Date</b>	11/24/2023	<b>Crossing Completion Date</b>	12/1/2023
<b>Milepost</b>	182.95	<b>Pre-Con Assessment Date</b>	11/22/2023	<b>Post-Con Assessment Date</b>	12/1/2023
<b>Station</b>	9659+76	<b>Bankfull Width (ft.)</b>	65.0	<b>Riffle:Pool Complexes Present?</b>	No
<b>State</b>	WV	<b>Stream Classification</b>	Perennial		
<b>County</b>	Monroe	<b>303(d) Impairment Listing</b>	Biological, Fecal

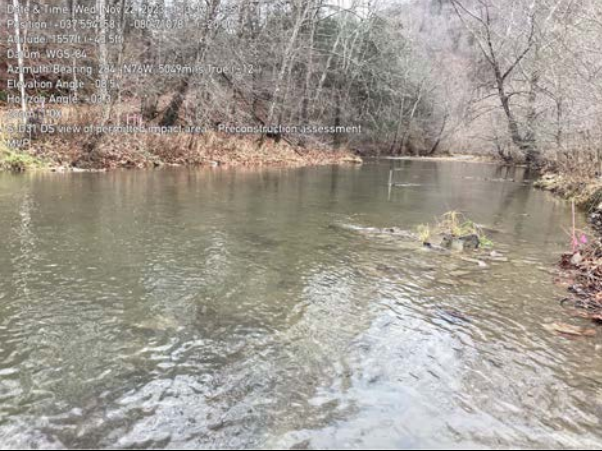
AFE 124300135		Date/Time 11/22/2023 1:31 PM		Report # 411	
Required Photos					
<p>Date &amp; Time Wed, Nov 22, 2023 at 1:28:55 EST  Position: +037.5542581, -080.716931 (-20.0H)  Altitude: 15571 (+42.0H)  Datum: WGS-84  Azimuth Bearing: 284 N76W 5009mils True (+12)  Elevation Angle: +0.4  Horizon Angle: +0.3  Zoom: 1.0X  SD31 Downstream view of permitted impact area during pre-construction assessment  MVP</p>

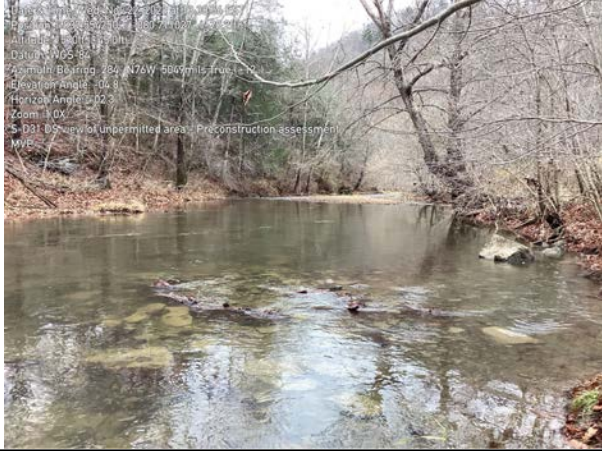
<p>Date &amp; Time Wed, Nov 22, 2023 at 1:28:55 EST  Position: +037.5542581, -080.716931 (-20.0H)  Altitude: 15571 (+42.0H)  Datum: WGS-84  Azimuth Bearing: 284 N76W 5009mils True (+12)  Elevation Angle: +0.4  Horizon Angle: +0.3  Zoom: 1.0X  SD31 Downstream view of unimpacted area during pre-construction assessment  MVP</p>

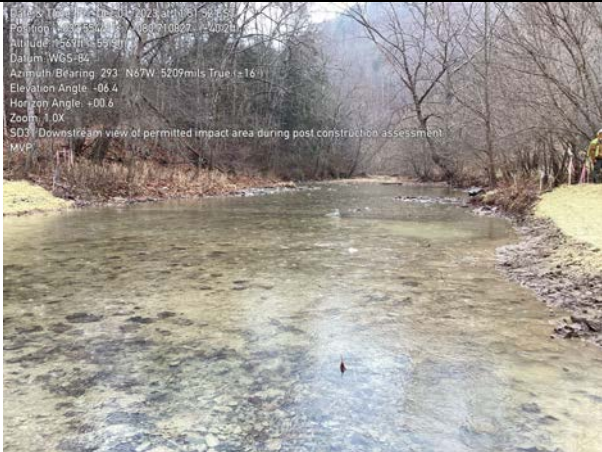
<p>Date &amp; Time Wed, Nov 22, 2023 at 1:51:56 EST  Position: +037.5542591, -080.716927 (-20.0H)  Altitude: 15670 (+42.0H)  Datum: WGS-84  Azimuth Bearing: 293 N67W 5209mils True (+16)  Elevation Angle: +08.4  Horizon Angle: +00.6  Zoom: 1.0X  SD31 Downstream view of permitted impact area during post construction assessment  MVP</p>

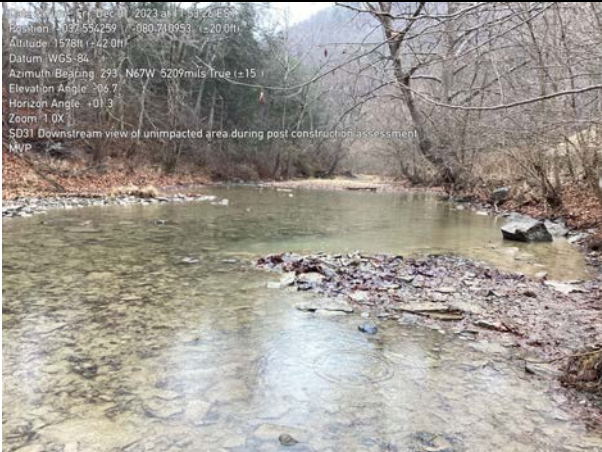
<p>Date &amp; Time Wed, Nov 22, 2023 at 1:51:26 EST  Position: +037.5542591, -080.716931 (-20.0H)  Altitude: 15788 (+42.0H)  Datum: WGS-84  Azimuth Bearing: 293 N67W 5209mils True (+15)  Elevation Angle: +08.2  Horizon Angle: +01.3  Zoom: 1.0X  SD31 Downstream view of unimpacted area during post construction assessment  MVP</p>

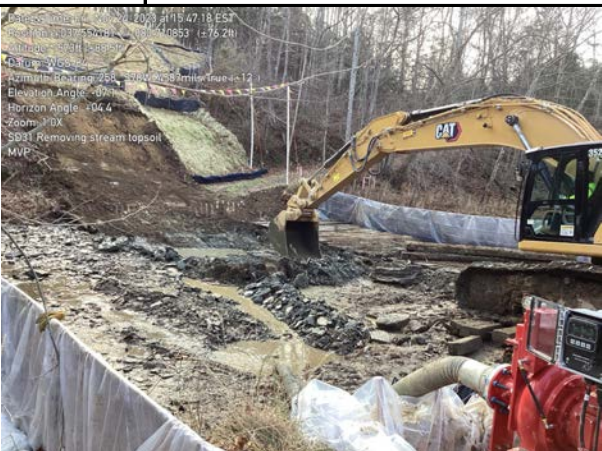
<p>Date &amp; Time Fri, Nov 24, 2023 at 15:47:18 EST  Position: +037.5541177, -080.716077 (-20.0H)  Altitude: 15790 (+42.0H)  Datum: WGS-84  Azimuth Bearing: 285 N65W 5200mils True (+12)  Elevation Angle: +08.3  Horizon Angle: +02.4  Zoom: 1.0X  SD31 Removing stream topsoil  MVP</p>

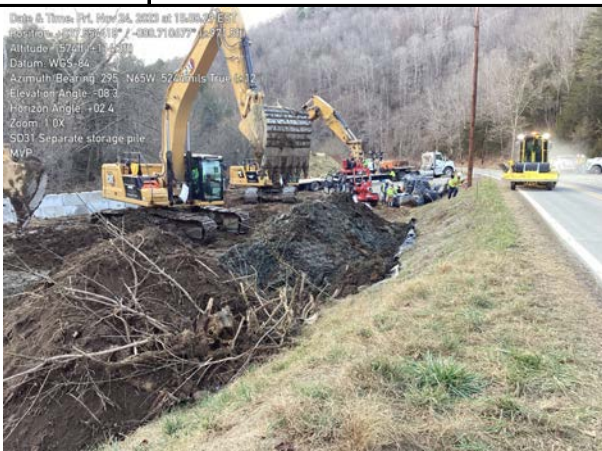
<p>Date &amp; Time Fri, Nov 24, 2023 at 15:48:29 EST  Position: +037.5541177, -080.716077 (-20.0H)  Altitude: 15790 (+42.0H)  Datum: WGS-84  Azimuth Bearing: 285 N65W 5200mils True (+12)  Elevation Angle: +08.3  Horizon Angle: +02.4  Zoom: 1.0X  SD31 Segregated substrate and topsoil from banks.  MVP</p>
