# STREAM BIOLOGICAL CONDITIONS ENVIRONMENTAL AUDITOR REPORT

Version 2.3

<b>Stream ID:</b> S-D8	<b>Crossing Start Date:</b> 11/10/2023	<b>Crossing Completion Date:</b> 11/20/2023
<b>Milepost:</b> 249.8	<b>Pre-Con Assessment Date:</b> 10/31/2023	<b>Post-Con Assessment Date:</b> 11/24/2023
<b>Station:</b> 13196+68	<b>Stream Classification:</b> Perennial (Perennial, Intermittent, Ephemeral)	<b>Bankfull Width (ft.):</b> 18
<b>County:</b> Franklin	<b>303(d) Impairment Listing:</b> Impaired	<b>Riffle:Pool Complexes Present?</b> No

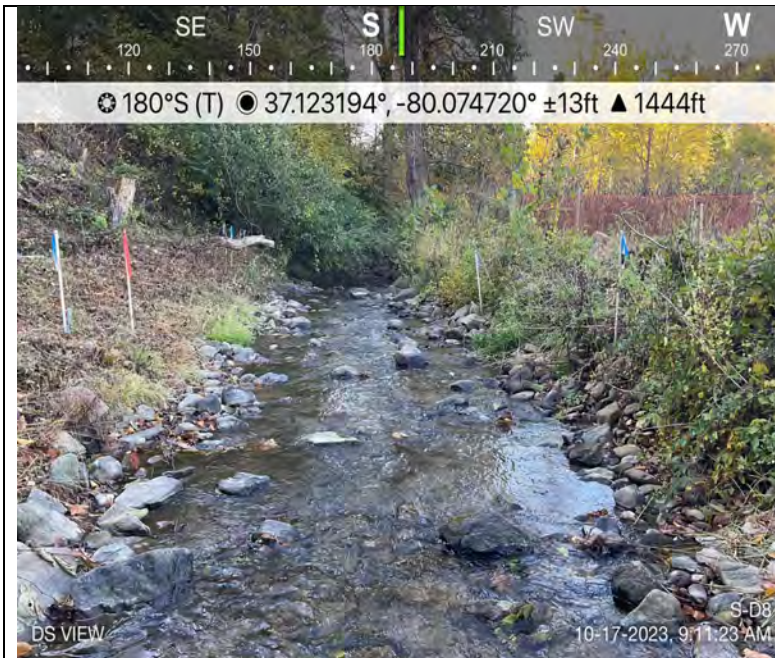
**Photo Description:** Downstream view of permitted impact area during pre-construction assessment.

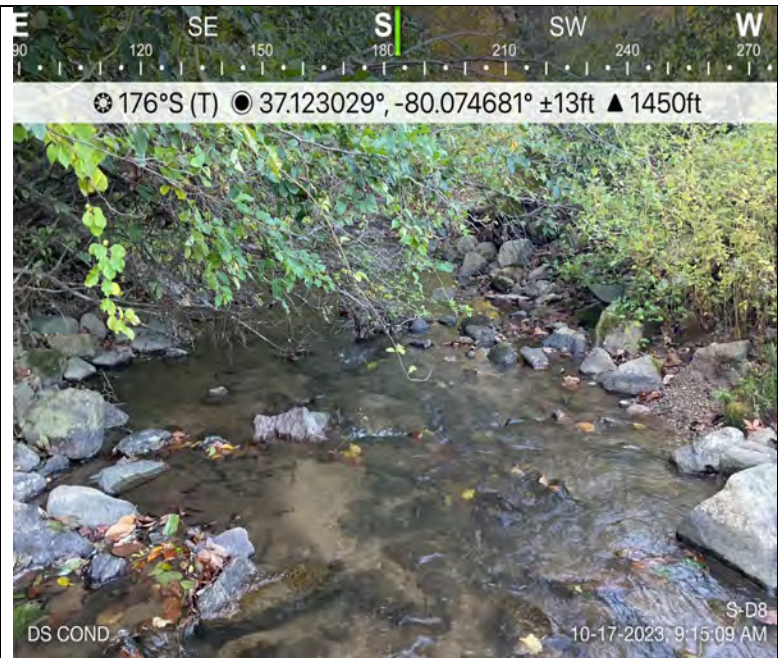
**Photo Description:** Conditions of the downstream area outside the ROW during pre-construction assessment.

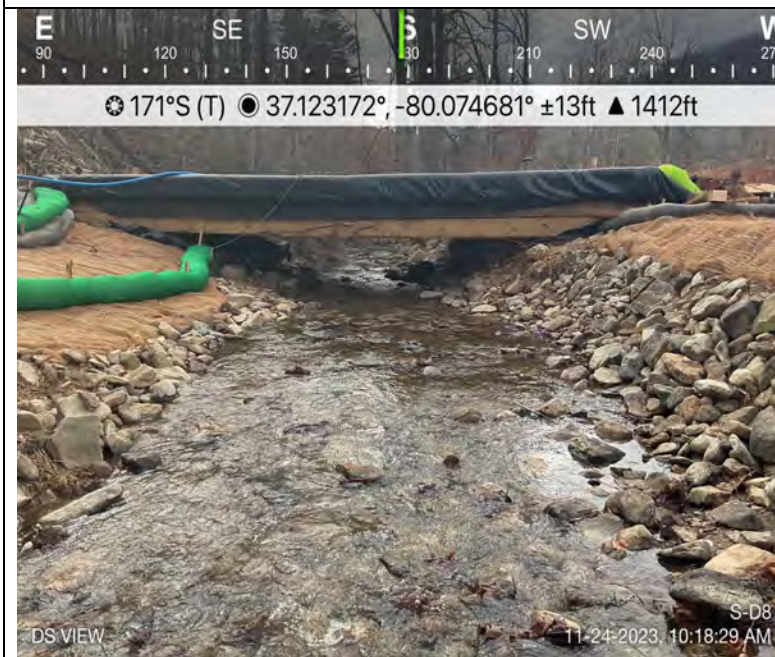
**Photo Description:** Downstream view of permitted impact area during post-construction assessment.

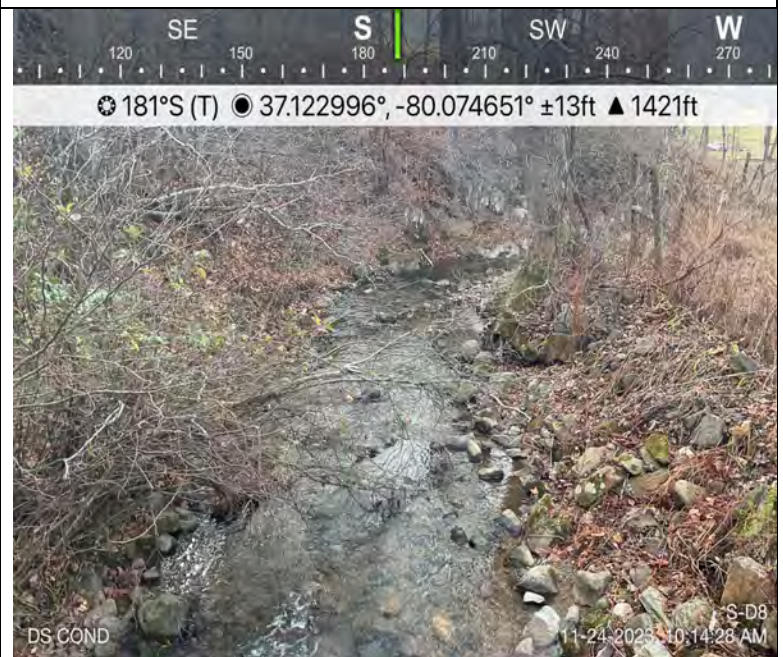
**Photo Description:** Conditions of the downstream area outside the ROW during post-construction assessment.

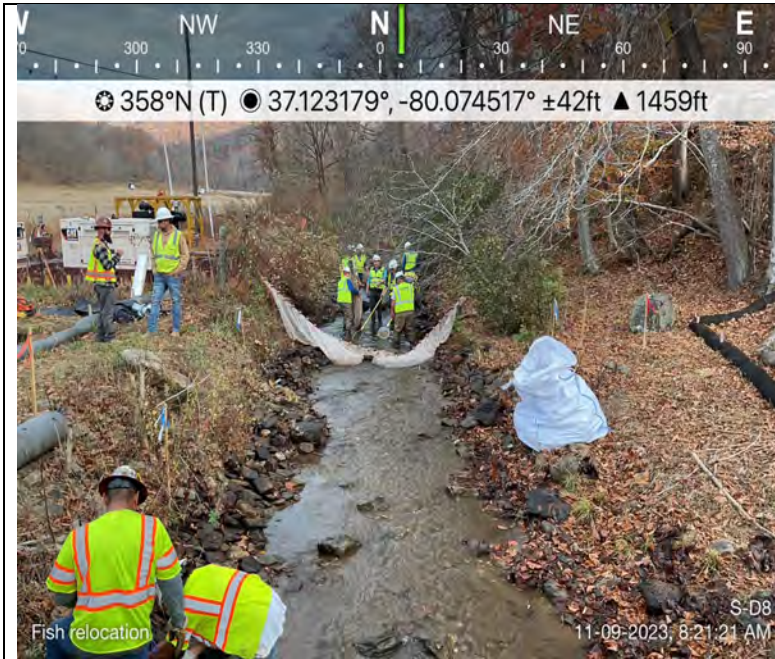
**Photo Description:** Fish relocation within the stream. The fish were relocated downstream. Upstream and downstream fish nets were installed.

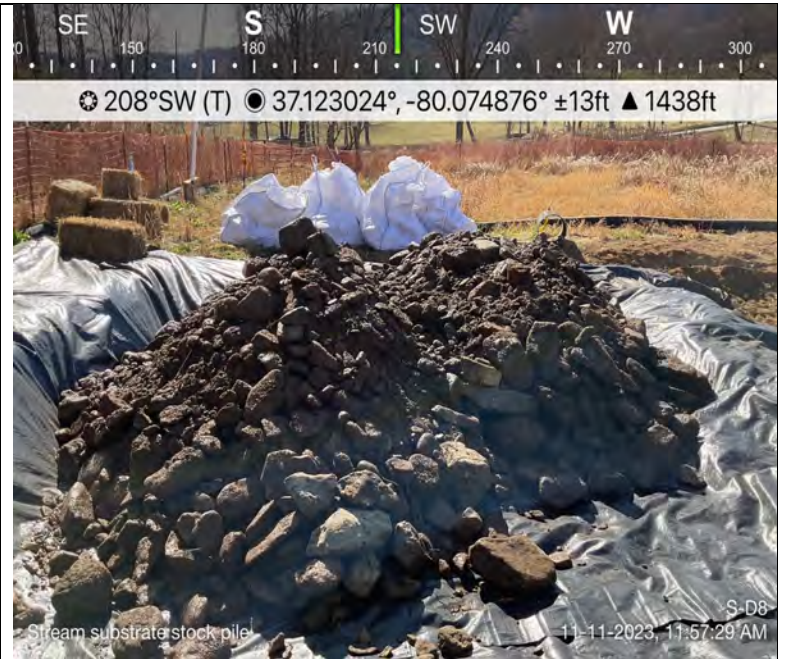
**Photo Description:** Stream substrate and stream cobble stockpiled on timber mats and geotech outside of the 50-foot buffer.

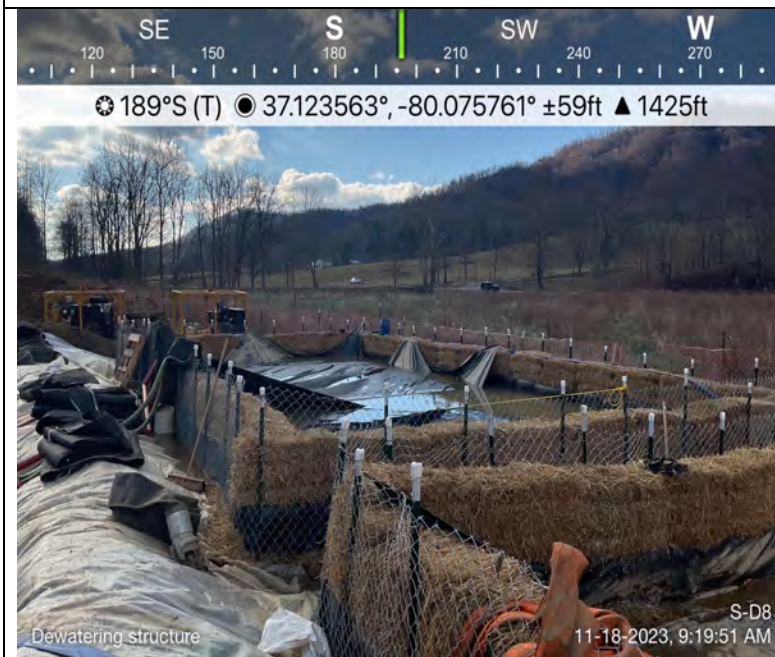
**Photo Description:** Dewatering structures used for filtering ground water from the trench.

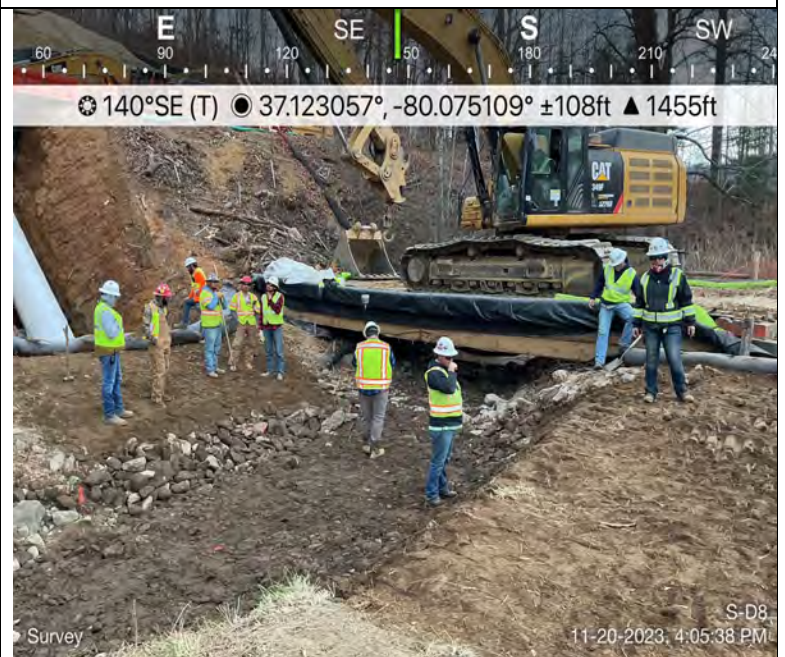
**Photo Description:** Survey shooting the final grade for the stream and banks within the 10-foot buffer.
