STREAM BIOLOGICAL CONDITIONS ENVIRONMENTAL AUDITOR REPORT

Stream ID: S-DD4-Braid-1	Crossing Start Date: 10/31/2023	Crossing Completion Date: 11/20/2023
Milepost: 298.3	Pre-Con Assessment Date: 10/25/2023	Post-Con Assessment Date: 11/22/2023
Station: 15757+93	Stream Classification: Intermittent (Perennial, Intermittent, Ephemeral)	Bankfull Width (ft.): 6
County: Pittsylvania	303(d) Impairment Listing: Not Impaired	Riffle:Pool Complexes Present? No

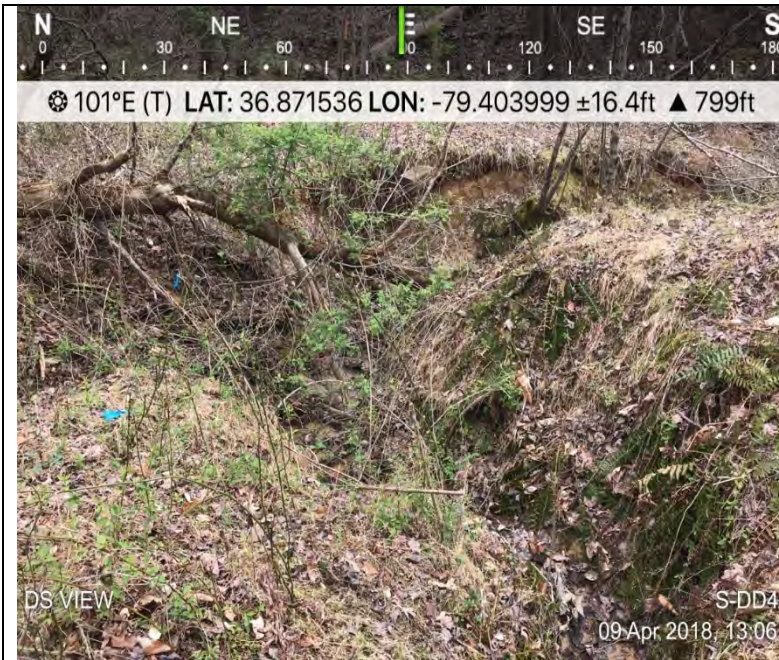
10-25-23: The pre-construction meeting was held. The MVP EI is Heath Benard, and the Precision Pipeline foreman is James Ganson. This resource crossing is to be a temporary impact/crossing, and will remain open and maintained while the adjacent railroad is bored. Construction activities on-site will include both open-cut and trenchless crossing equipment. Due to landowner modifications since permitting, the resource S-DD4-Braid-1 was combined with the adjacent delineated S-DD4, upstream & west of the railroad. There is another S-DD4 crossing further down the ROW on the eastern side of the railroad. This report represents construction activities at the resource crossing for permitted S-DD4 (US) & S-DD4-Braid-1, all west of the railroad. The resource shows signs of bank erosion and sediment deposition within the streambed. -V. Smith

Photo Description: Downstream view of permitted impact area during pre-construction assessment.

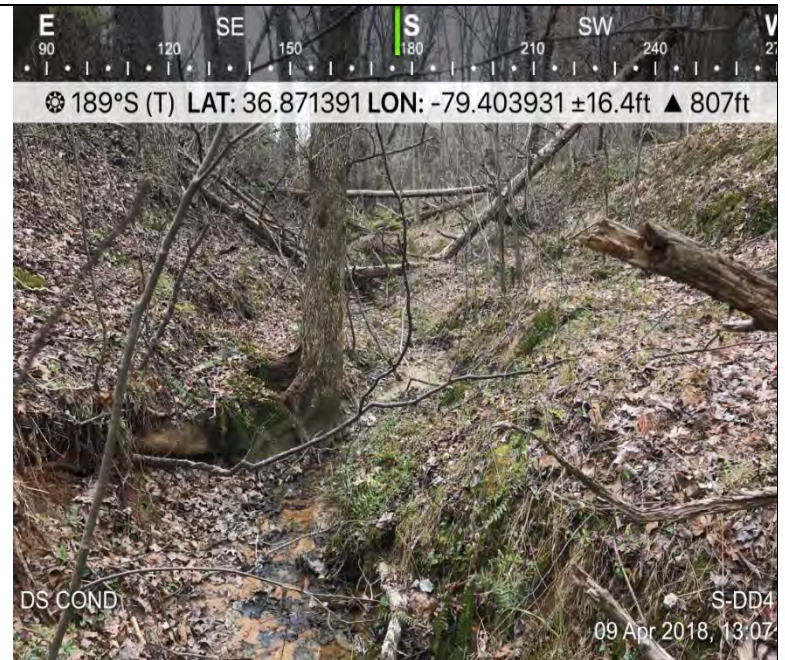
Photo Description: Conditions of the downstream area outside the ROW during pre-construction assessment.

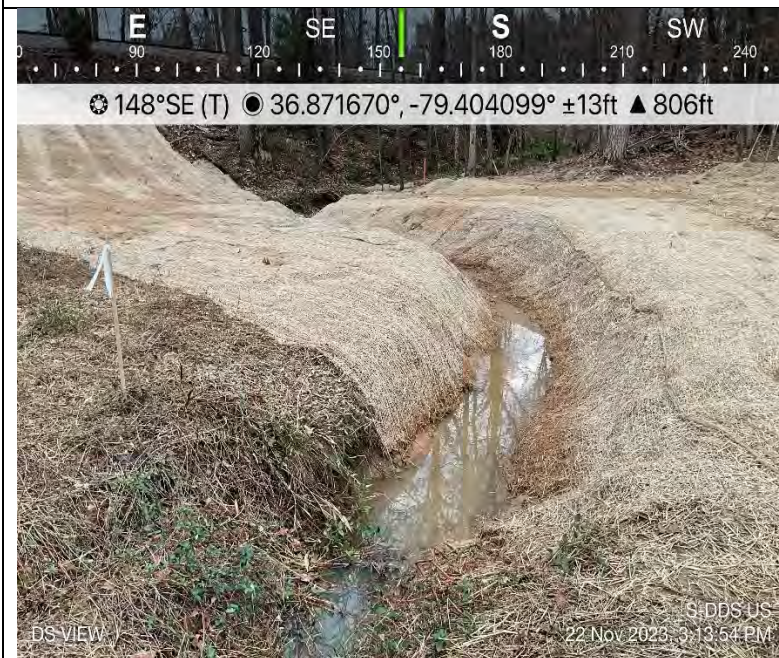
*Restoration of stream bed, topsoil, and substrate. No unauthorized discharge, accumulation of materials outside of resource, or impacts to biological conditions were noted. The crossing was returned to its original function and condition. The stream was restored to its optimal condition. -V. Smith

Photo Description: Downstream view of permitted impact area during post-construction assessment. Site appears different due to landowner modifications and construction activities since 2018.

11-20-23: Site restoration. The crew finished creating the contours of the stream to optimal condition for long term stability, replaced stream substrate, installed erosion control matting, applied seed and straw mulch. -V. Smith

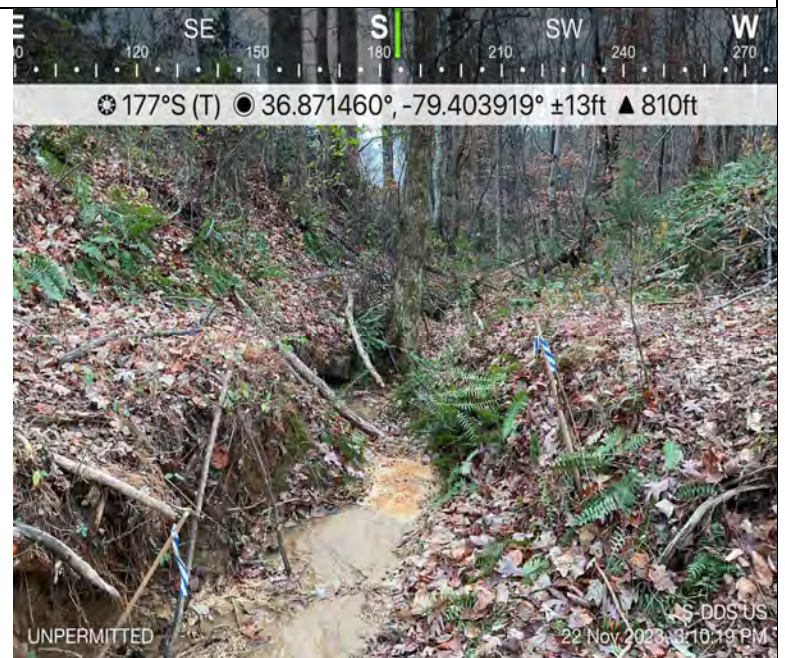
Photo Description: Conditions of the downstream area outside the ROW during post-construction assessment. Site appears different due to landowner modifications and construction activities since 2018.

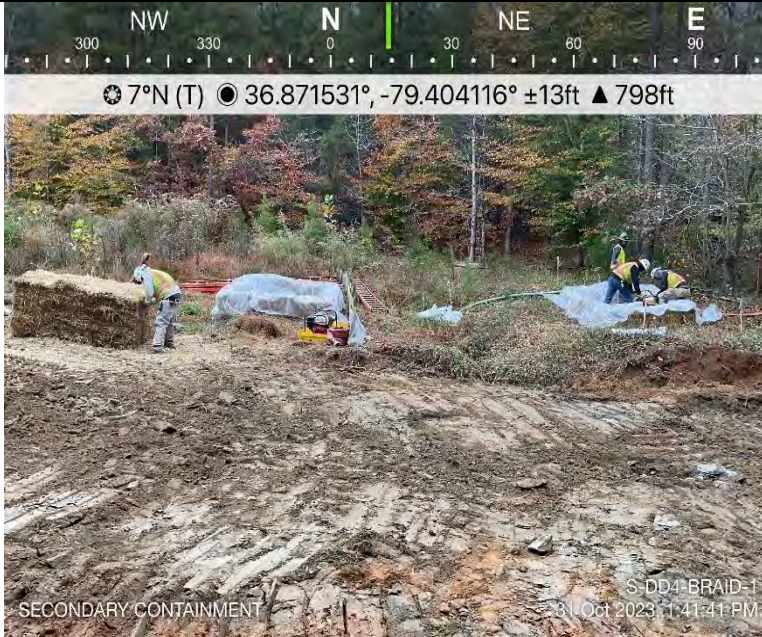
Photo Description: The crew installing secondary containment to be used during construction.

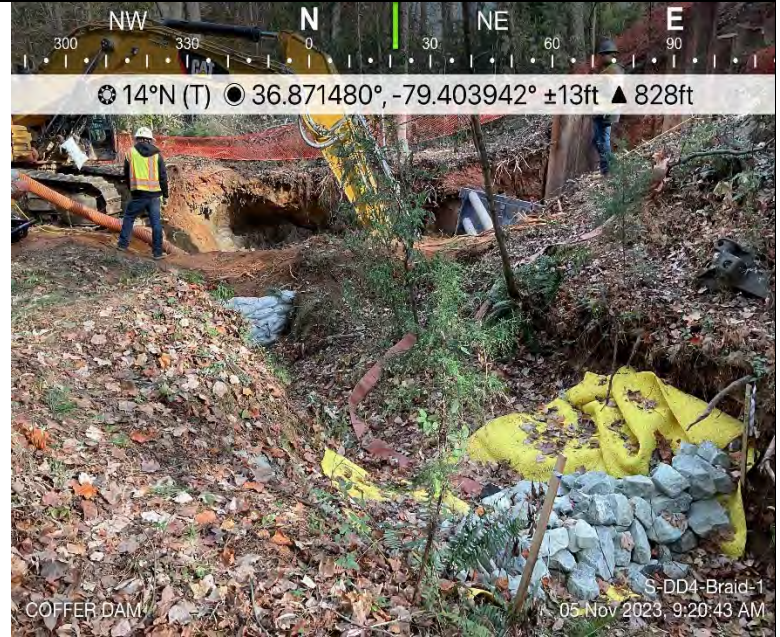
Photo Description: The dam and pump energy dissipation device was installed and maintained throughout the crossing.

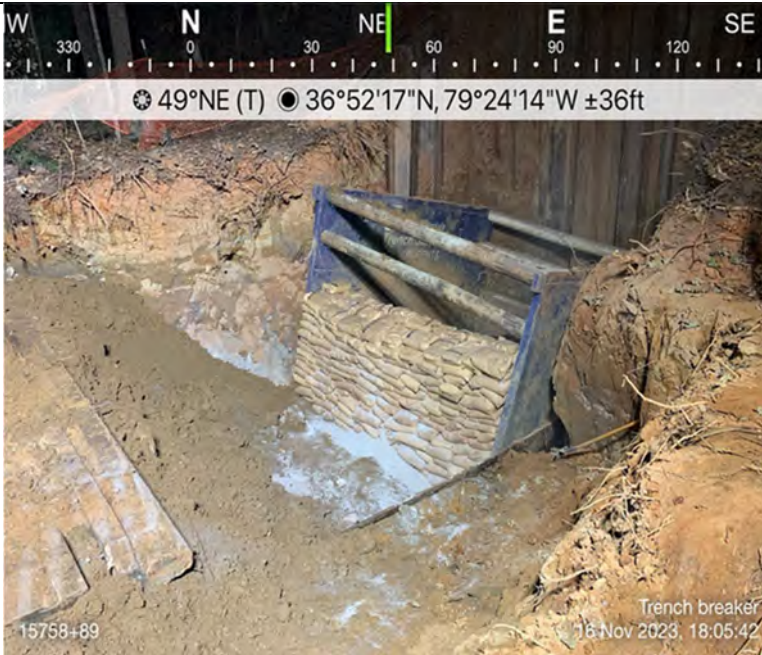
Photo Description: A trench breaker after installation and during subsoil backfill.

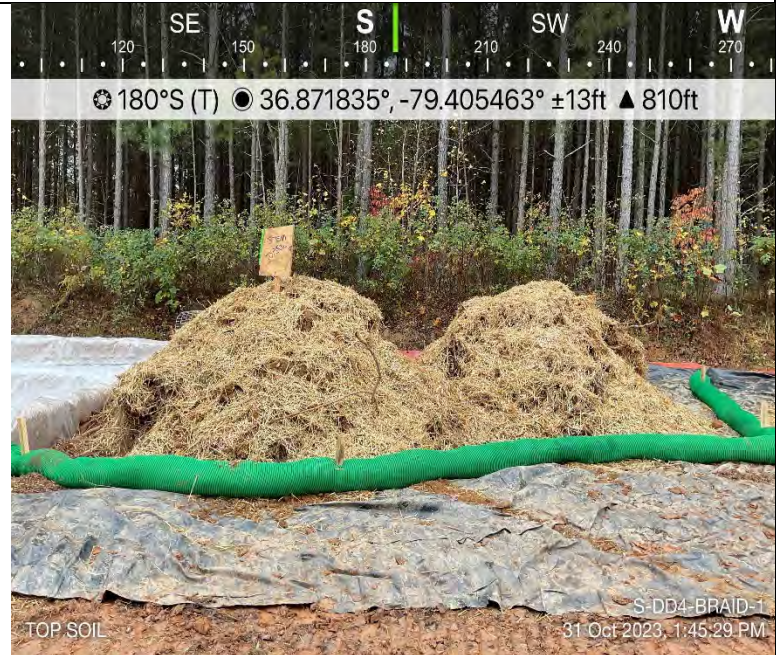
Photo Description: The streambed material was stockpiled separately from subsoil in the upland area on a geotextile liner.
