STREAM BIOLOGICAL CONDITIONS ENVIRONMENTAL AUDITOR REPORT

Stream ID: S-F15	Crossing Start Date: 11/03/2023	Crossing Completion Date: 11/09/2023
Milepost: 229.1	Pre-Con Assessment Date: 11/01/2023	Post-Con Assessment Date: 11/10/2023
Station: 12108+41	Stream Classification: Intermittent (Perennial, Intermittent, Ephemeral)	Bankfull Width (ft.): 6
County: Montgomery	303(d) Impairment Listing: Not Impaired	Riffle:Pool Complexes Present? No

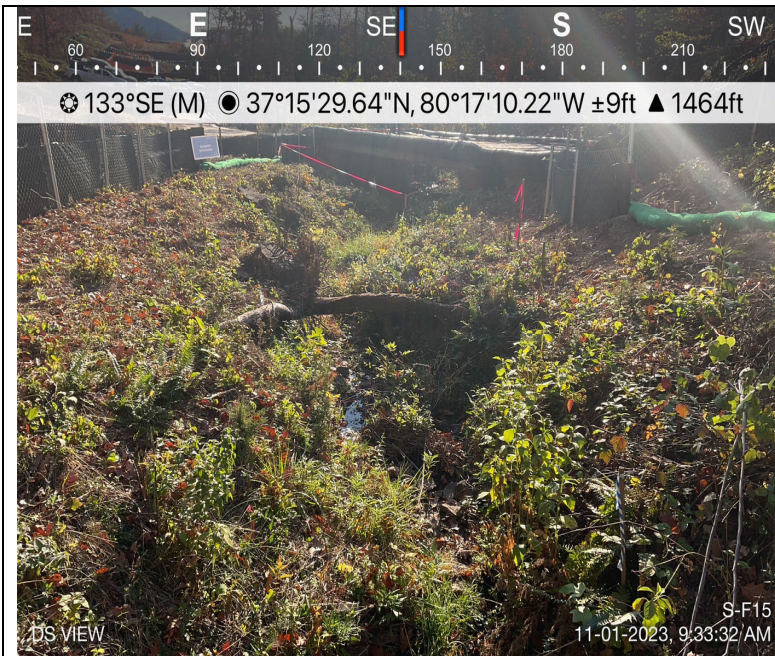
Photo Description: Downstream view of permitted impact area during pre-construction assessment.

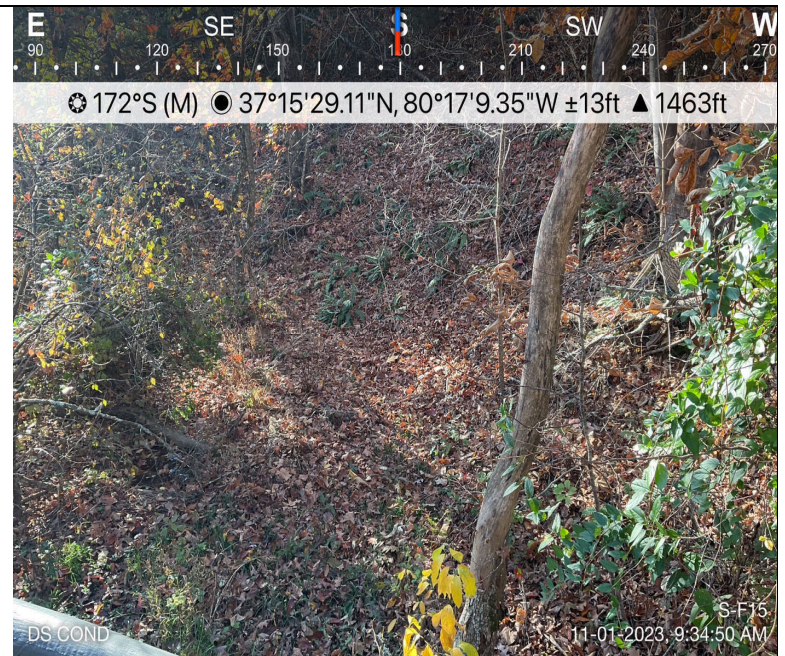
Photo Description: Conditions of the downstream area outside the ROW during pre-construction assessment.

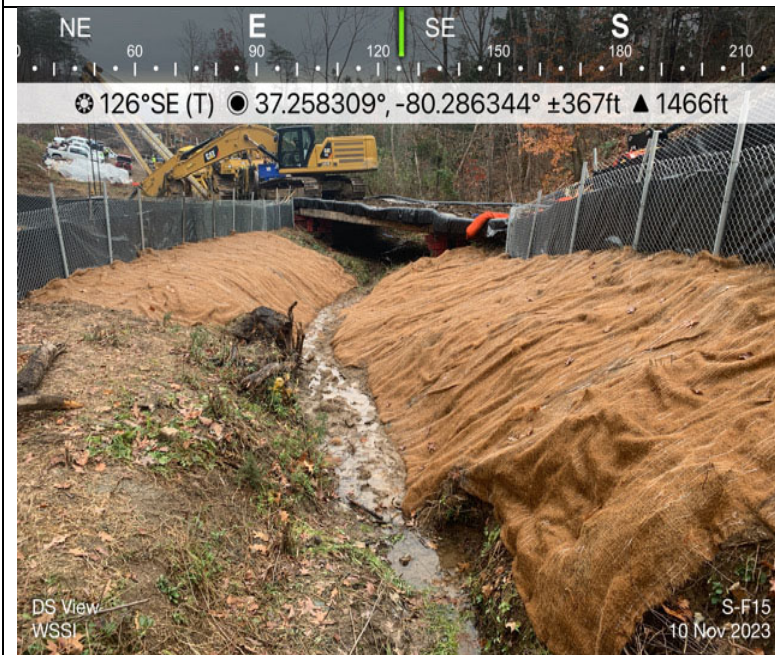
Photo Description: Downstream view of permitted impact area during post-construction assessment.

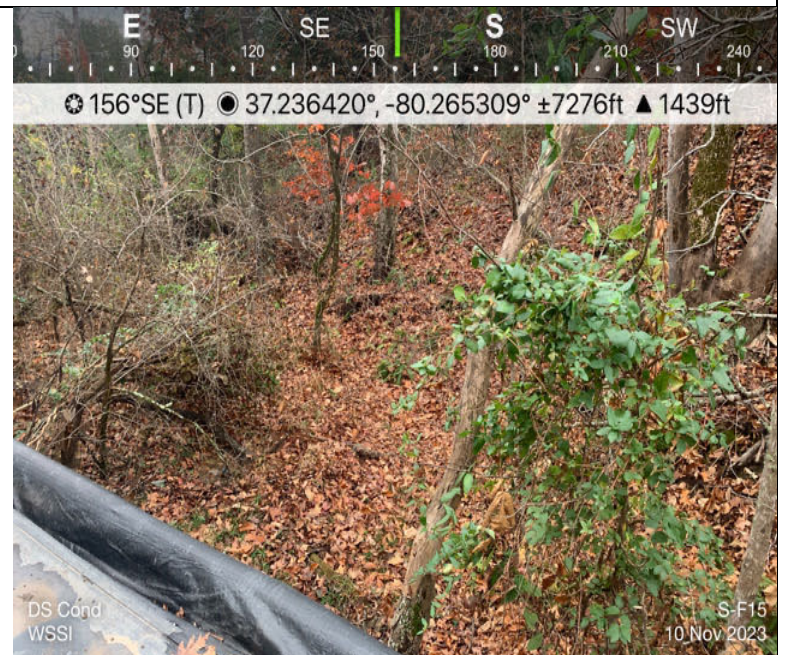
Photo Description: Conditions of the downstream area outside the ROW during post-construction assessment.

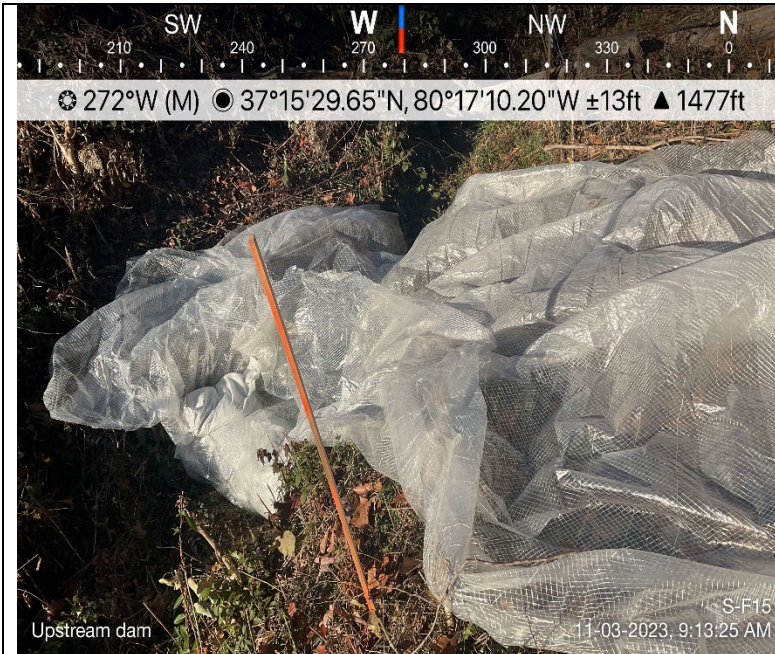
Photo Description: Upstream dam installed and functioning properly

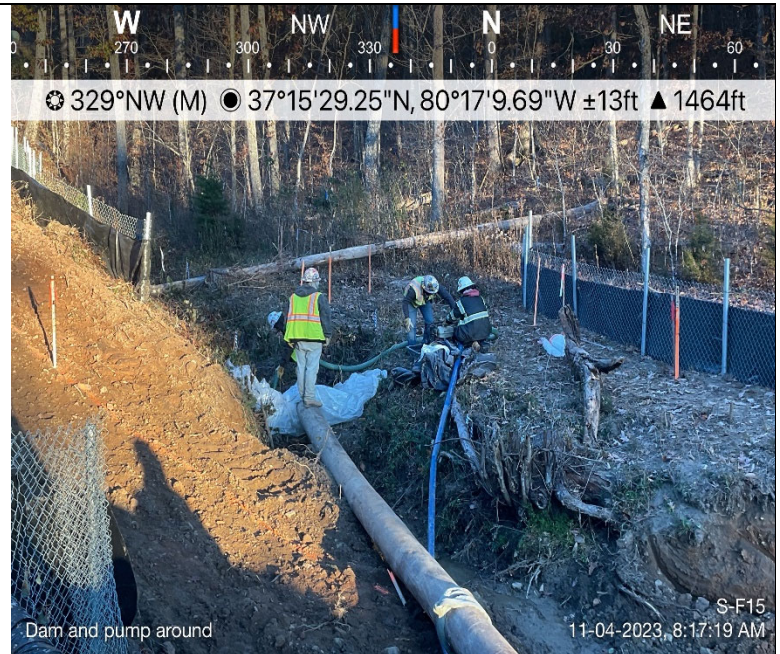
Photo Description: Flume installed. The dam and pump around was utilized when stream work was active.

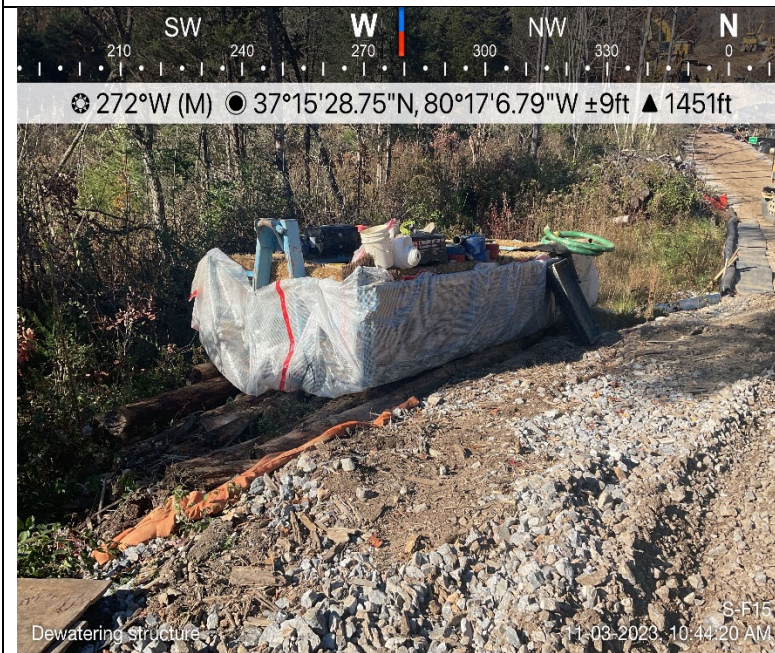
Photo Description: An overview of the dewatering structure.

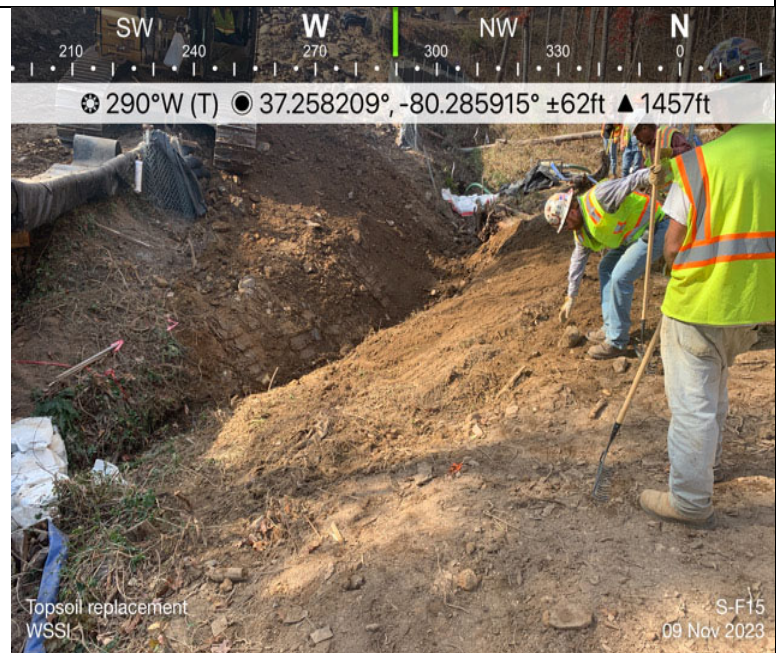
Photo Description: Restoration of the topsoil and survey as-builts.
