# STREAM BIOLOGICAL CONDITIONS ENVIRONMENTAL AUDITOR REPORT

Version 2.3

<b>Stream ID:</b> S-F16a-F16b	<b>Crossing Start Date:</b> 11/11/2023	<b>Crossing Completion Date:</b> 11/16/2023
<b>Milepost:</b> 229.2	<b>Pre-Con Assessment Date:</b> 11/09/2023	<b>Post-Con Assessment Date:</b> 11/16/2023
<b>Station:</b> 12112+13	<b>Stream Classification:</b> Ephemeral (Perennial, Intermittent, Ephemeral)	<b>Bankfull Width (ft.):</b> 3
<b>County:</b> Montgomery	<b>303(d) Impairment Listing:</b> Not Impaired	<b>Riffle:Pool Complexes Present?</b> No

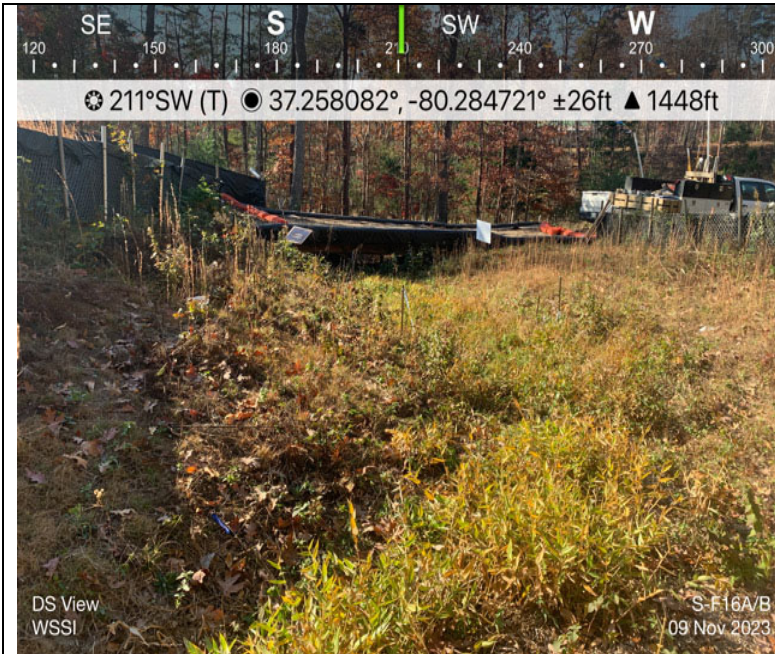
**Photo Description:** Downstream view of permitted impact area during pre-construction assessment.

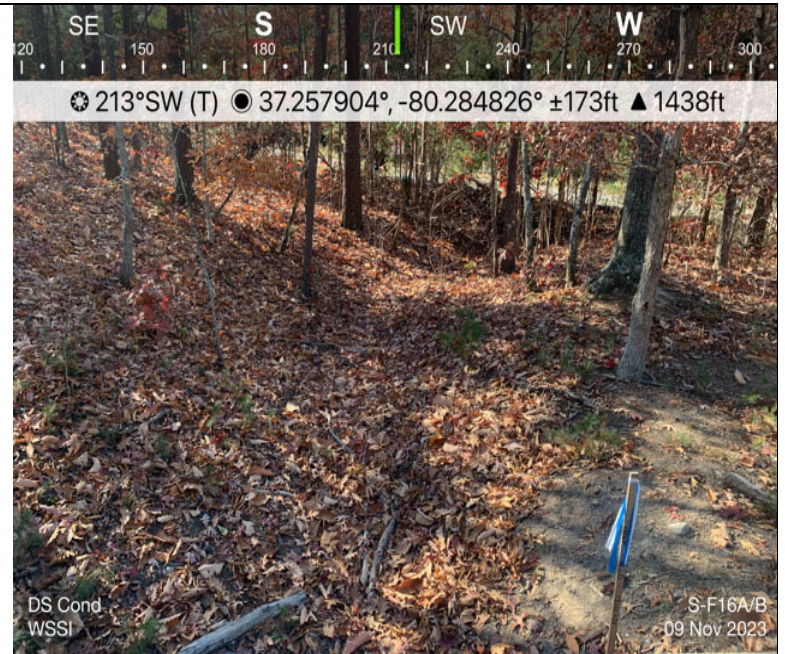
**Photo Description:** Conditions of the downstream area outside the ROW during pre-construction assessment.

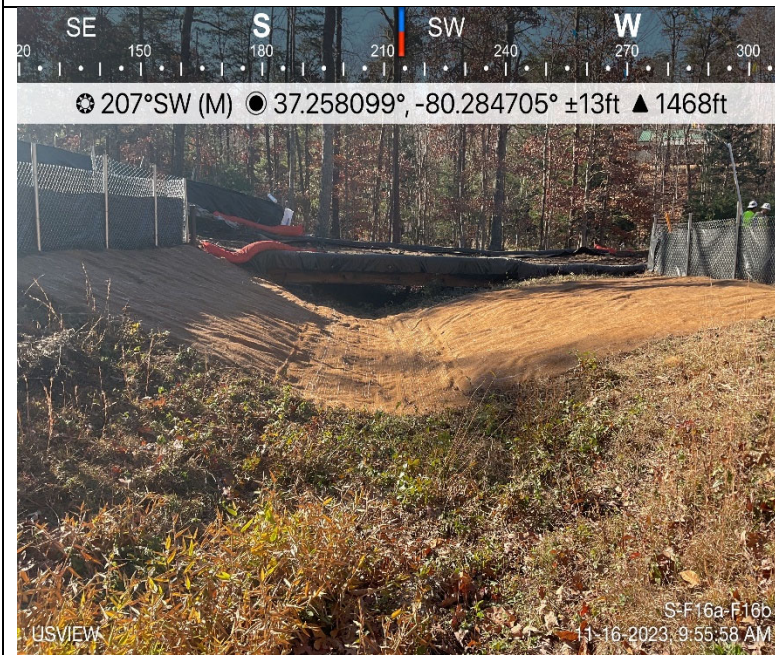
**Photo Description:** Downstream view of permitted impact area during post-construction assessment.

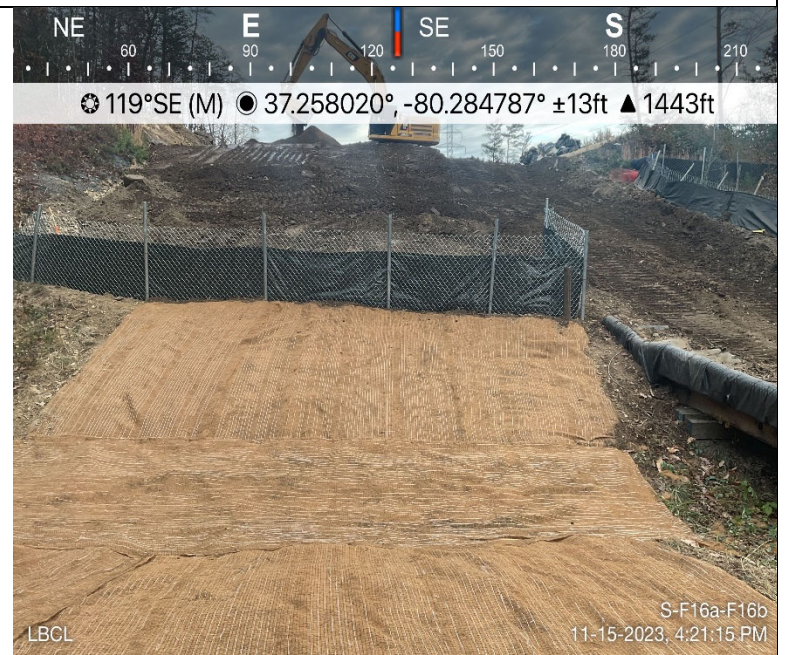
**Photo Description:** Standing on left bank viewing the centerline across the impact area. Area under the bridge and downstream areas remain unimpacted by construction activity.

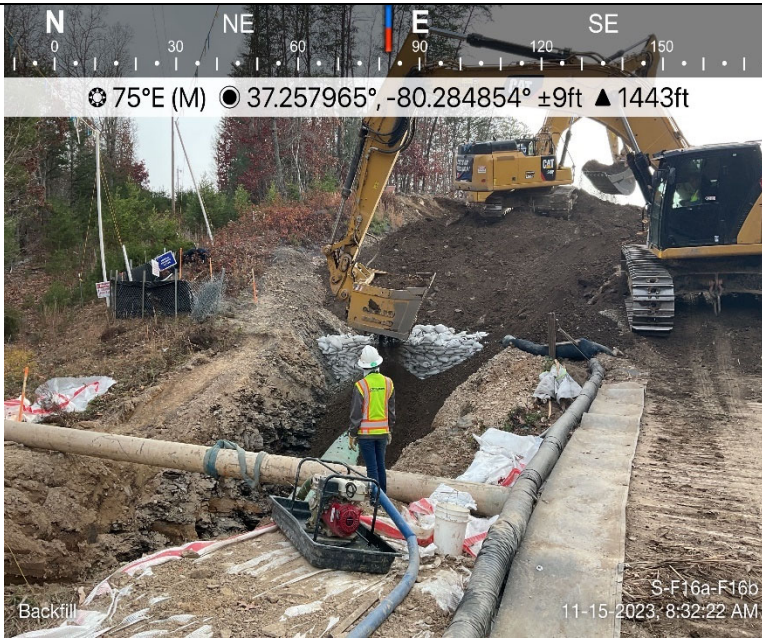
**Photo Description:** Padding the pipe with subsoil prior to full subsoil backfill and final restoration. Trenchbreaker installed and flume remained installed throughout crossing.

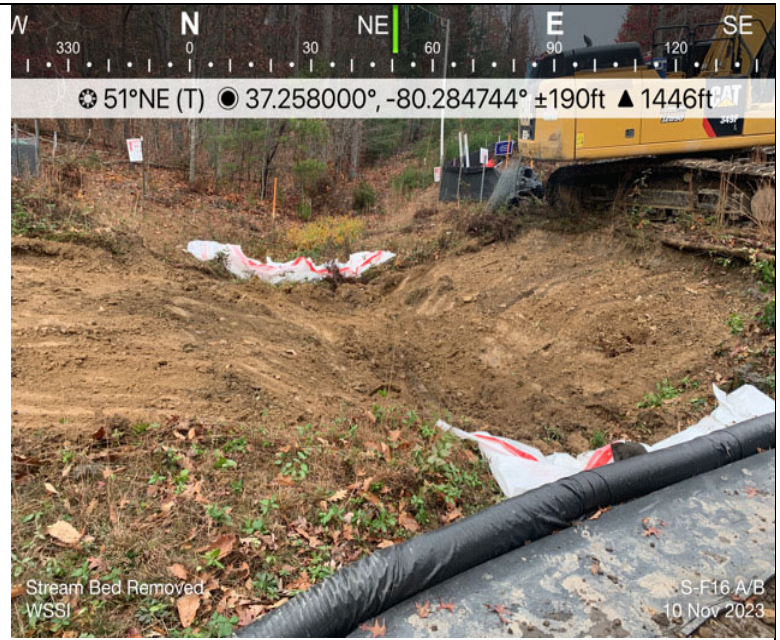
**Photo Description:** Streambed and buffer zone topsoil removed and stockpiled separately prior to subsoil excavation.

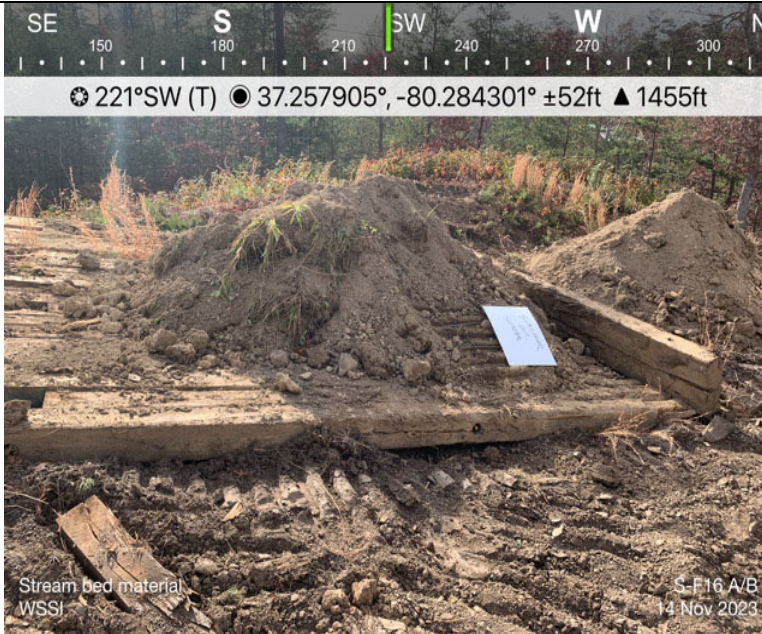
**Photo Description:** Top 12" of streambed substrate segregated and stockpiled separately.

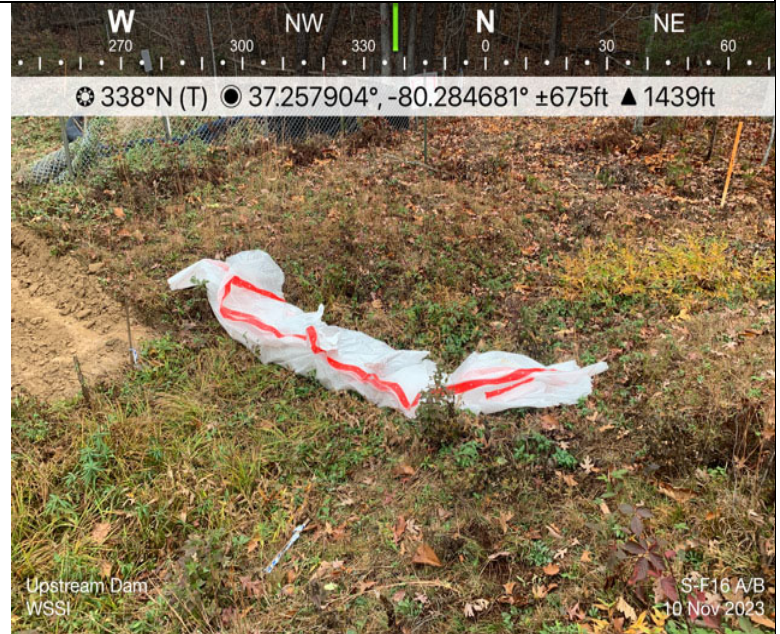
**Photo Description:** Upstream dam installed and operating prior to in-stream work activity.
