STREAM BIOLOGICAL CONDITIONS ENVIRONMENTAL AUDITOR REPORT

Stream ID: S-G16	Crossing Start Date: 10/21/2023	Crossing Completion Date: 11/20/2023
Milepost: 282.3	Pre-Con Assessment Date: 10/05/2023	Post-Con Assessment Date: 11/22/2023
Station: 14915+84	Stream Classification: Perennial (Perennial, Intermittent, Ephemeral)	Bankfull Width (ft.): 30
County: Franklin	303(d) Impairment Listing: Not Impaired	Riffle:Pool Complexes Present? No

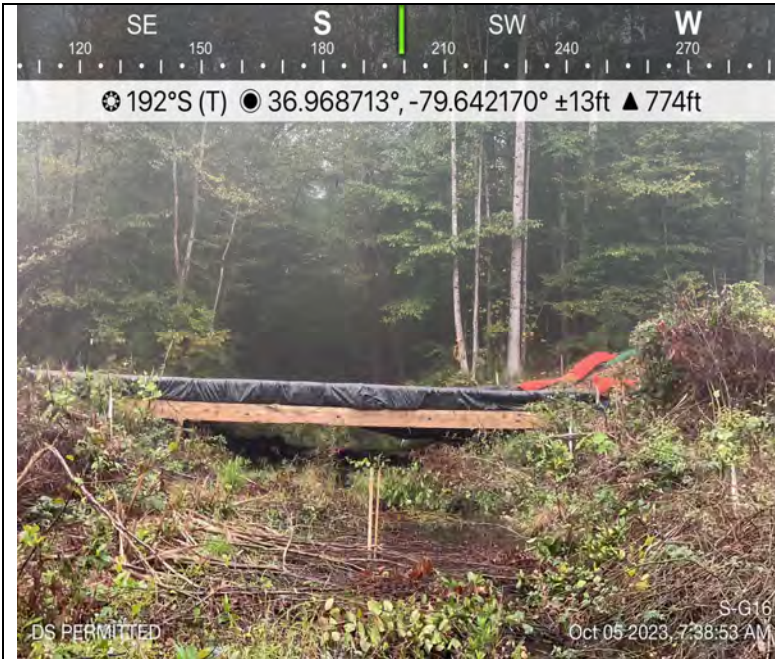
Photo Description: Downstream view of permitted impact area during pre-construction assessment.

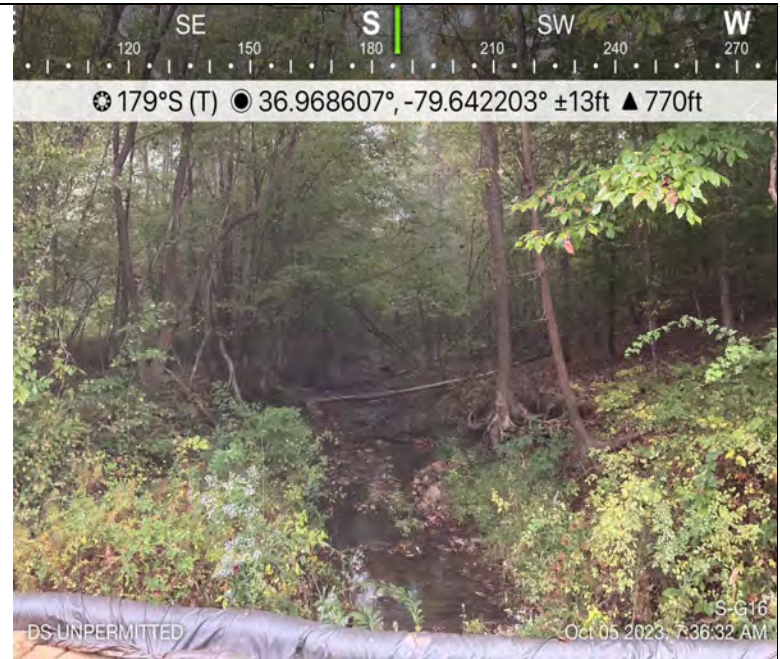
Photo Description: Conditions of the downstream area outside the ROW during pre-construction assessment.

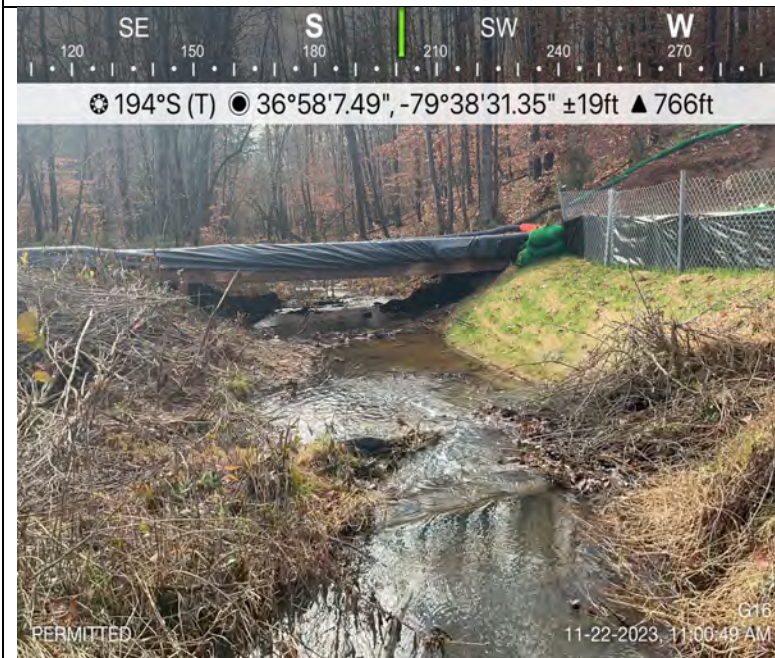
Photo Description: Downstream view of permitted impact area during post-construction assessment.

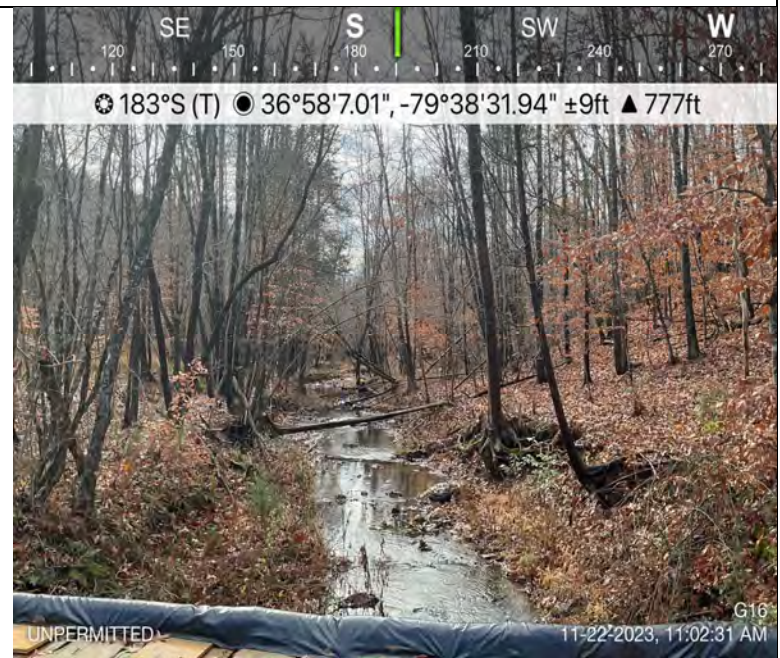
Photo Description: Conditions of the downstream area outside the ROW during post-construction assessment.

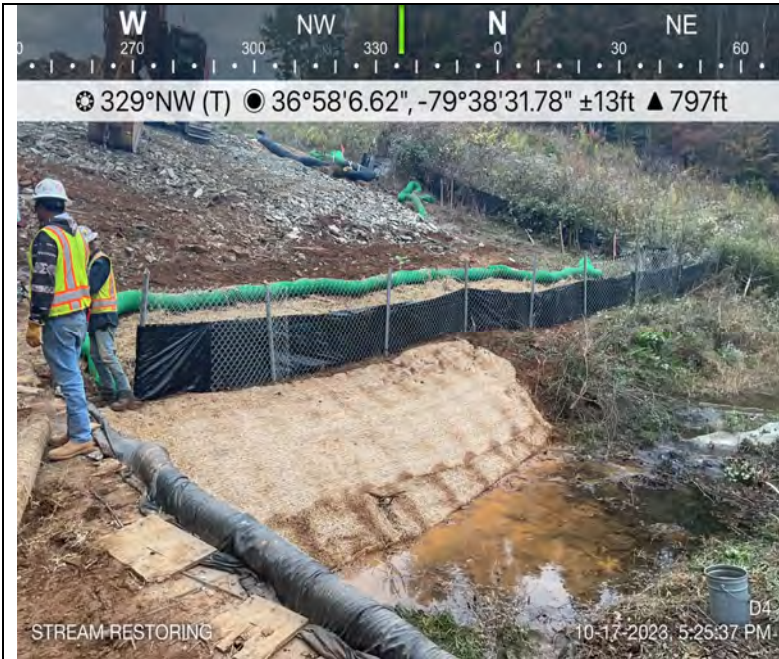
ITEM #14 10-17-23: Excavating the GAS for bore pit. Set up the CIS for blasting. Blasting caused *tire mats* to shift into the stream. All other work stopped for mitigation. The total disturbed area is 25'x12.5' from the middle of stream to the buffer zone. Mats and rock were removed from the stream and the streambed by the environmental crew. The streambed was restored to the correct slope, temporary seed was applied, and the area was blanketed with erosion control sediment blankets. Filter socks were also installed. -G. Aceves

Photo Description: Stream restoration after the unauthorized discharge.

* ITEM #14* 10-18-23: The environmental crew returned to remove the rock dam and apply permanent riparian seed to the disturbed resource area. The stream and streambank are now restored. The GAS was excavated, and trench boxes were installed at 15-feet from ground level. -G. Aceves

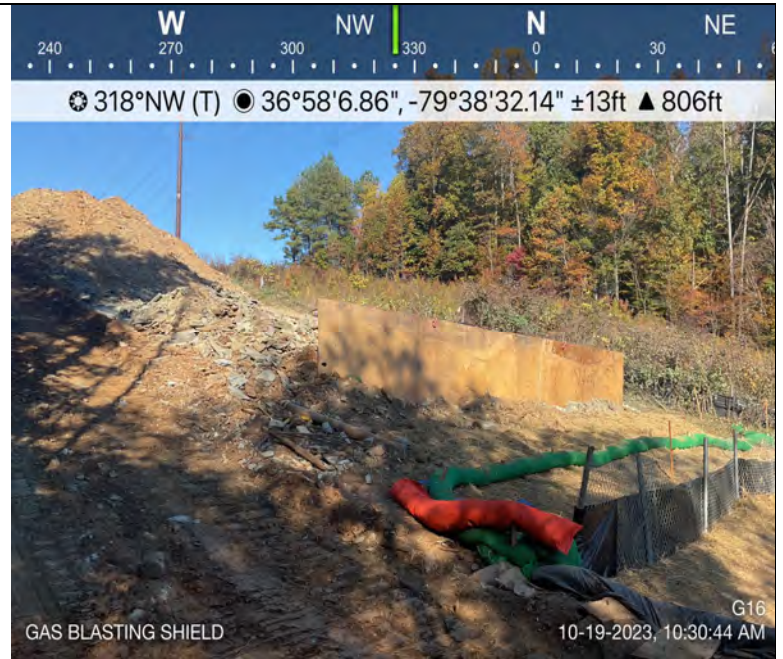
Photo Description: Stream protection installed for blasting activities.

10-19-23: Continued excavating the GAS entry pit. Installed and stabilized a second trench box. A metal wall was created for the second CIS blasting to obstruct material from falling into the stream. The blasting crew dug holes in preparation. -G. Aceves

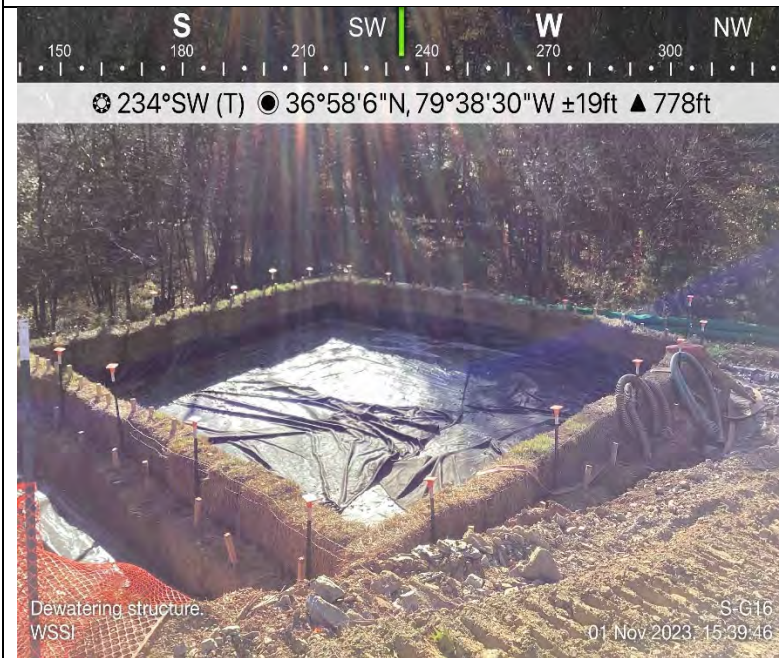
Photo Description: An overview of the dewatering structure.

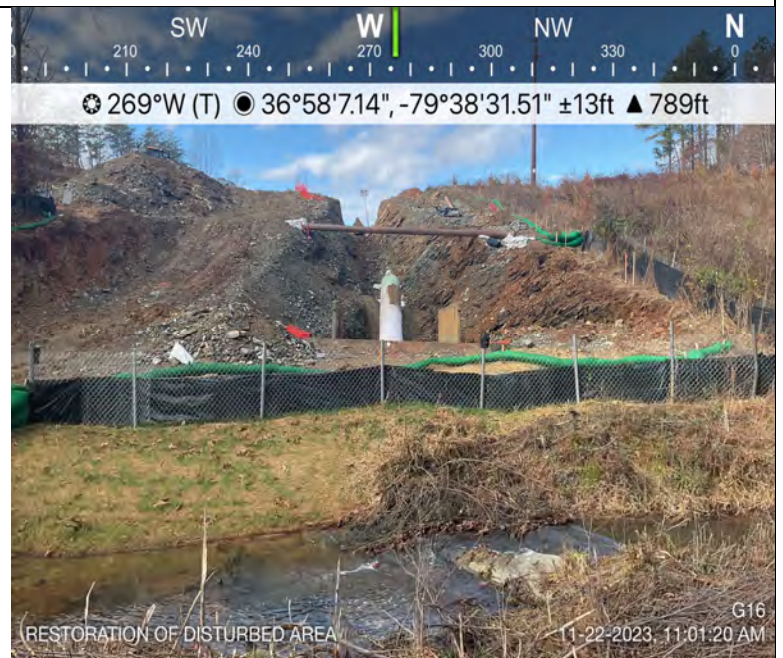
Photo Description: Stream restoration approximately one month after the unauthorized discharge.
