STREAM BIOLOGICAL CONDITIONS ENVIRONMENTAL AUDITOR REPORT

Stream ID: S-G18	Crossing Start Date: 09/28/2023	Crossing Completion Date: 09/30/2023
Milepost: 275	Pre-Con Assessment Date: 09/27/2023	Post-Con Assessment Date: 09/30/2023
Station: 14531+15	Stream Classification: Intermittent (Perennial, Intermittent, Ephemeral)	Bankfull Width (ft.): 2
County: Franklin	303(d) Impairment Listing: Not Impaired	Riffle:Pool Complexes Present? No

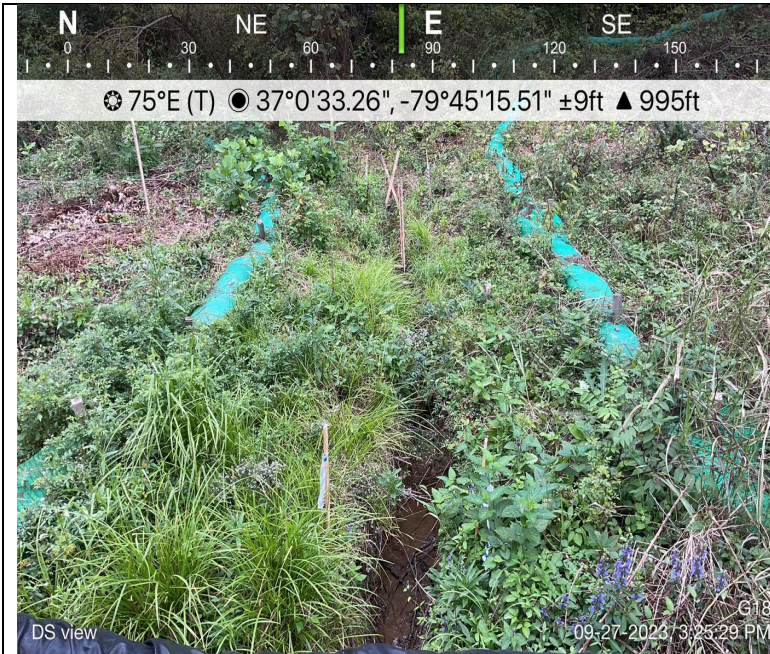
Photo Description: Upstream view of permitted impact area during pre-construction assessment. Typo on photo watermark.

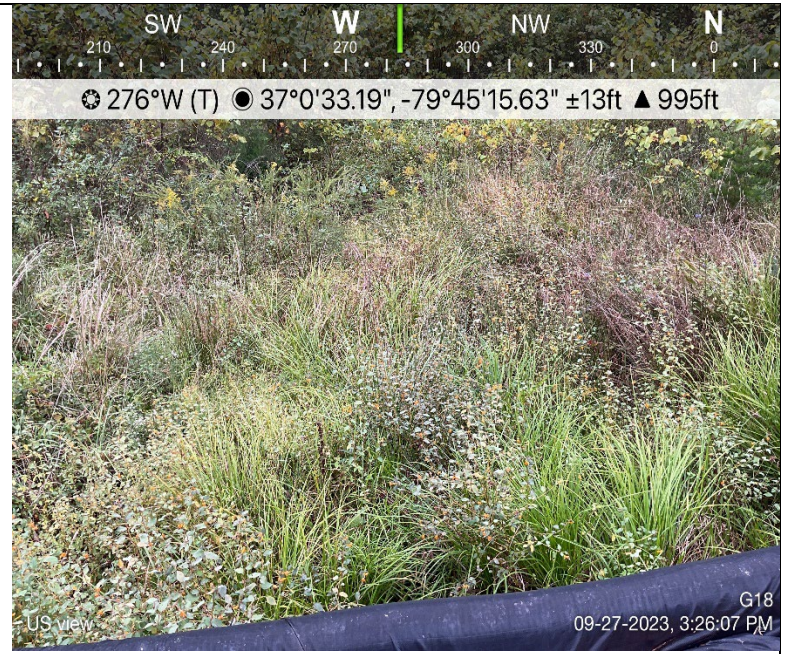
Photo Description: Conditions of the downstream area outside the ROW during pre-construction assessment. Typo on photo watermark

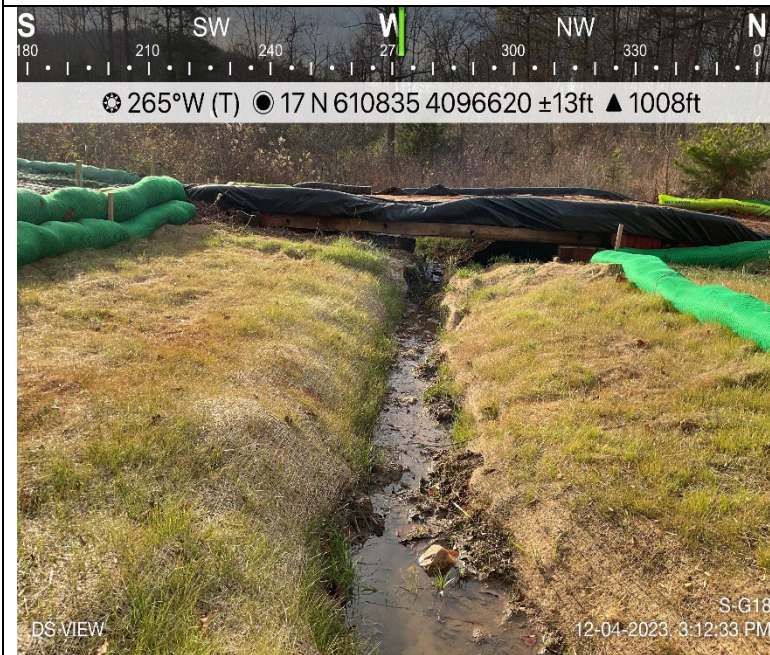
Photo Description: Downstream view of permitted impact area during post-construction assessment.

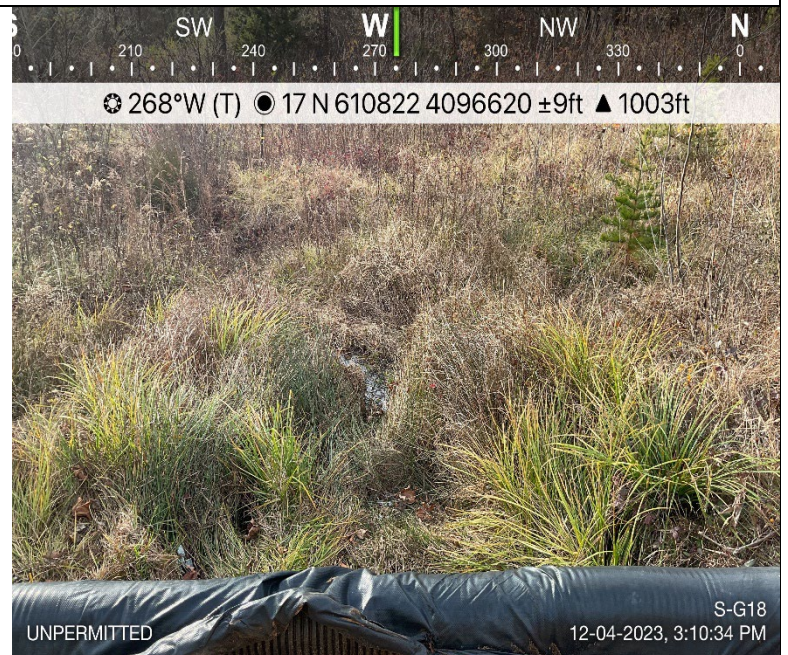
Photo Description: Conditions of the unpermitted downstream area outside the ROW during post-construction assessment. No impacts observed.

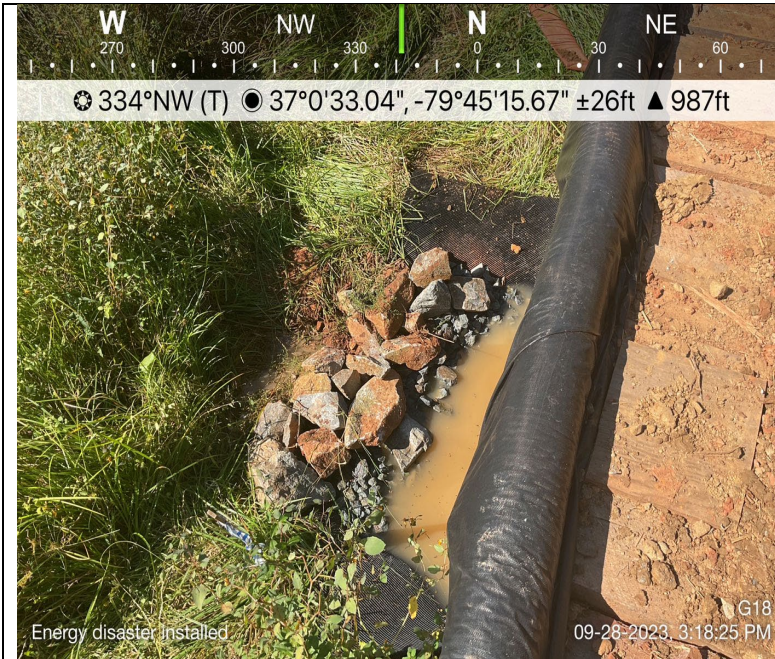
Photo Description: Energy dissipater

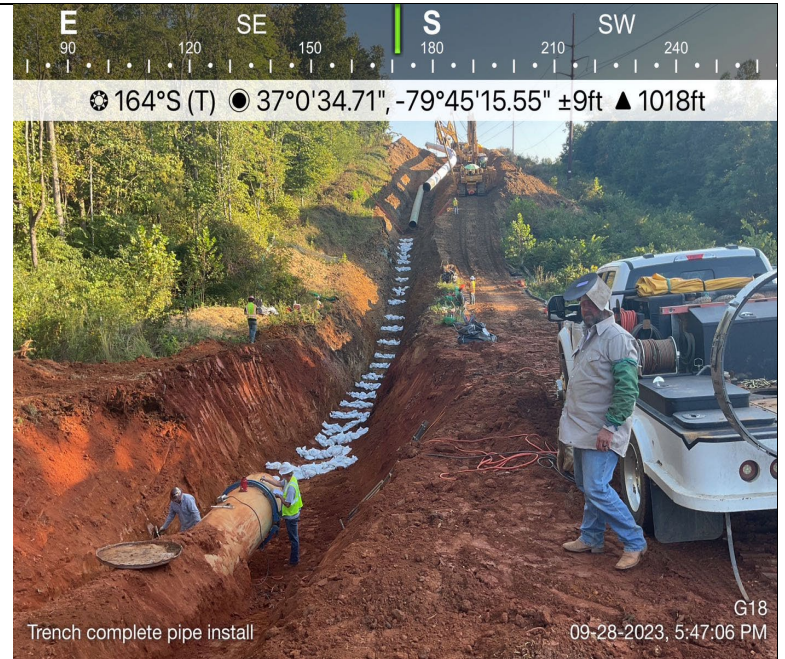
Photo Description: Trenching overview

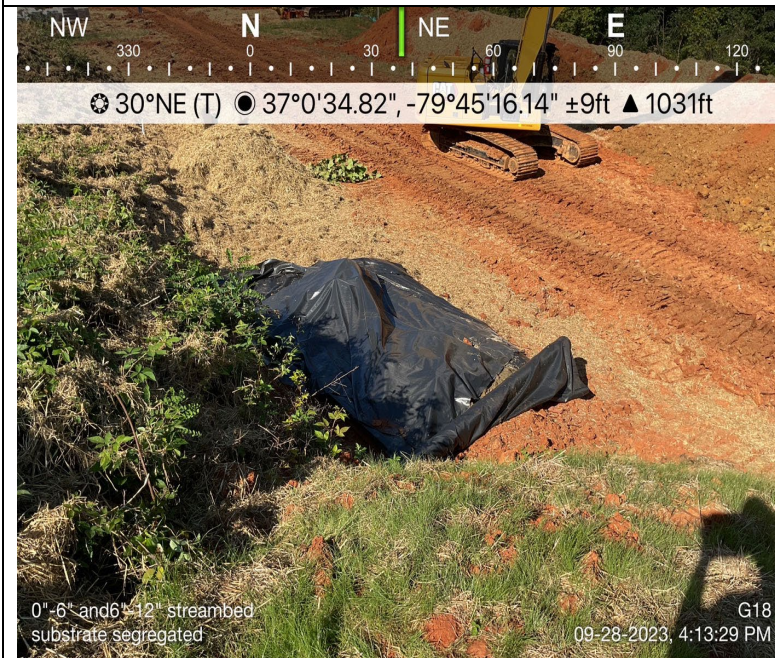
Photo Description: Stockpiled substrate.

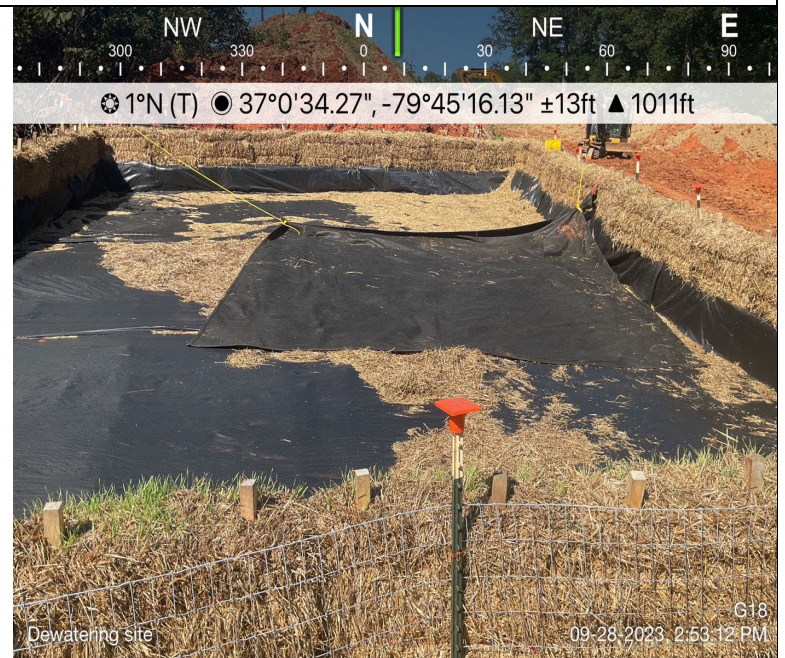
Photo Description: Dewatering area
