STREAM BIOLOGICAL CONDITIONS ENVIRONMENTAL AUDITOR REPORT

Stream ID: S-G32	Crossing Start Date: 11/09/2023	Crossing Completion Date: 11/20/2023
Milepost: 202.4	Pre-Con Assessment Date: 11/08/2023	Post-Con Assessment Date: 11/20/2023
Station: 10712+73	Stream Classification: Intermittent (Perennial, Intermittent, Ephemeral)	Bankfull Width (ft.): 6
County: Giles	303(d) Impairment Listing: Not Impaired	Riffle:Pool Complexes Present? No

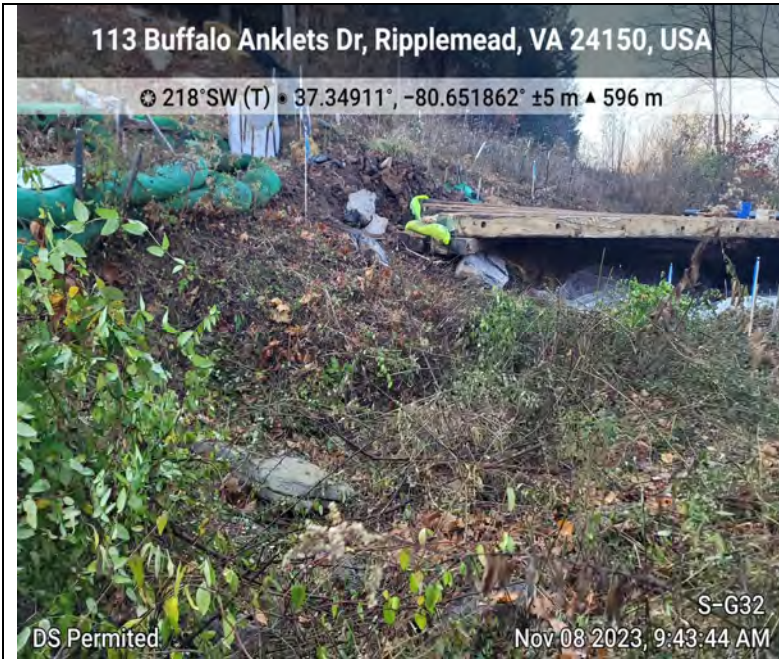
Photo Description: Downstream view of permitted impact area during pre-construction assessment.

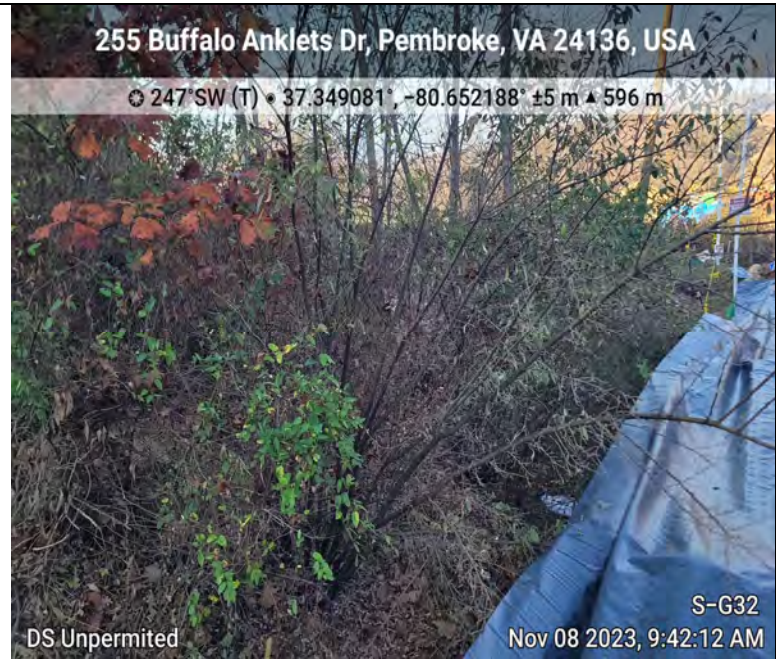
Photo Description: Conditions of the downstream area outside the ROW during pre-construction assessment.

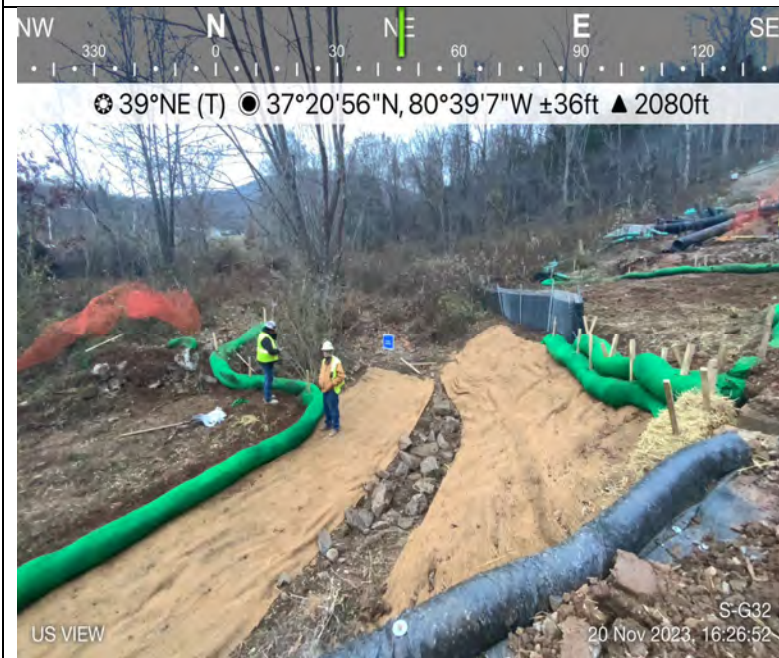
Photo Description: Upstream view of permitted impact area during post-construction assessment.

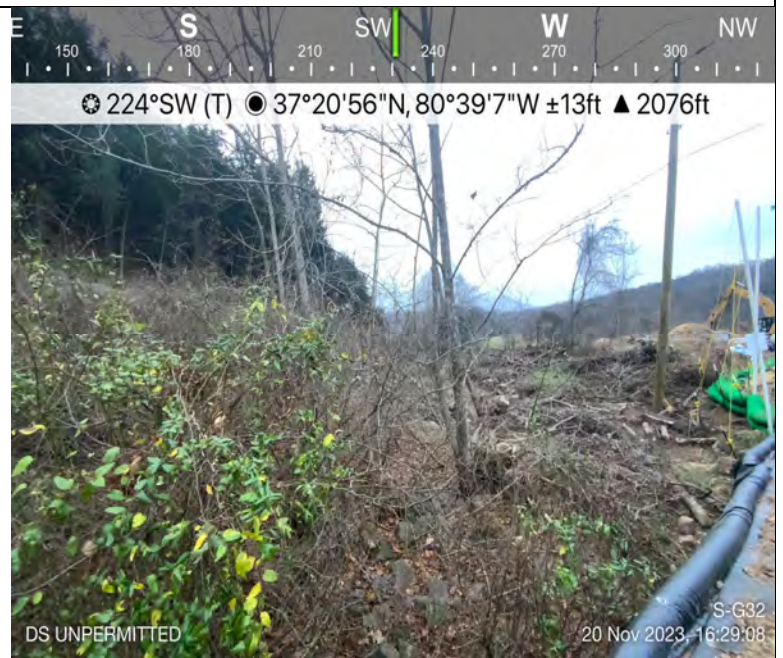
Photo Description: Conditions of the downstream area outside the ROW during post-construction assessment.

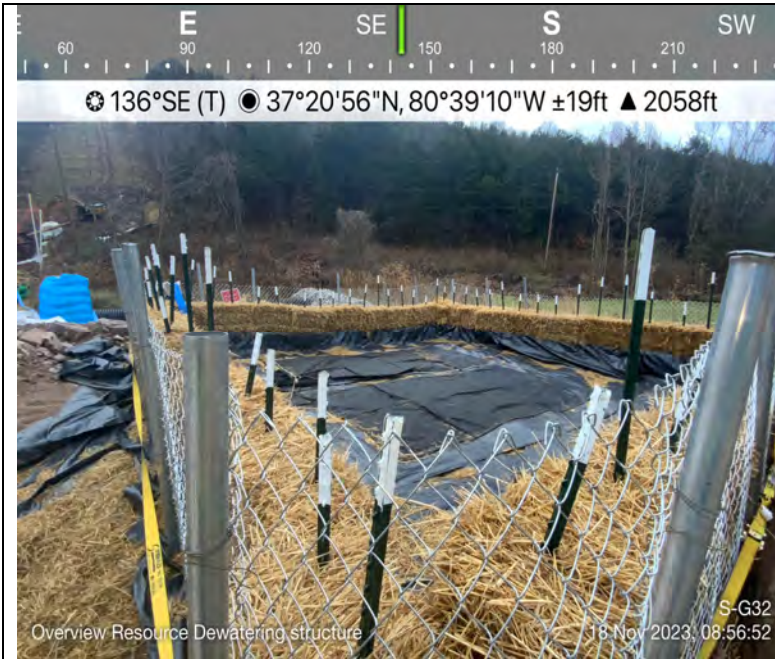
Photo Description: An overview of the dewatering structure.

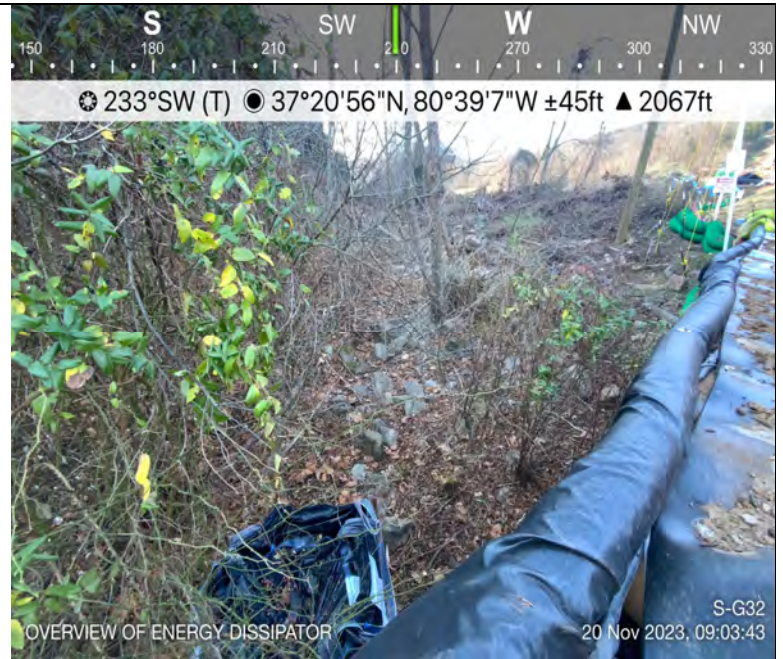
Photo Description: An overall view of the energy dissipator, dam, and pump set up under the timber mat bridge.

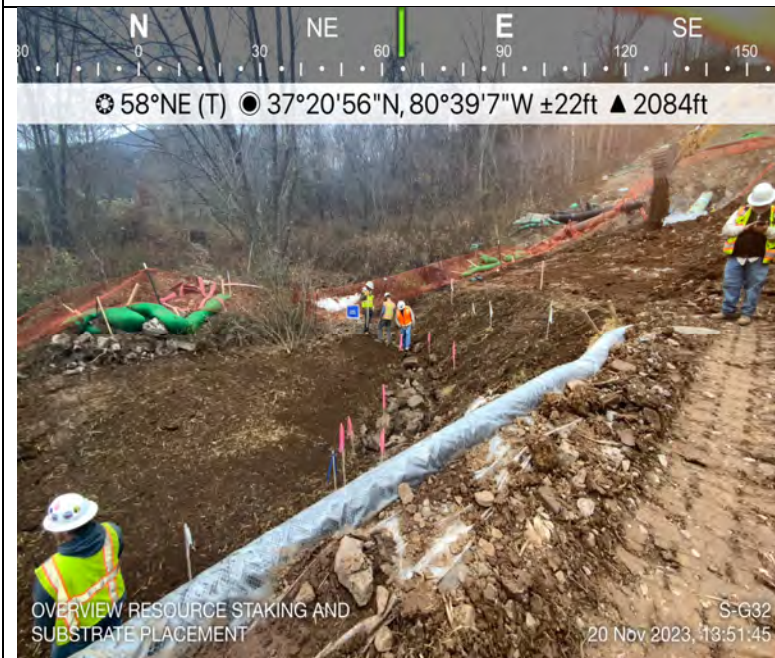
Photo Description: The survey crew providing guidance for stream substrate replacement.

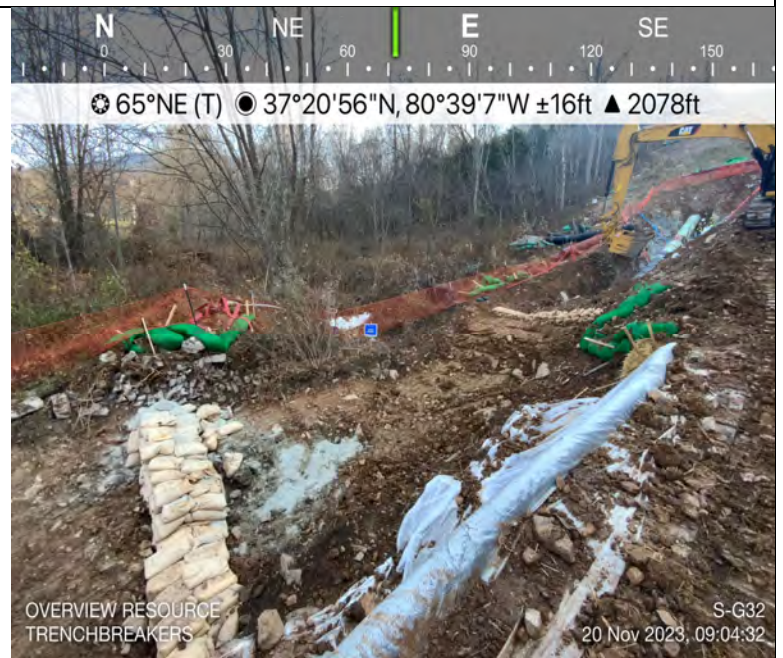
Photo Description: An overview of the trench breakers after installation.
