Stream Biological Conditions EA Report

Project Name	H-600 Pipeline Spread F	AFE	124300135	Spread	H-600 Pipeline Spread F
Contractor	Price Gregory	Report #	421		
Environmental Auditor	Beth Burdette	Date/Time	12/4/2023 9:19 AM		
Stream ID	S-G44	Crossing Start Date	12/4/2023	Crossing Completion Date	12/16/2023
Milepost	190.08	Pre-Con Assessment Date	12/4/2023	Post-Con Assessment Date	12/16/2023
Station	10036+08	Bankfull Width (ft.)	5.3	Riffle:Pool Complexes Present?	No
State	WV	Stream Classification	Ephemeral		
County	Monroe	303(d) Impairment Listing	No

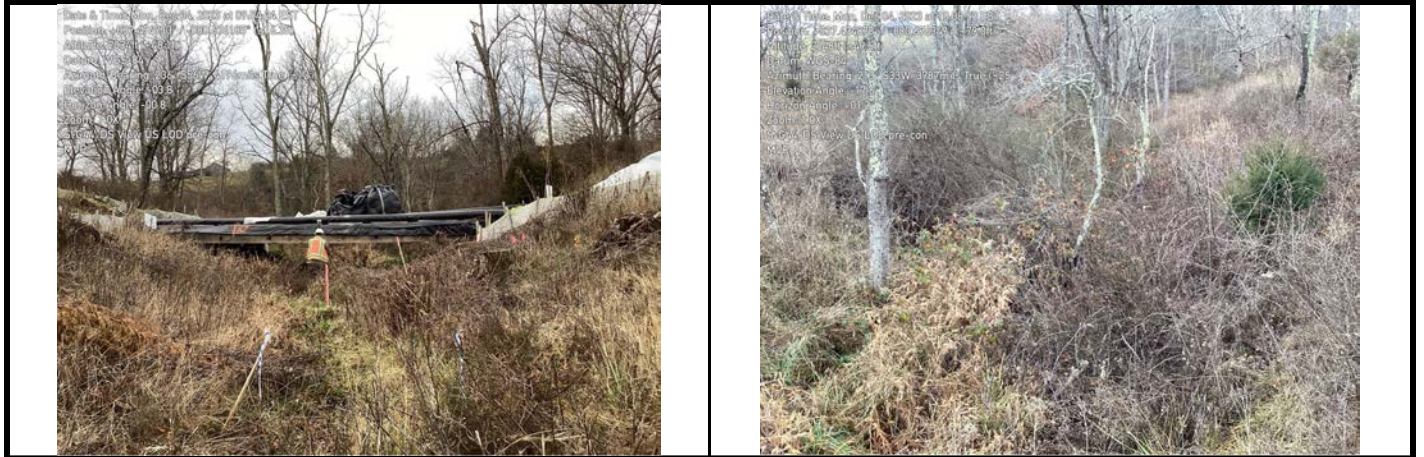
Description Downstream view of permitted impact area during pre-construction assessment. DS VIEW FROM US EDGE ROW PRE-CONSTRUCTION	Description Downstream view of unimpacted area during pre-construction assessment. DS VIEW FROM DS EDGE ROW PRE-CONSTRUCTION
---	---

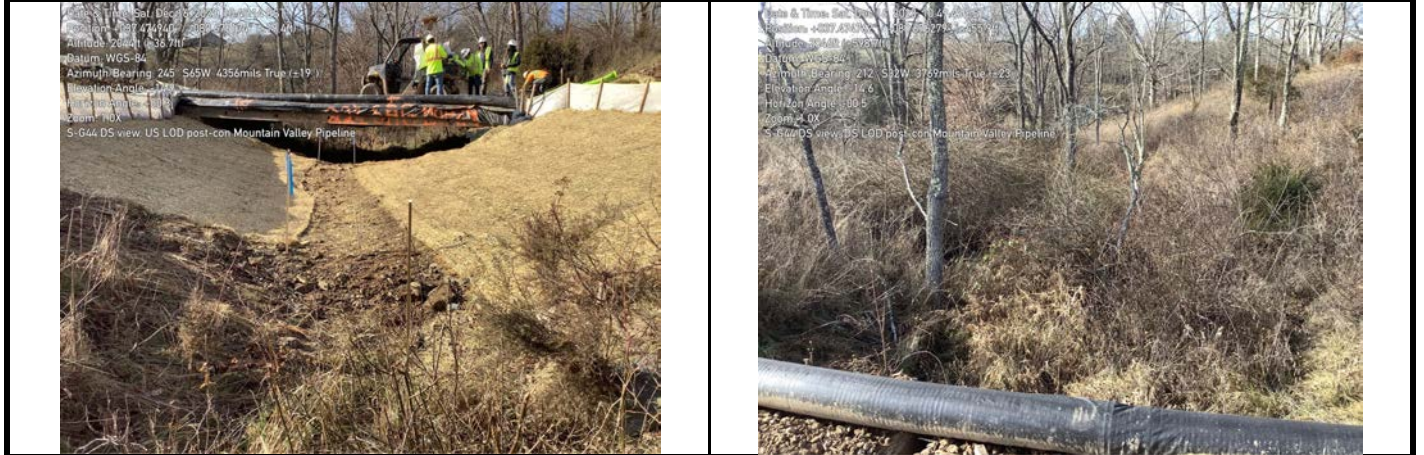
Description Downstream view of permitted impact area during post-construction assessment.	Description Downstream view of unimpacted area during post-construction assessment.
--	--

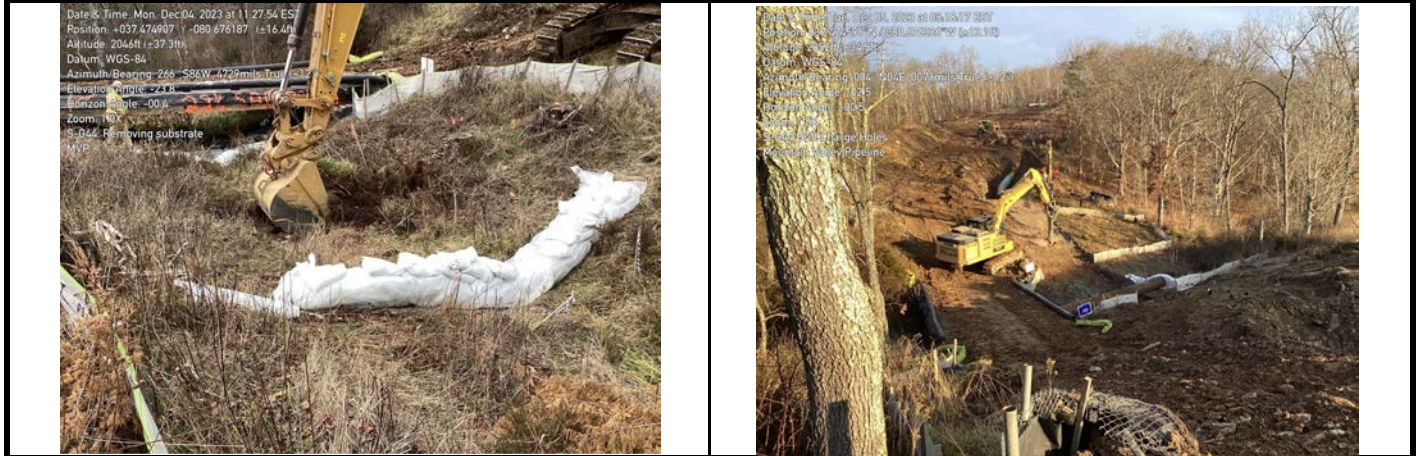
Description Photo 1: Stream substrate removal.	Description Photo 2: Drilling holes for charges.
---	---

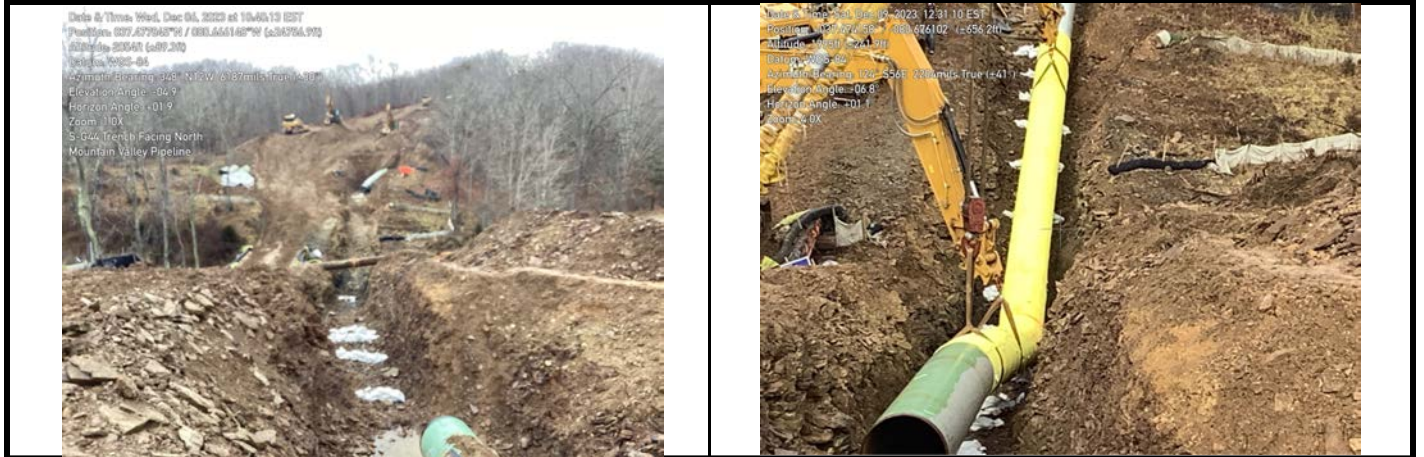
GPS Location See Photo	GPS Location See Photo
Description Photo 3: Trench completed in aquatic resource.	Description Photo 4: Lowering pipe into trench.

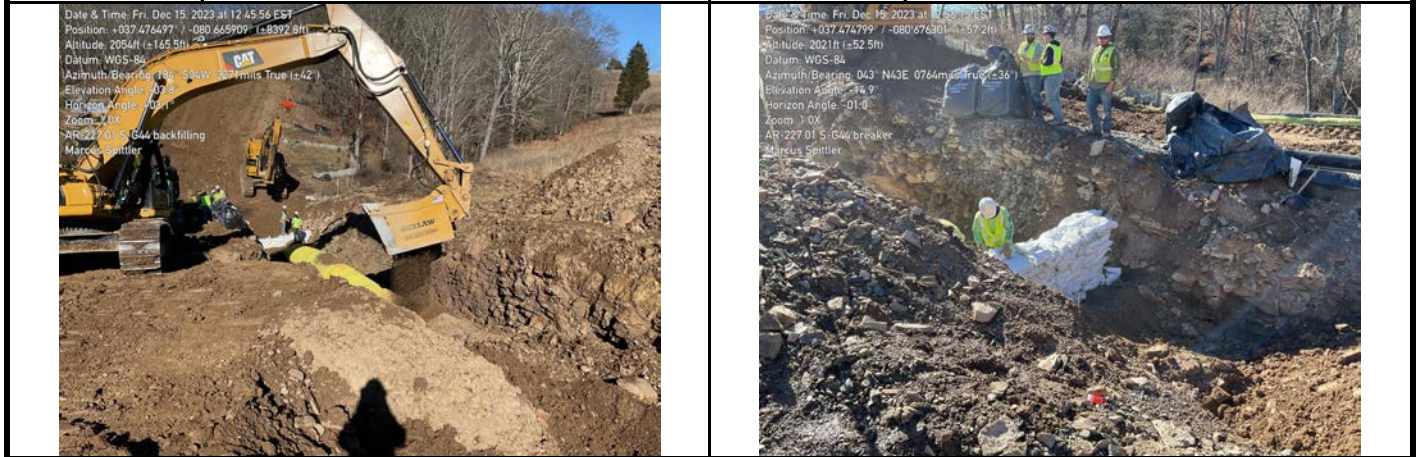
GPS Location See Photo	GPS Location See Photo
Description Photo 5: Backfilling.	Description Photo 6: Constructing trench breaker.

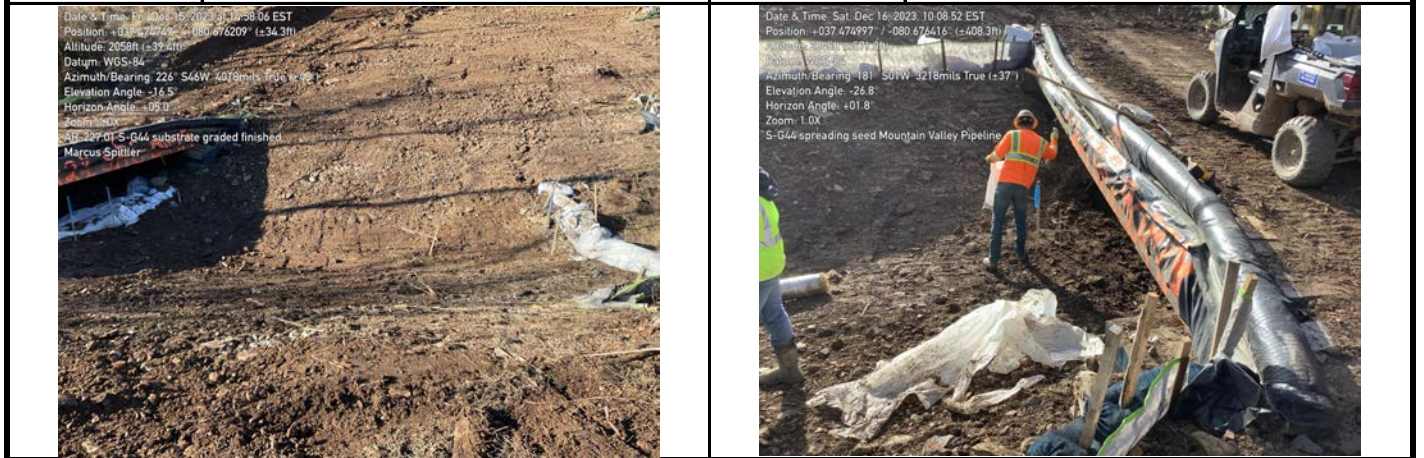
GPS Location See Photo	GPS Location See Photo
Description Photo 7: Substrate added and channel contoured.	Description Photo 8: Seeding buffer.
