STREAM BIOLOGICAL CONDITIONS ENVIRONMENTAL AUDITOR REPORT

Stream ID: S-G5	Crossing Start Date: 11/06/2023	Crossing Completion Date: 11/08/2023
Milepost: 291.7	Pre-Con Assessment Date: 11/04/2023	Post-Con Assessment Date: 11/08/2023
Station: 15414+85	Stream Classification: Ephemeral (Perennial, Intermittent, Ephemeral)	Bankfull Width (ft.): 6
County: Pittsylvania	303(d) Impairment Listing: Not Impaired	Riffle:Pool Complexes Present? No

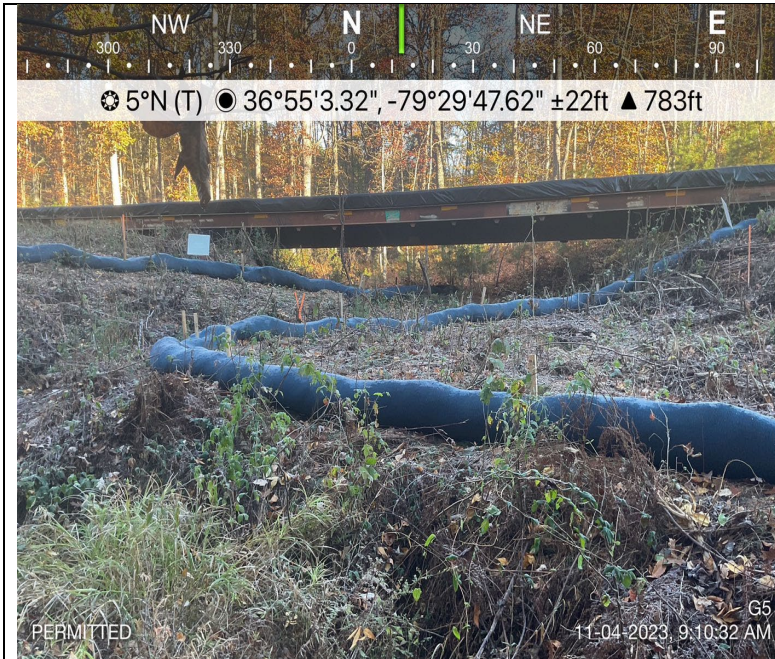
Photo Description: Downstream view of permitted impact area during pre-construction assessment.

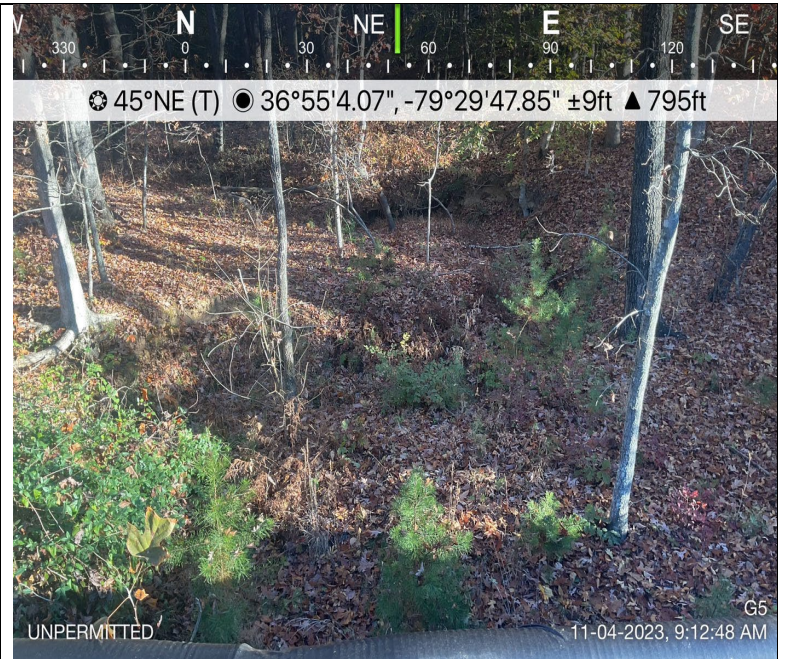
Photo Description: Conditions of the downstream area outside the ROW during pre-construction assessment.

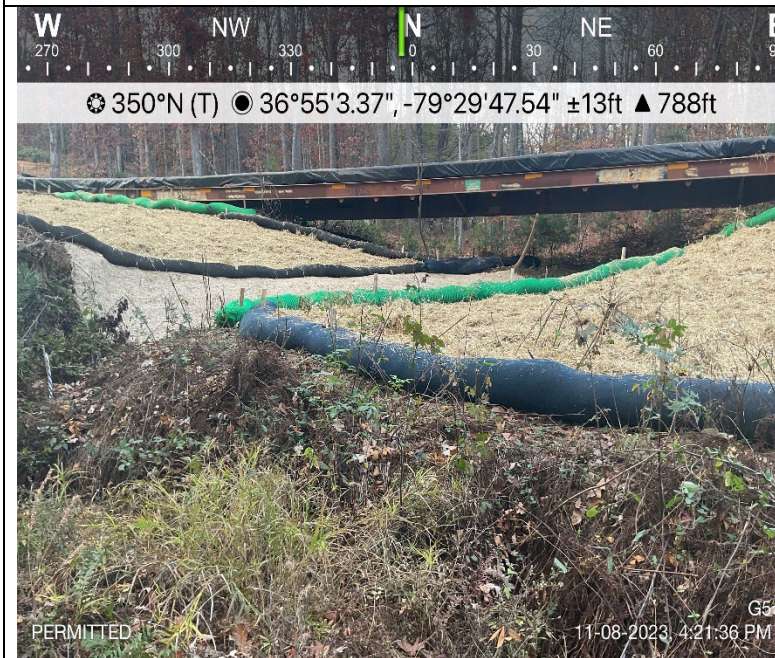
Photo Description: Downstream view of permitted impact area during post-construction assessment.

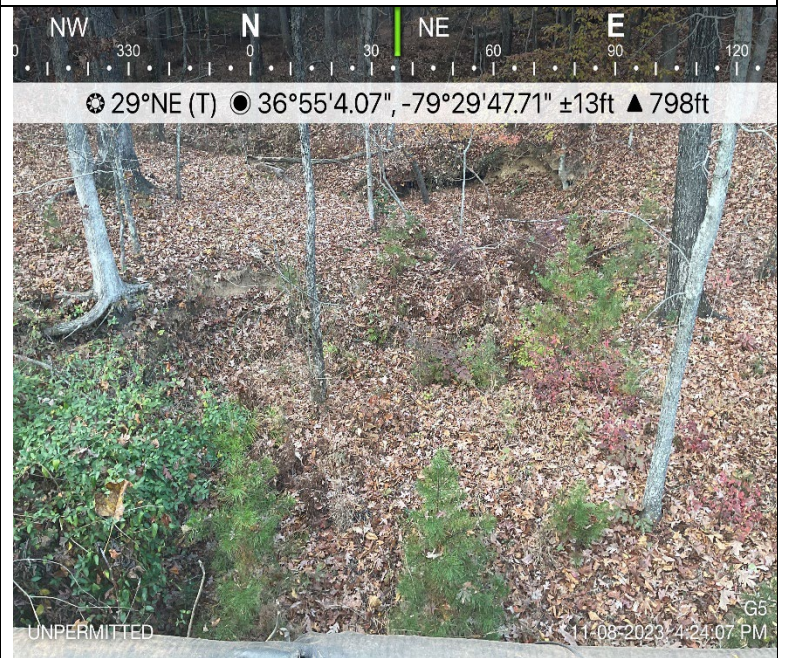
Photo Description: Conditions of the downstream area outside the ROW during post-construction assessment.

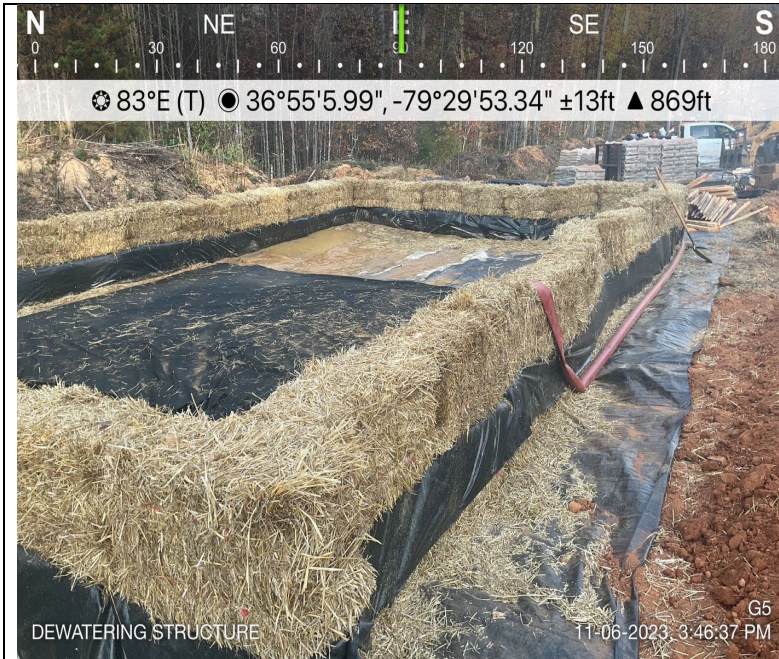
Photo Description: Dewatering structure for bags and sediment control.

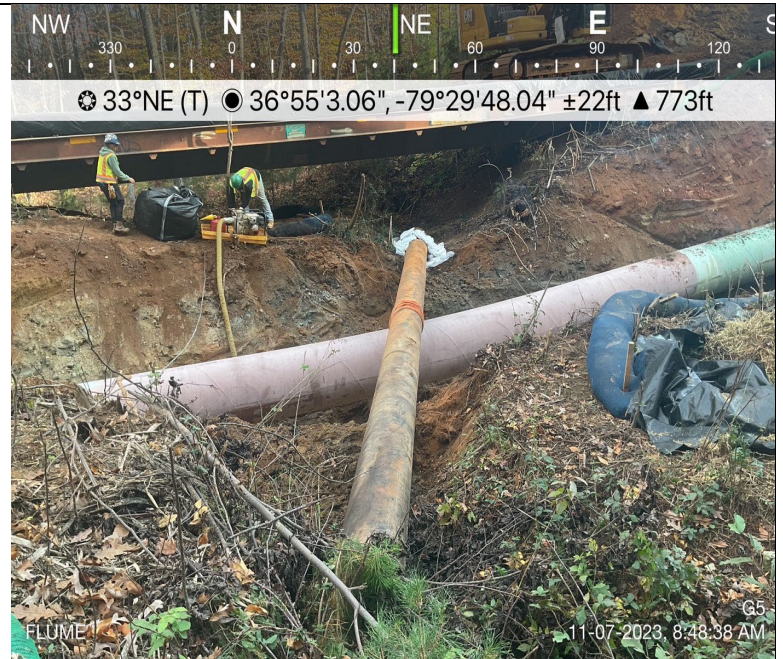
Photo Description: Flume installed throughout crossing.

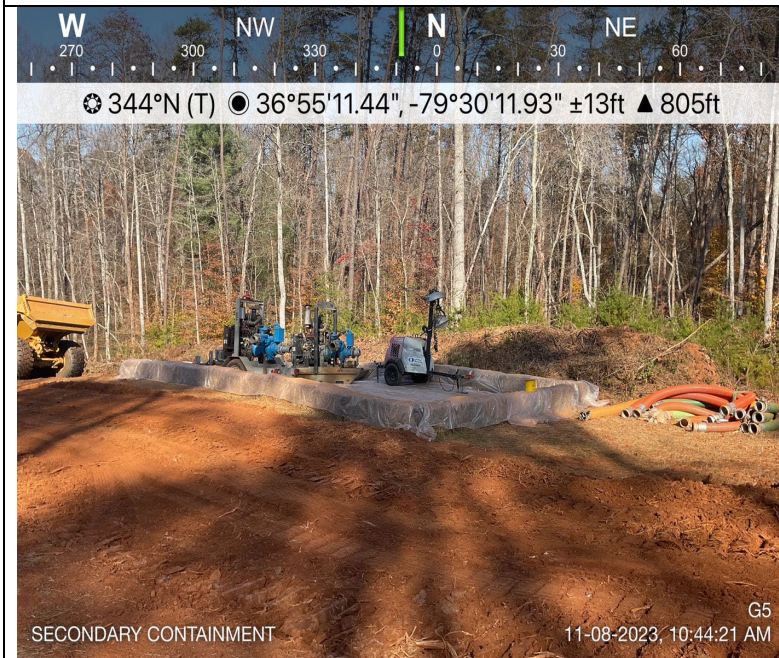
Photo Description: Secondary containment for light plants and pumps.

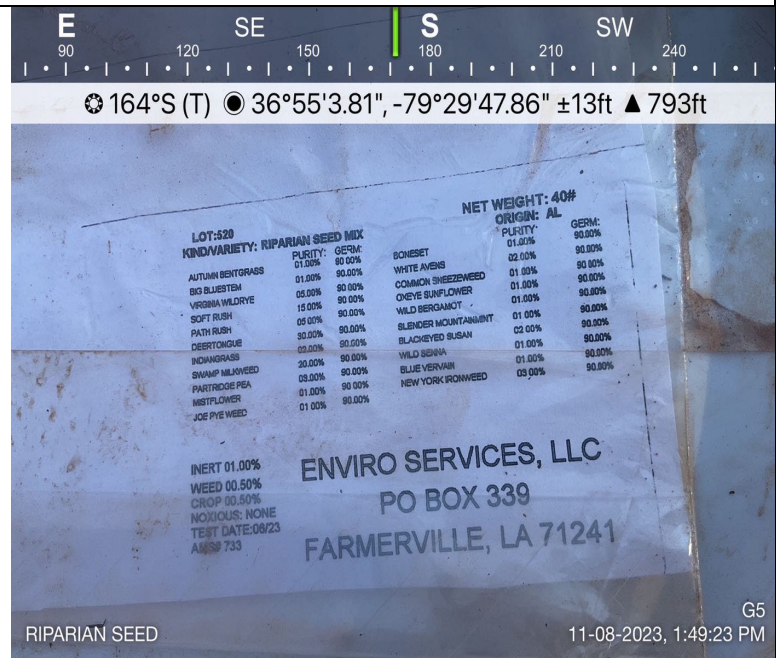
Photo Description: Riparian seed used for stream bank
