STREAM BIOLOGICAL CONDITIONS ENVIRONMENTAL AUDITOR REPORT

Stream ID: S-G6	Crossing Start Date: 11/08/2023	Crossing Completion Date: 11/11/2023
Milepost: 291.2	Pre-Con Assessment Date: 11/02/2023	Post-Con Assessment Date: 11/11/2023
Station: 15384+99	Stream Classification: Intermittent (Perennial, Intermittent, Ephemeral)	Bankfull Width (ft.): 6
County: Pittsylvania	303(d) Impairment Listing: Not Impaired	Riffle:Pool Complexes Present? No

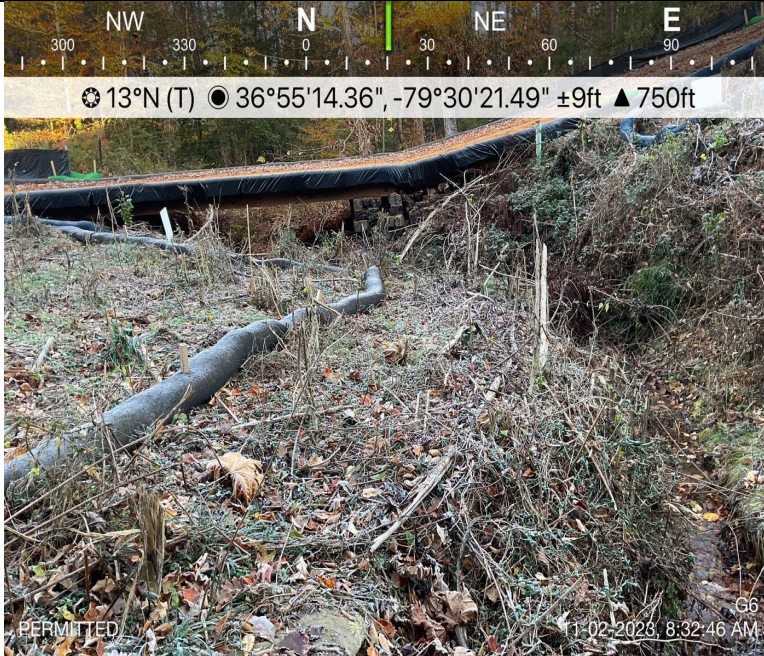
Photo Description: Downstream view of permitted impact area during pre-construction assessment.

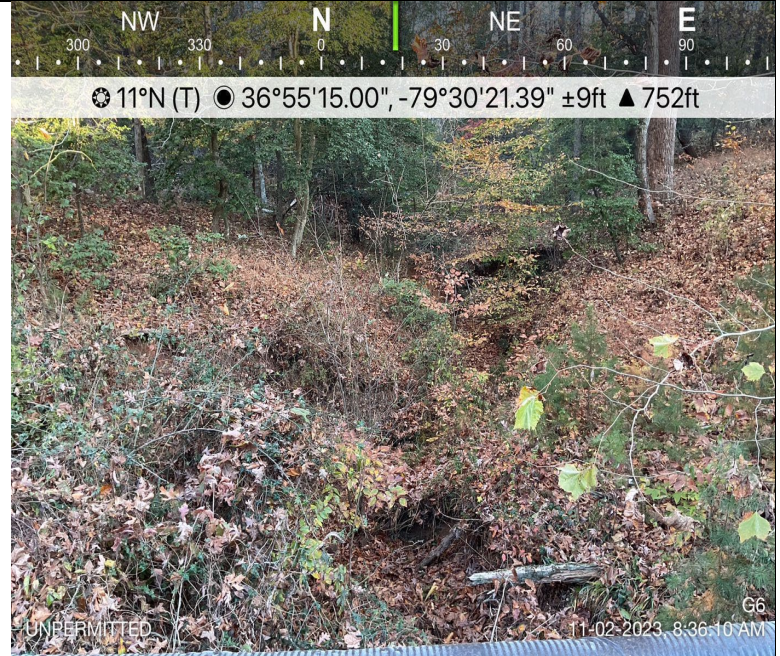
Photo Description: Conditions of the downstream area outside the ROW during pre-construction assessment.

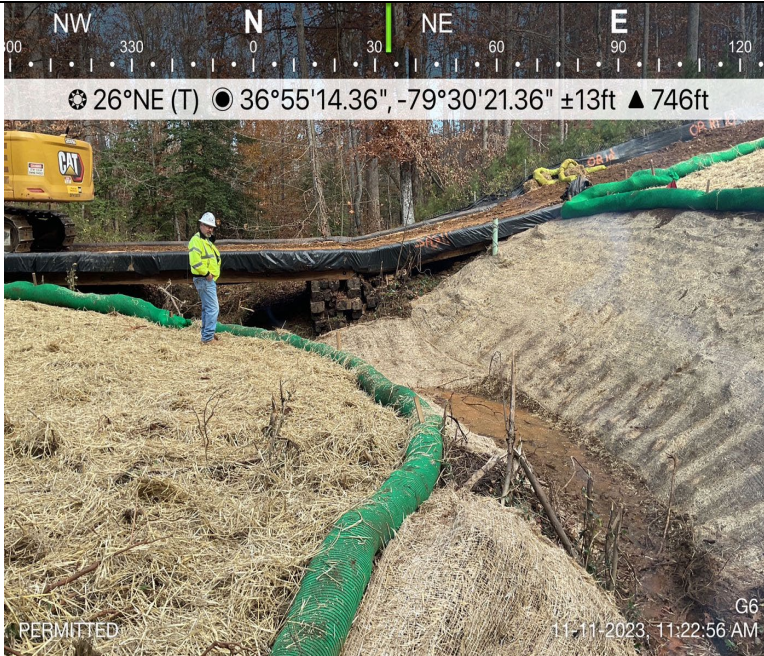
Photo Description: Downstream view of permitted impact area during post-construction assessment.

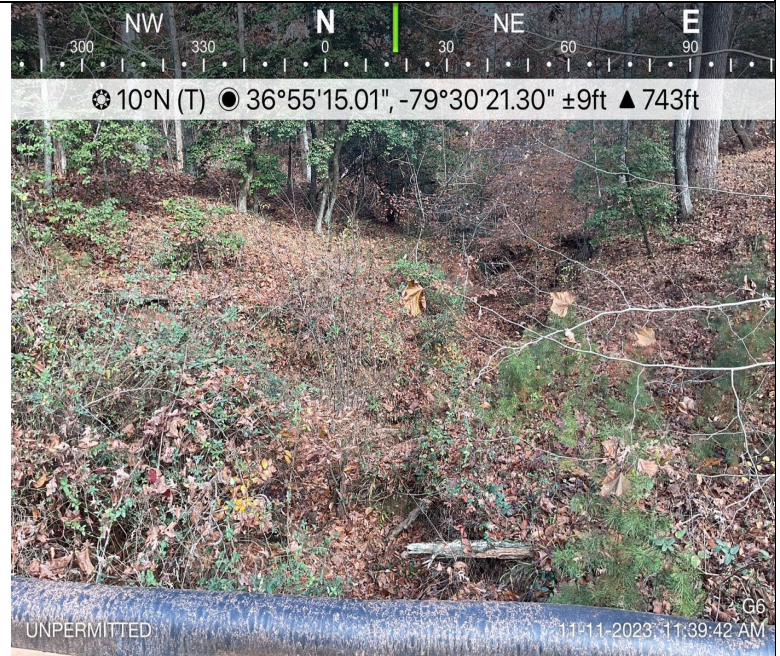
Photo Description: Conditions of the downstream area outside the ROW during post-construction assessment.

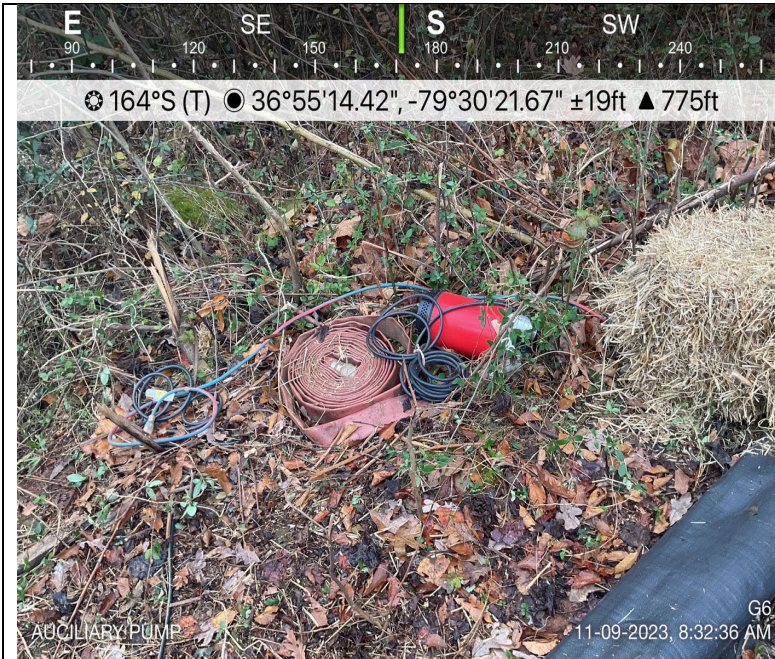
Photo Description: Auxiliary pump

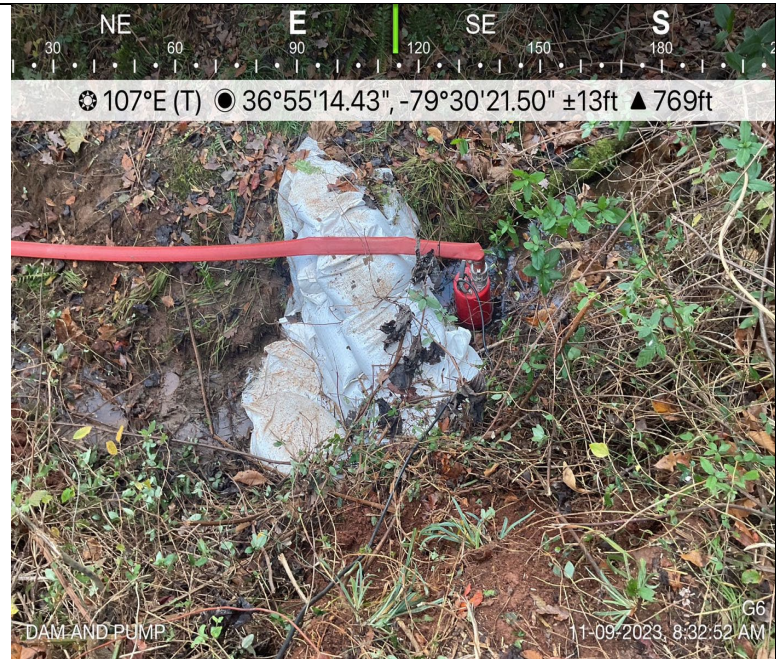
Photo Description: Dam and pump

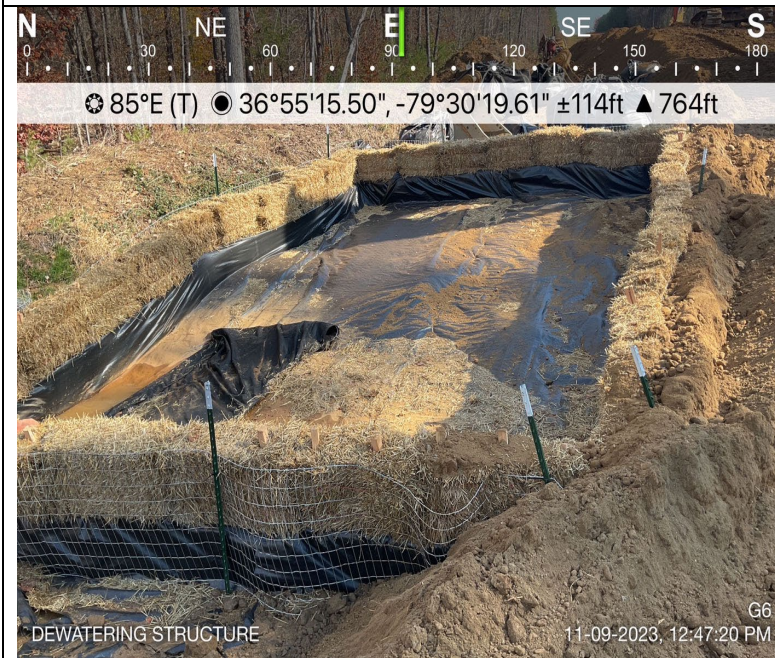
Photo Description: Dewatering Structure

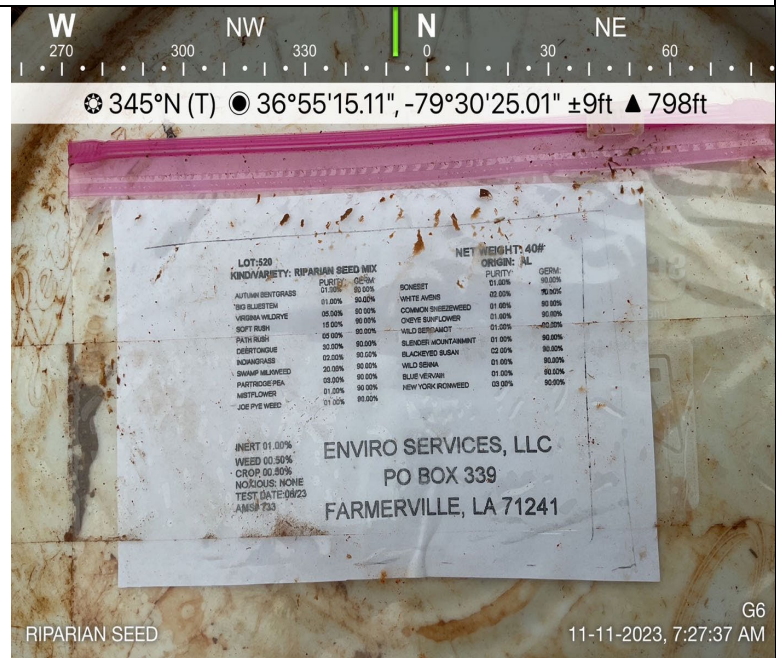
Photo Description: Riparian seed
