STREAM BIOLOGICAL CONDITIONS ENVIRONMENTAL AUDITOR REPORT

| Stream ID: S-GH15 | Crossing Start Date: 11/04/2023 | Crossing Completion Date: 11/09/2023 |
| Milepost: 252.1 | Pre-Con Assessment Date: 10/23/2023 | Post-Con Assessment Date: 11/10/2023 |

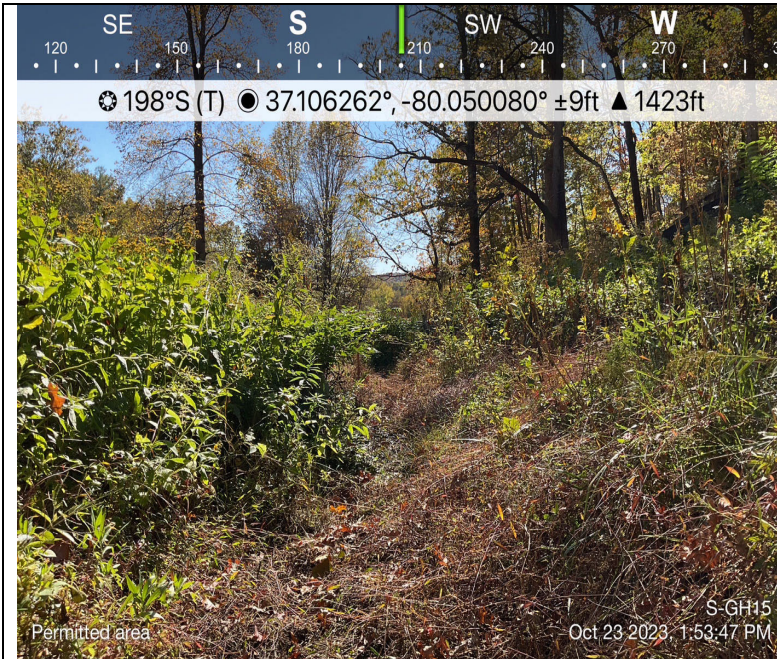
Photo Description: Downstream view of permitted impact area during pre-construction assessment.

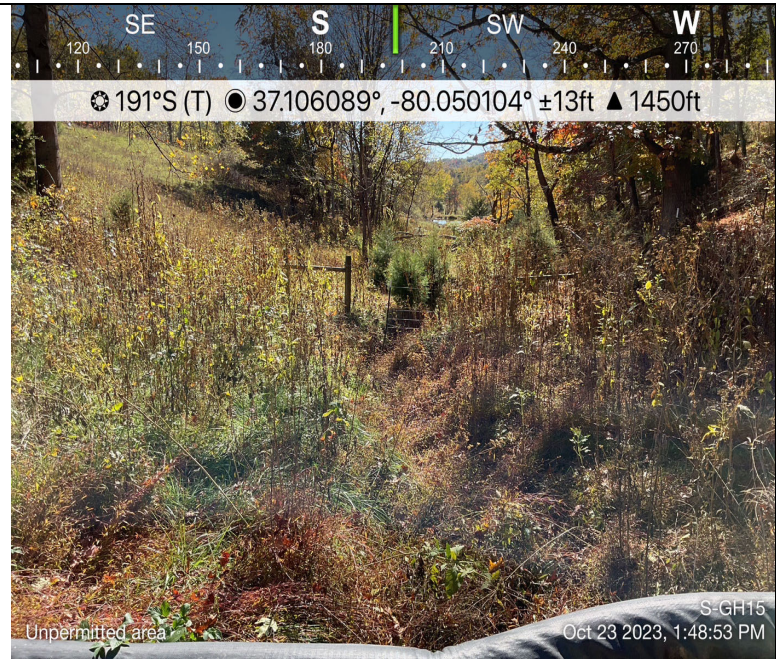
Photo Description: Conditions of the downstream area outside the ROW during pre-construction assessment.

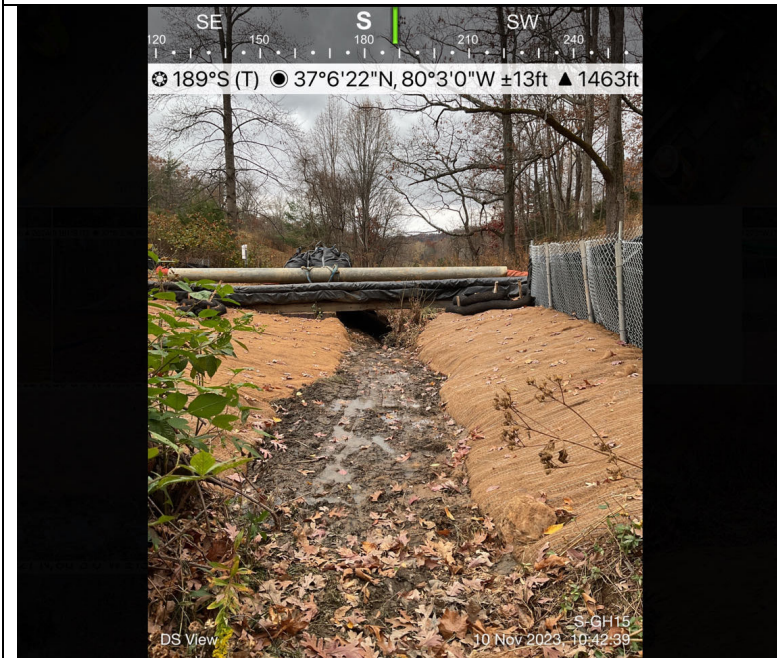
Photo Description: Downstream view of permitted impact area during post-construction assessment.

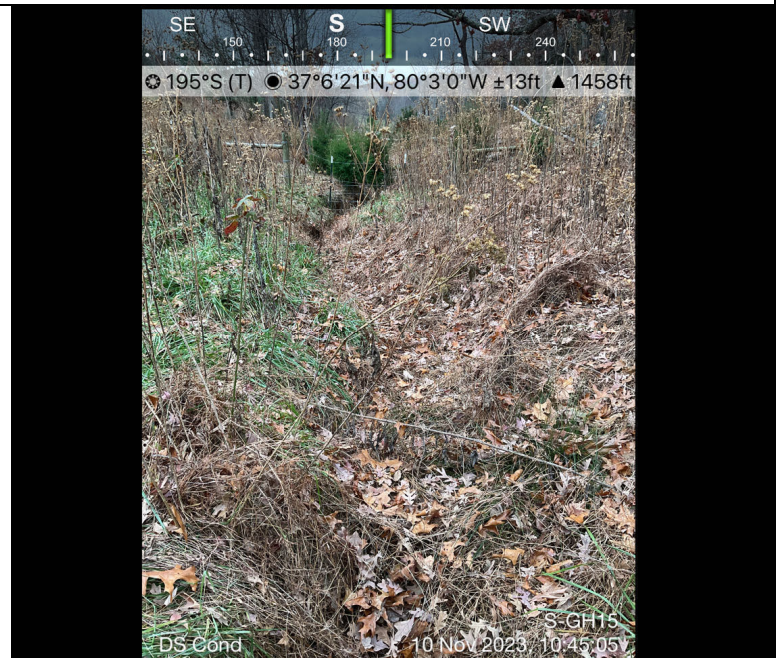
Photo Description: Conditions of the downstream area outside the ROW during post-construction assessment.

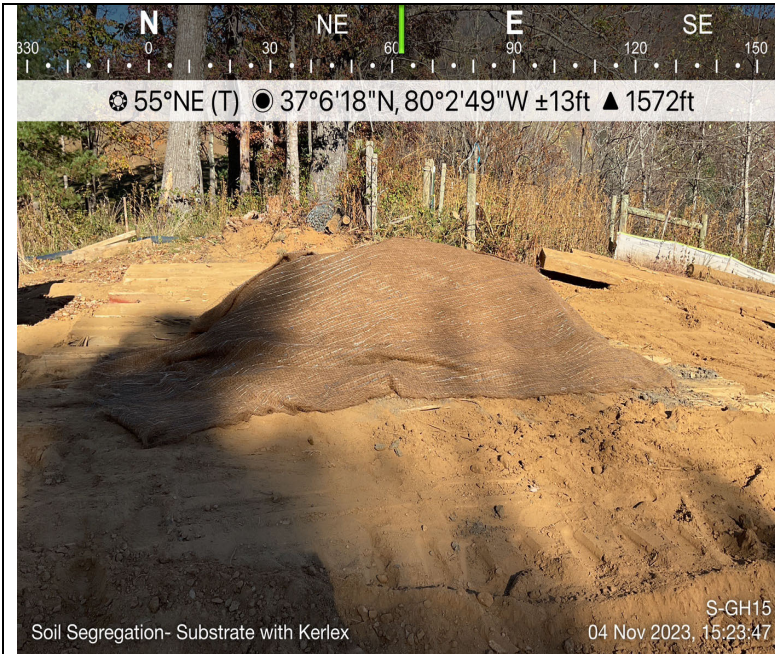
Photo Description: Soil Segregation - Substrate under erosion control matting.

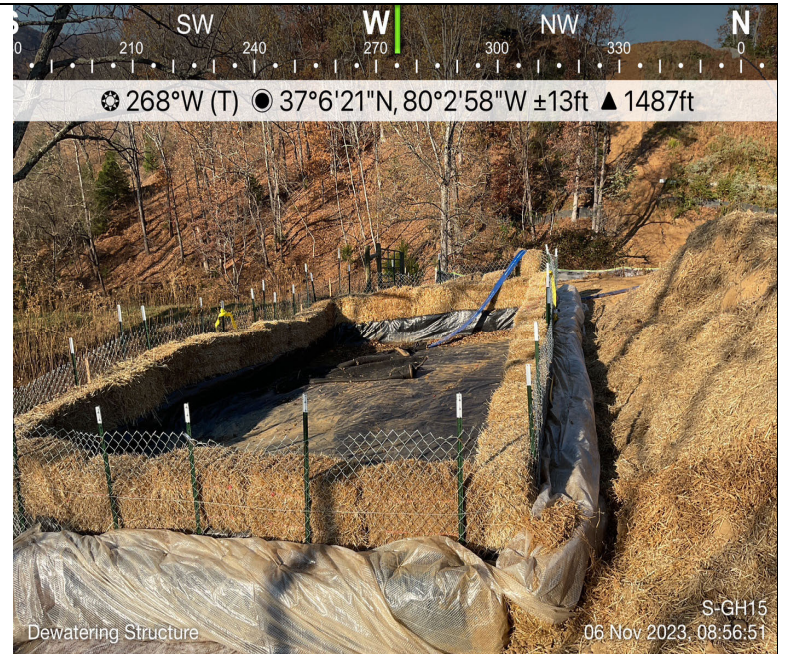
Photo Description: Dewatering structure on-site throughout crossing.

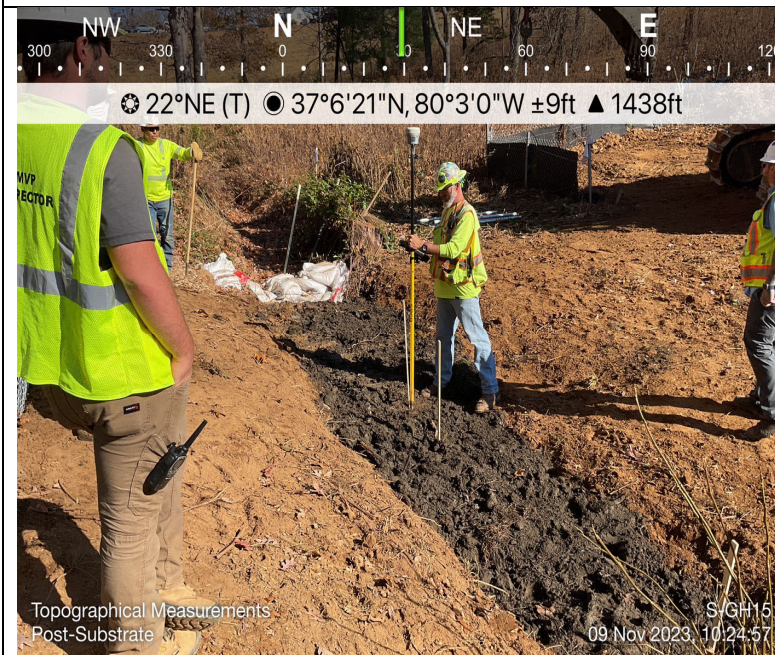
Photo Description: Survey on-site assisting with restoration.

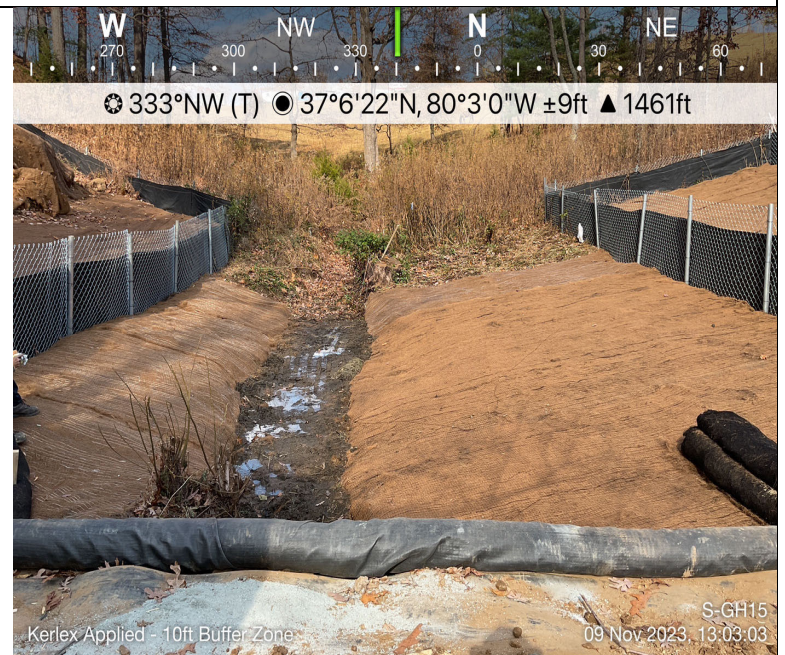
Photo Description: Erosion control matting Installed in buffer zones.
