STREAM BIOLOGICAL CONDITIONS ENVIRONMENTAL AUDITOR REPORT

Stream ID: S-H13	Crossing Start Date: 11/01/2023	Crossing Completion Date: 11/04/2023
Milepost: 290.5	Pre-Con Assessment Date: 10/24/2023	Post-Con Assessment Date: 11/04/2023
Station: 15347+11	Stream Classification: Perennial (Perennial, Intermittent, Ephemeral)	Bankfull Width (ft.): 20
County: Pittsylvania	303(d) Impairment Listing: Not Impaired	Riffle:Pool Complexes Present? Yes

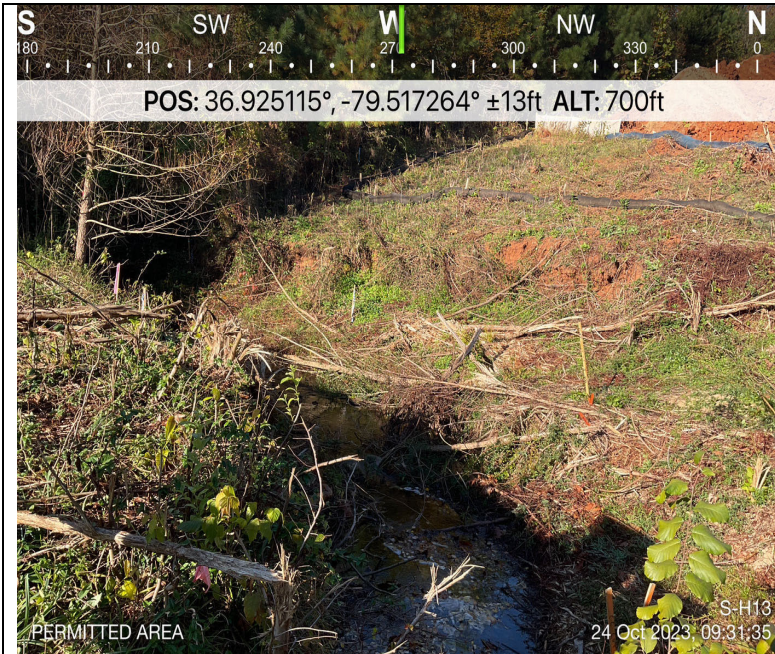
Photo Description: Downstream view of permitted impact area during pre-construction assessment.

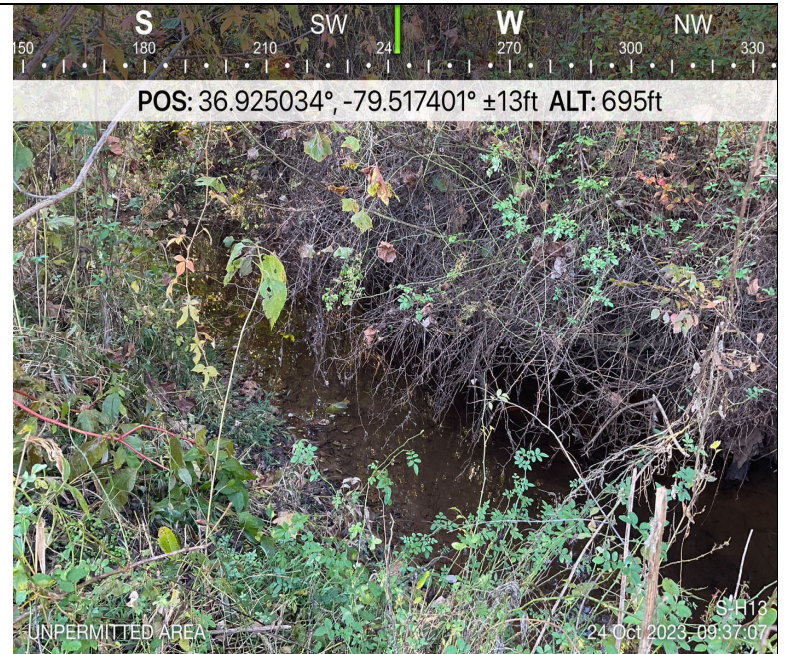
Photo Description: Conditions of the downstream area outside the ROW during pre-construction assessment.

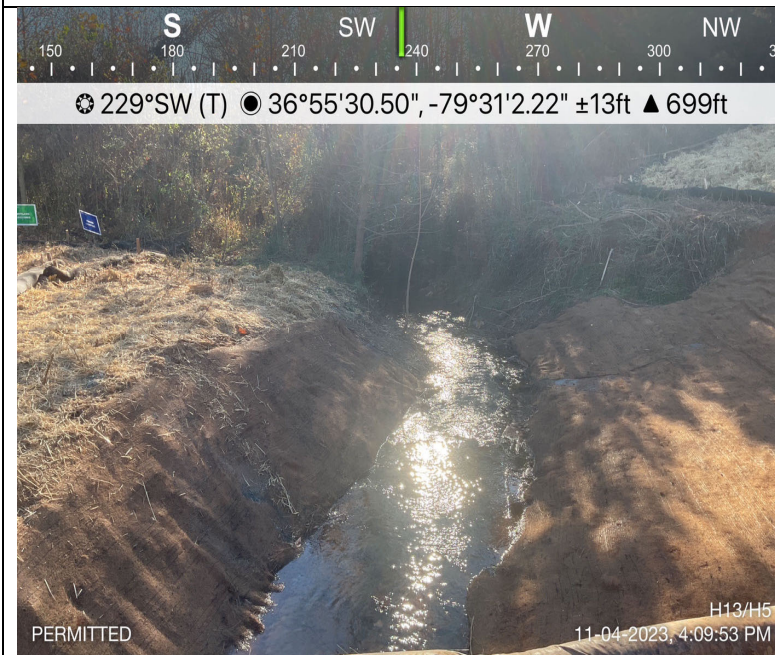
Photo Description: Downstream view of permitted impact area during post-construction assessment.

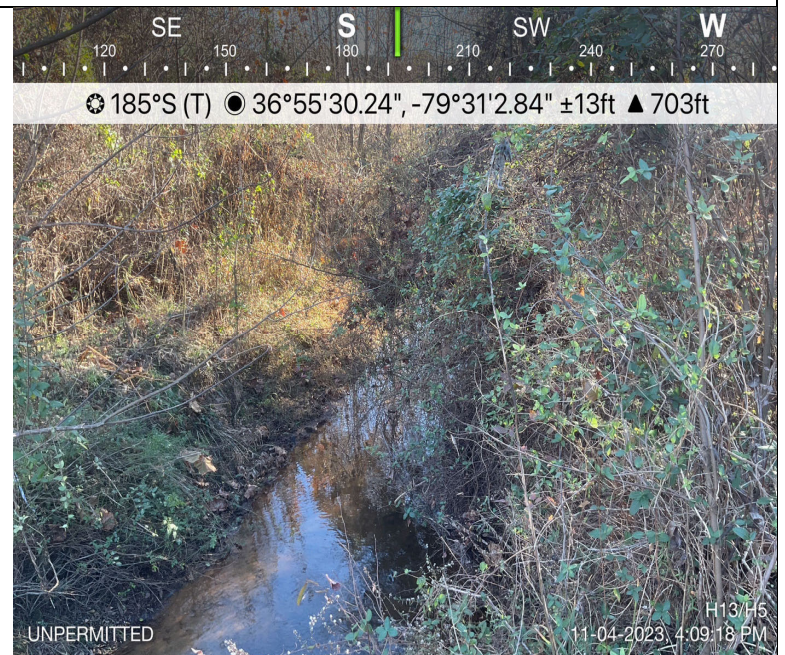
Photo Description: Conditions of the downstream area outside the ROW during post-construction assessment.

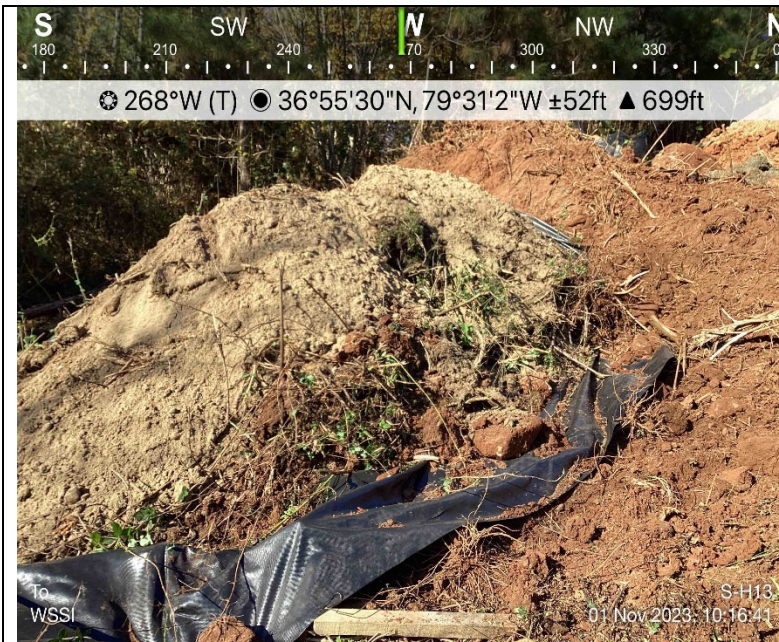
Photo Description: Topsoil stockpiled separately and stabilized.

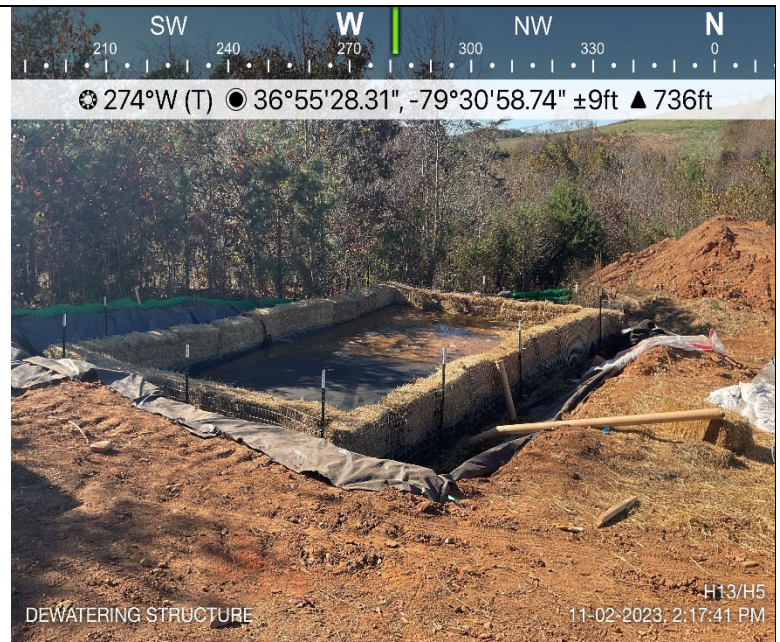
Photo Description: Dewatering structure installed for throughout crossing.

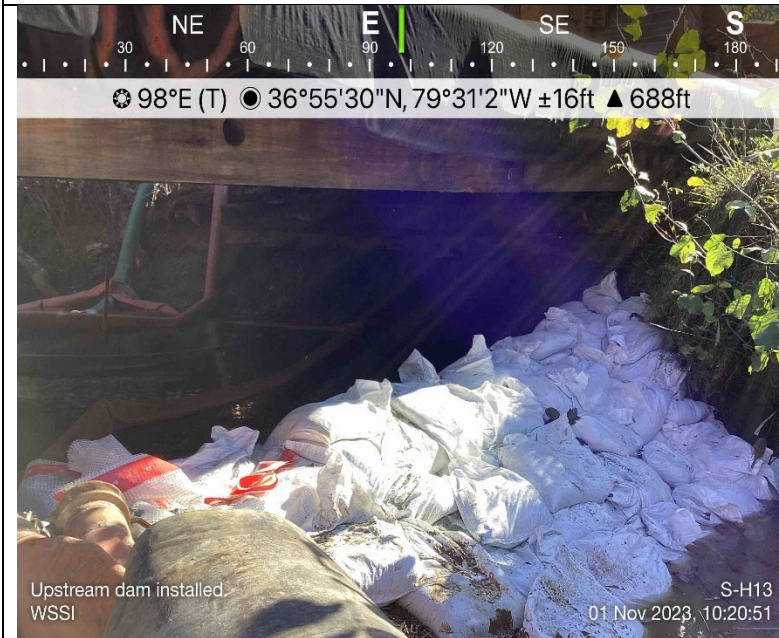
Photo Description: Upstream dam installed and functional throughout crossing.

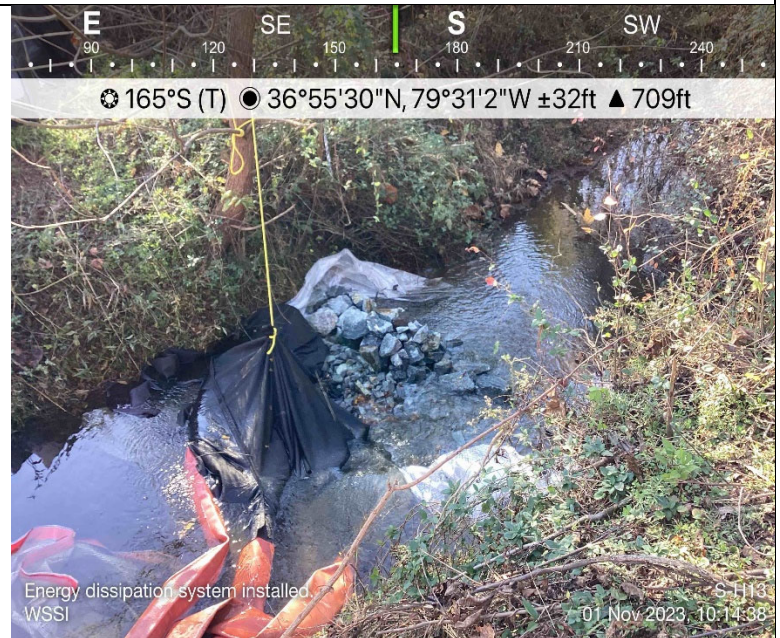
Photo Description: Energy dissipation for pump around
