STREAM BIOLOGICAL CONDITIONS ENVIRONMENTAL AUDITOR REPORT

Stream ID: S-H17	Crossing Start Date: 11/03/2023	Crossing Completion Date: 11/13/2023
Milepost: 281.1	Pre-Con Assessment Date: 10/23/2023	Post-Con Assessment Date: 11/13/2023
Station: 14853+39	Stream Classification: Intermittent (Perennial, Intermittent, Ephemeral)	Bankfull Width (ft.): 8
County: Franklin	303(d) Impairment Listing: Not Impaired	Riffle:Pool Complexes Present? No

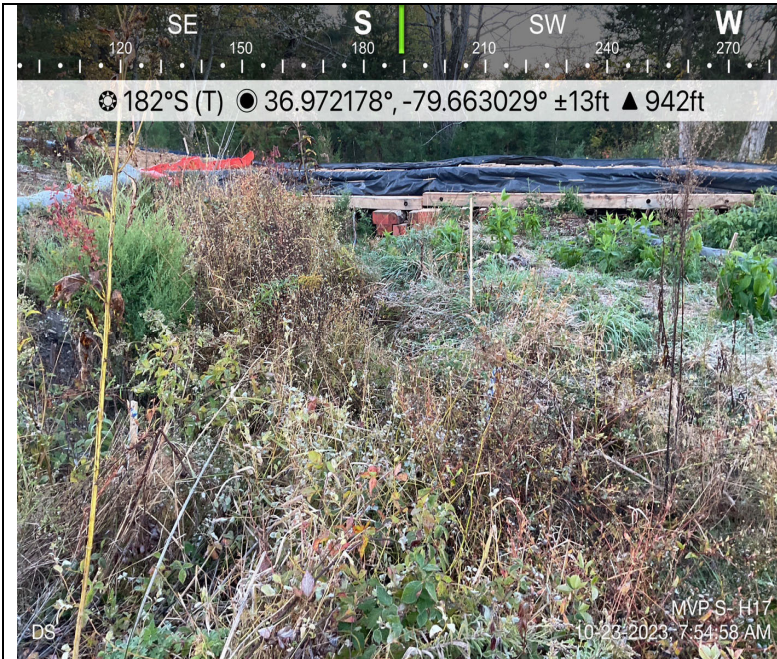
Photo Description: Downstream view of permitted impact area during pre-construction assessment.

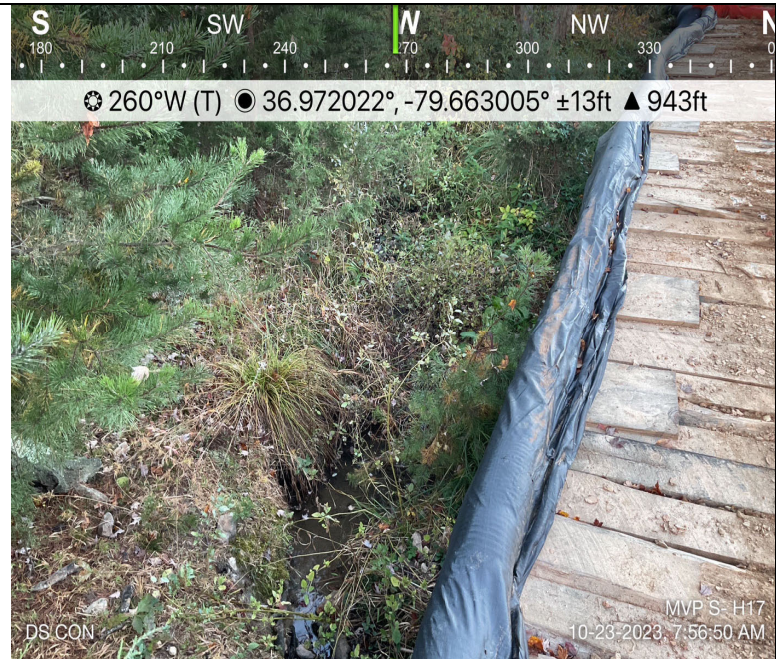
Photo Description: Conditions of the downstream area outside the ROW during pre-construction assessment.

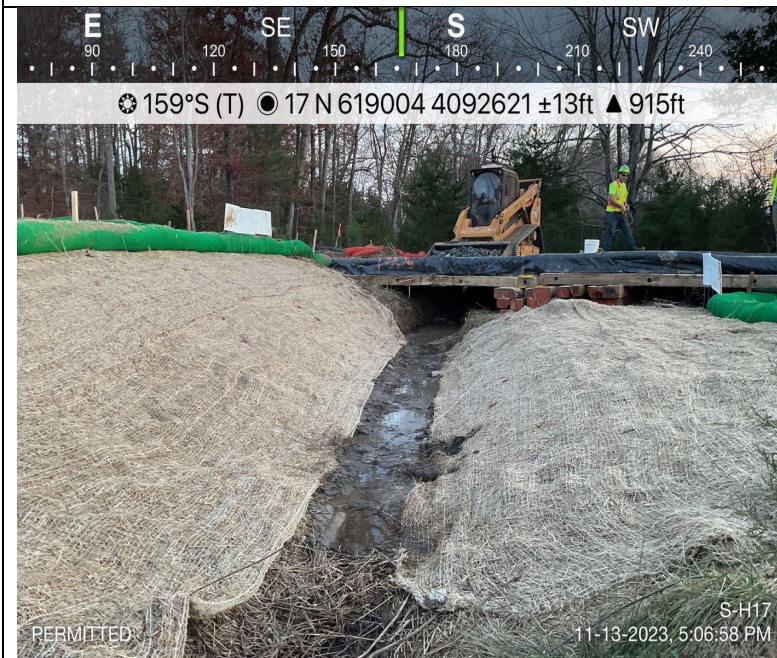
Photo Description: Downstream view of permitted impact area during post-construction assessment.

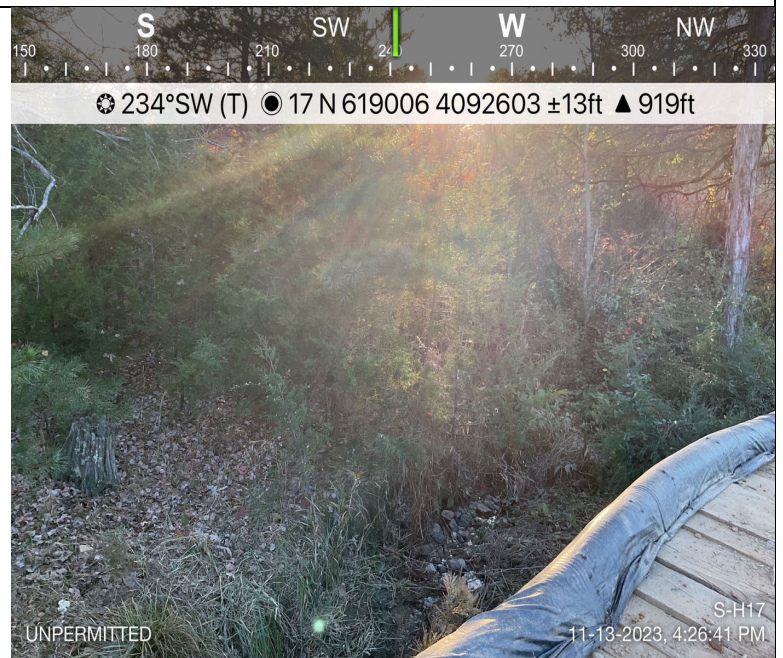
Photo Description: Conditions of the downstream area outside the ROW during post-construction assessment.

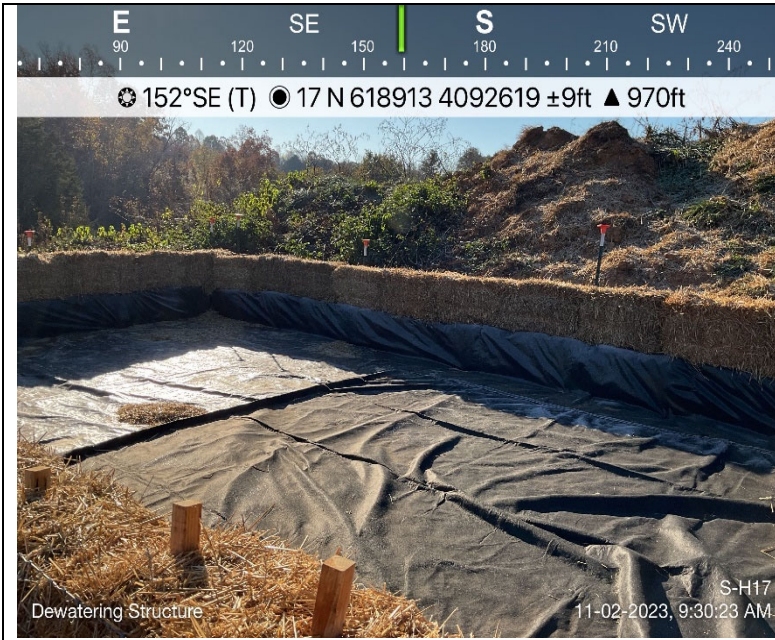
Photo Description: An overview of the dewatering structure.

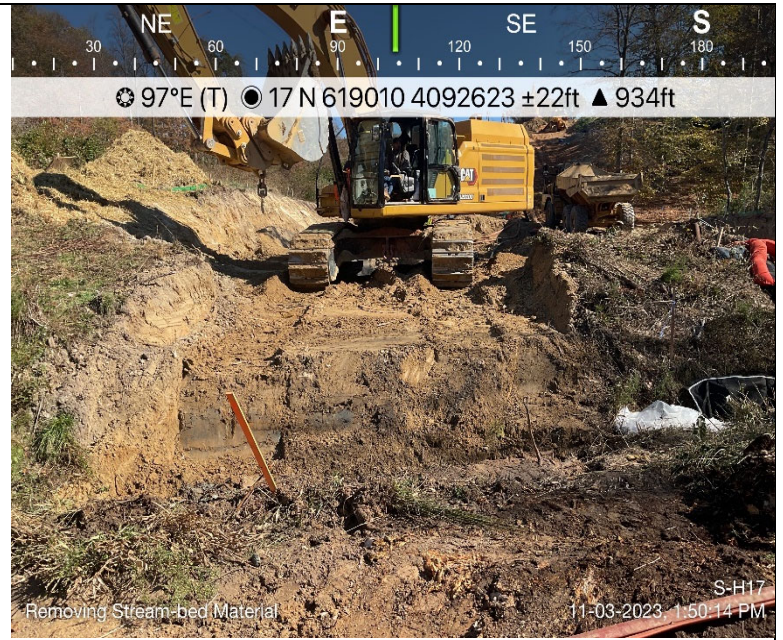
Photo Description: Excavation of the streambed.

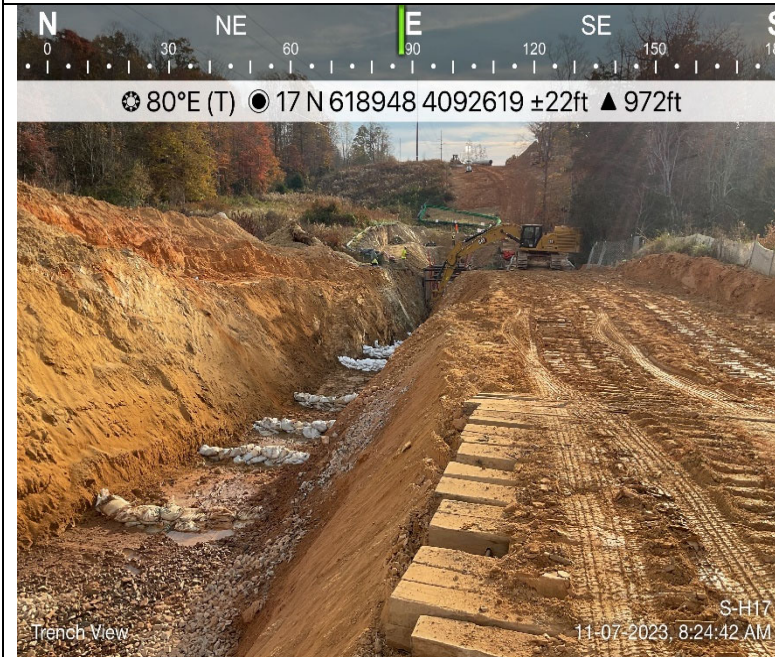
Photo Description: Rock check dams installed in the trench.

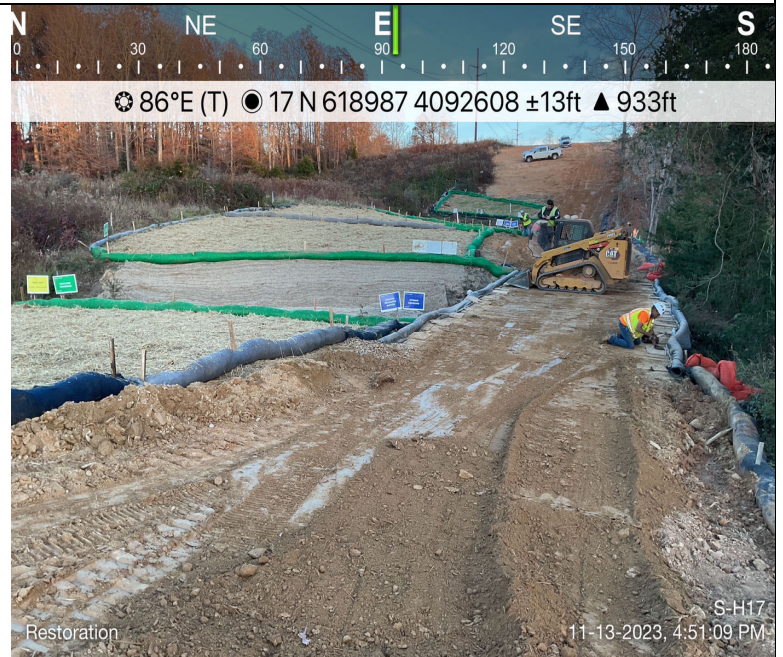
Photo Description: Site restoration and installation of the filter sock.
