# STREAM BIOLOGICAL CONDITIONS ENVIRONMENTAL AUDITOR REPORT

<b>Stream ID:</b> S-H37	<b>Crossing Start Date:</b> 11/13/2023	<b>Crossing Completion Date:</b> 11/15/2023
<b>Milepost:</b> 277.7	<b>Pre-Con Assessment Date:</b> 11/11/2023	<b>Post-Con Assessment Date:</b> 11/15/2023
<b>Station:</b> 14673+10	<b>Stream Classification:</b> Ephemeral (Perennial, Intermittent, Ephemeral)	<b>Bankfull Width (ft.):</b> 6
<b>County:</b> Franklin	<b>303(d) Impairment Listing:</b> Not Impaired	<b>Riffle:Pool Complexes Present?</b> No

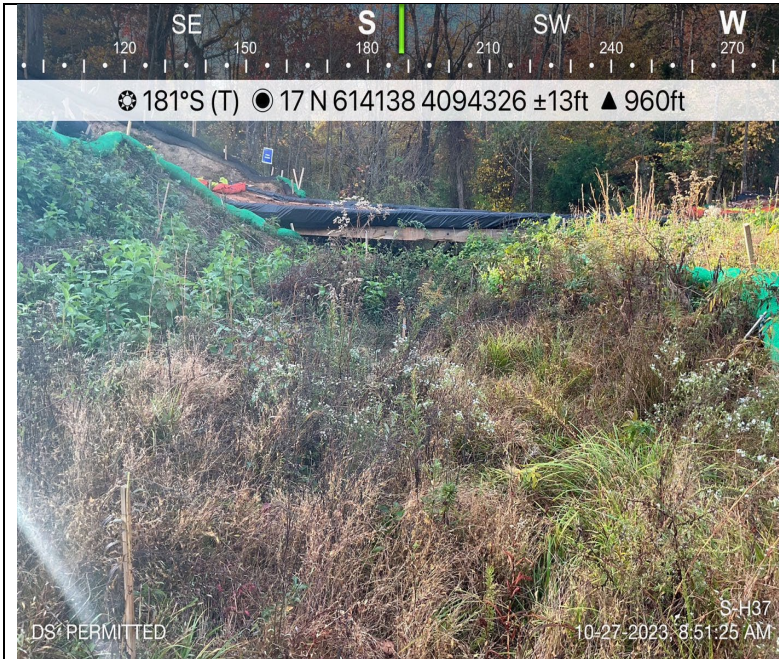
**Photo Description:** Downstream view of permitted impact area during pre-construction assessment.

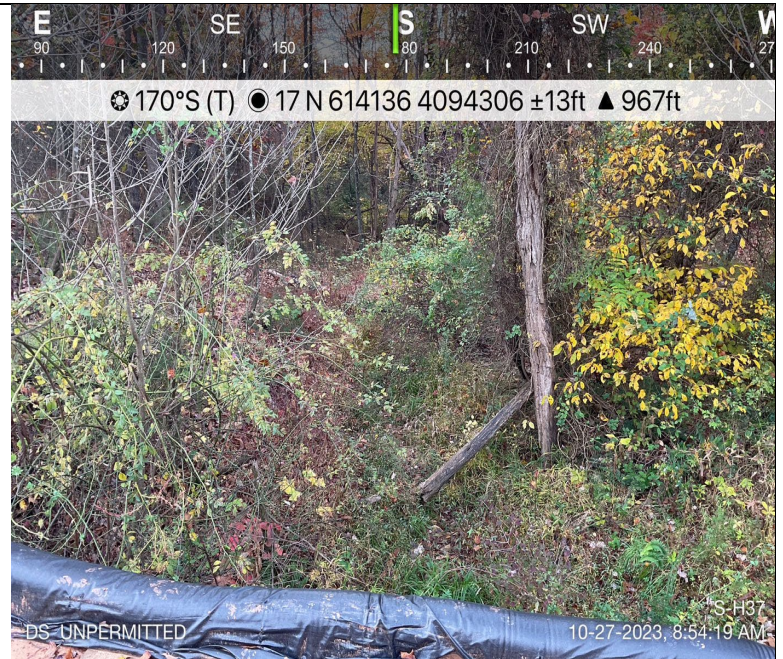
**Photo Description:** Conditions of the downstream area outside the ROW during pre-construction assessment.

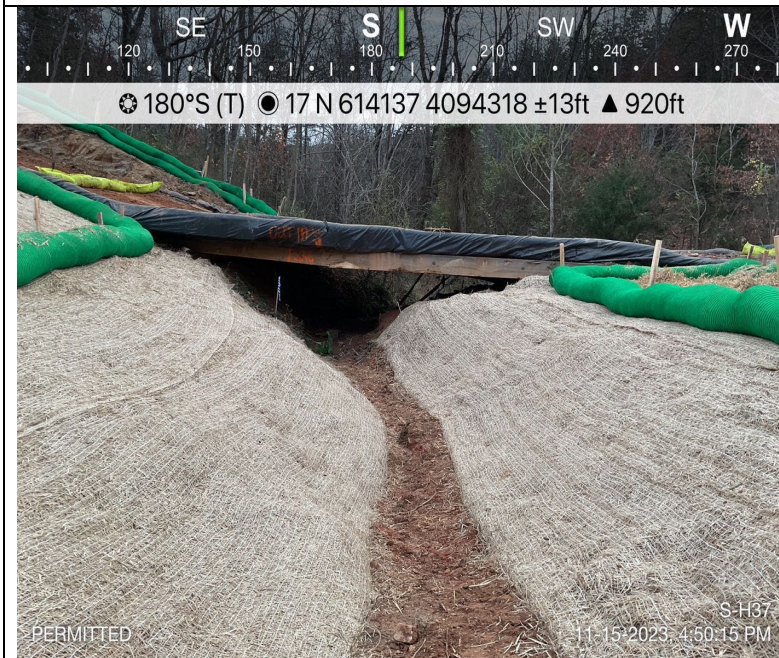
**Photo Description:** Downstream view of permitted impact area during post-construction assessment.

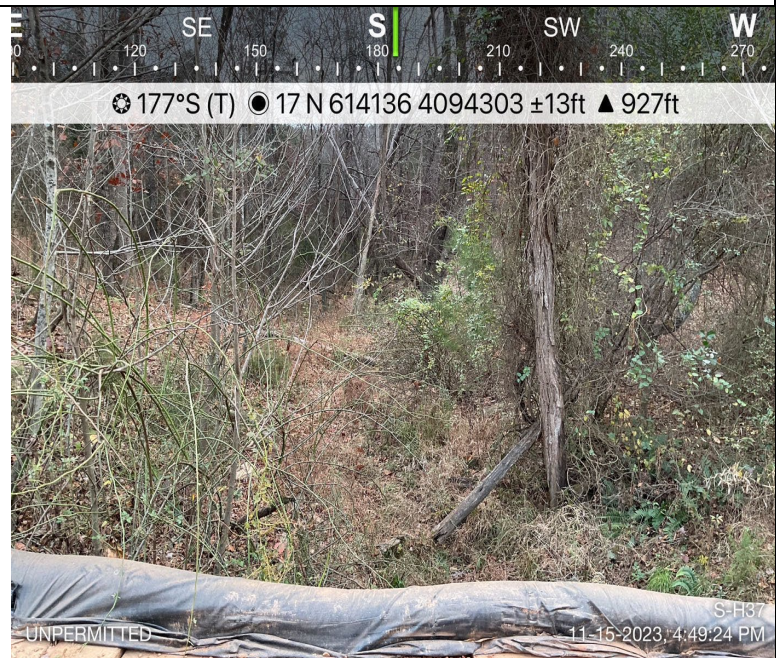
**Photo Description:** Conditions of the downstream area outside the ROW during post-construction assessment.

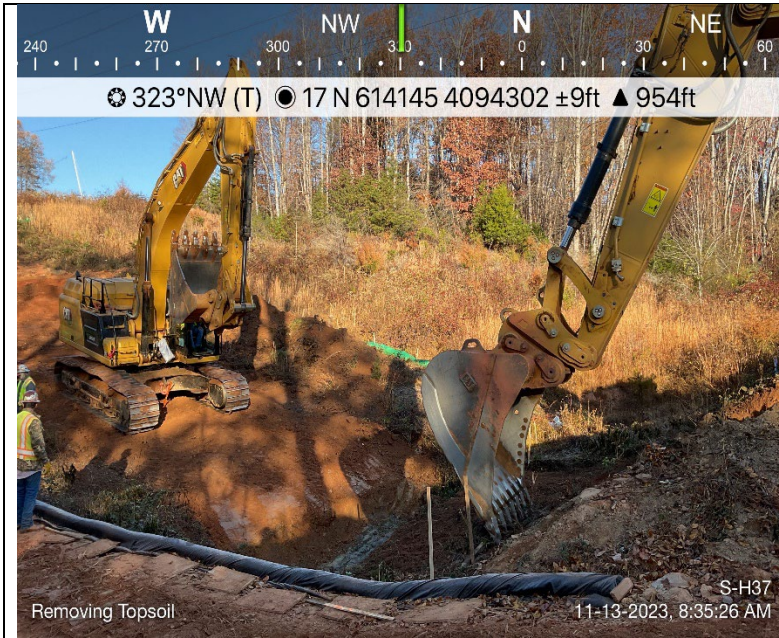
**Photo Description:** Excavation of the topsoil.

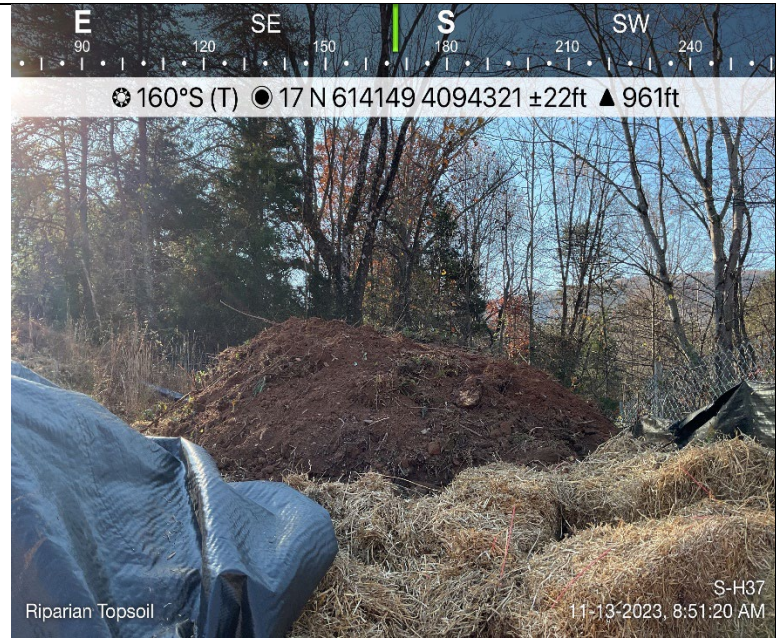
**Photo Description:** The topsoil has been segregated and stockpiled.

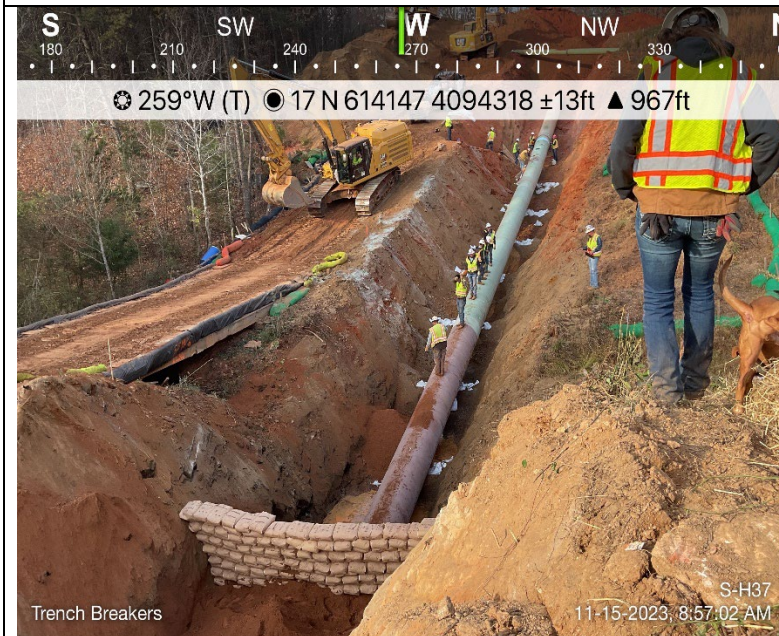
**Photo Description:** A trench breaker after installation.

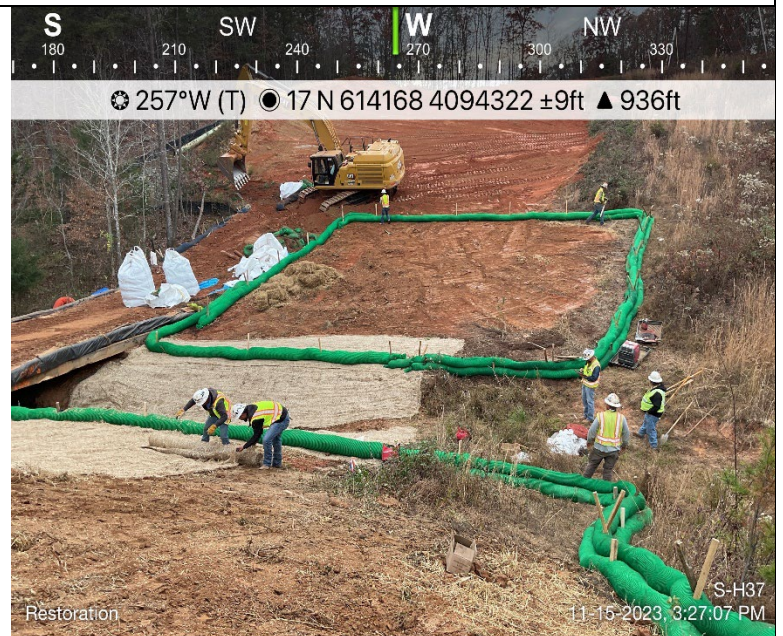
**Photo Description:** The environmental crew installing straw matting during restoration.
