# STREAM BIOLOGICAL CONDITIONS ENVIRONMENTAL AUDITOR REPORT

<b>Stream ID:</b> S-H5	<b>Crossing Start Date:</b> 11/06/2023	<b>Crossing Completion Date:</b> 11/09/2023
<b>Milepost:</b> 302.1	<b>Pre-Con Assessment Date:</b> 10/28/2023	<b>Post-Con Assessment Date:</b> 11/10/2023
<b>Station:</b> 15962+32	<b>Stream Classification:</b> Perennial (Perennial, Intermittent, Ephemeral)	<b>Bankfull Width (ft.):</b> 8
<b>County:</b> Pittsylvania	<b>303(d) Impairment Listing:</b> Impaired	<b>Riffle:Pool Complexes Present?</b> No

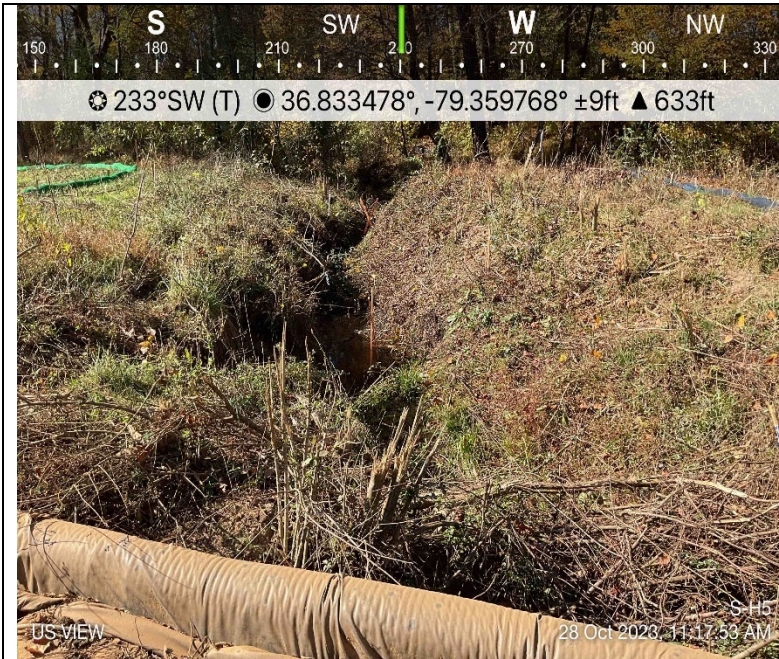
**Photo Description:** Upstream view of permitted impact area during pre-construction assessment.

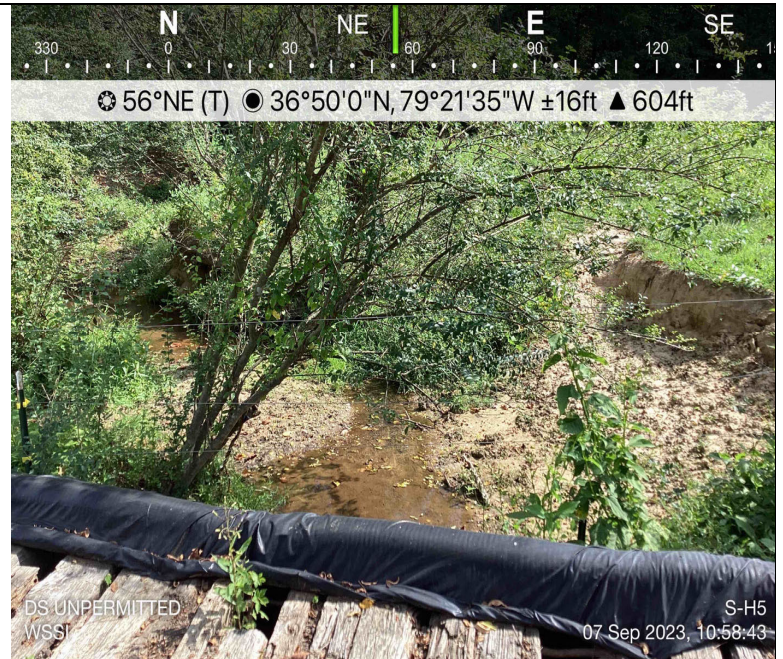
**Photo Description:** Conditions of the downstream area outside the ROW during pre-construction assessment.

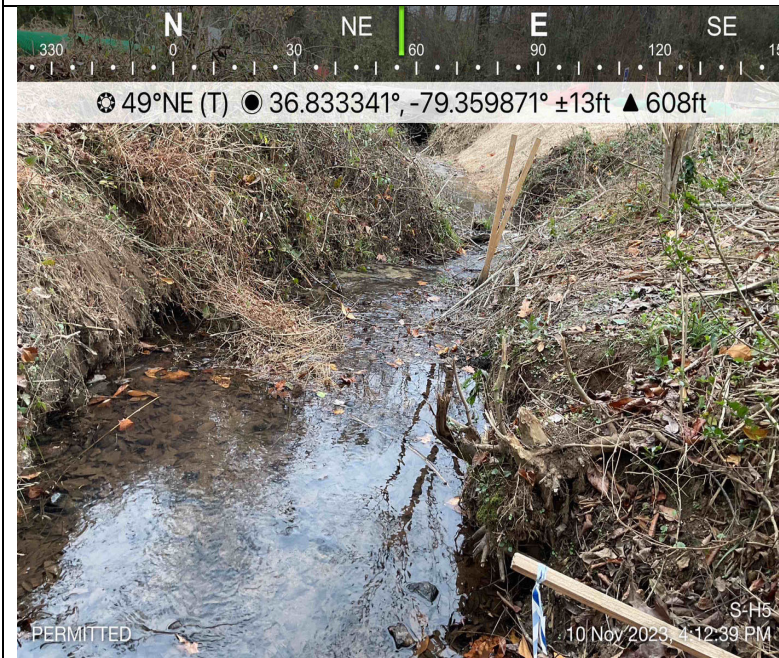
**Photo Description:** Downstream view of permitted impact area during post-construction assessment.

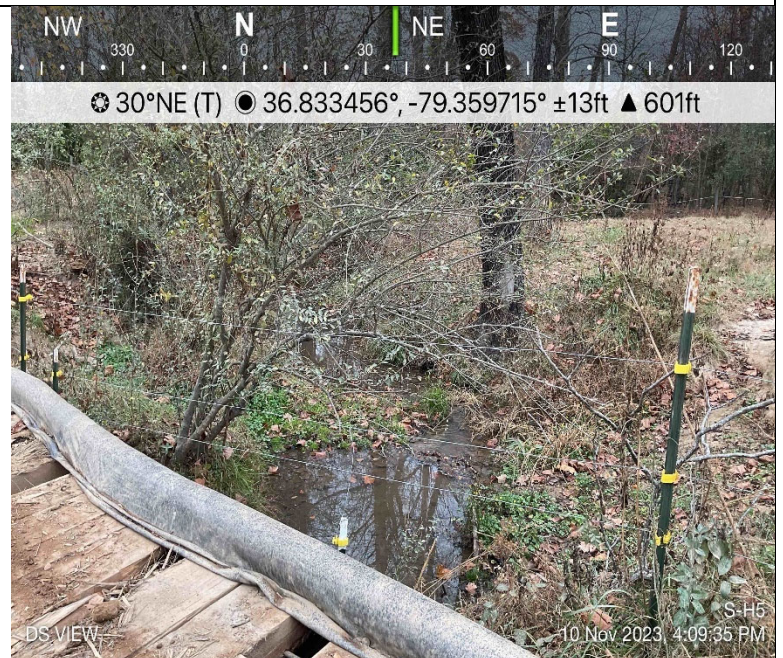
**Photo Description:** Conditions of the downstream area outside the ROW during post-construction assessment.

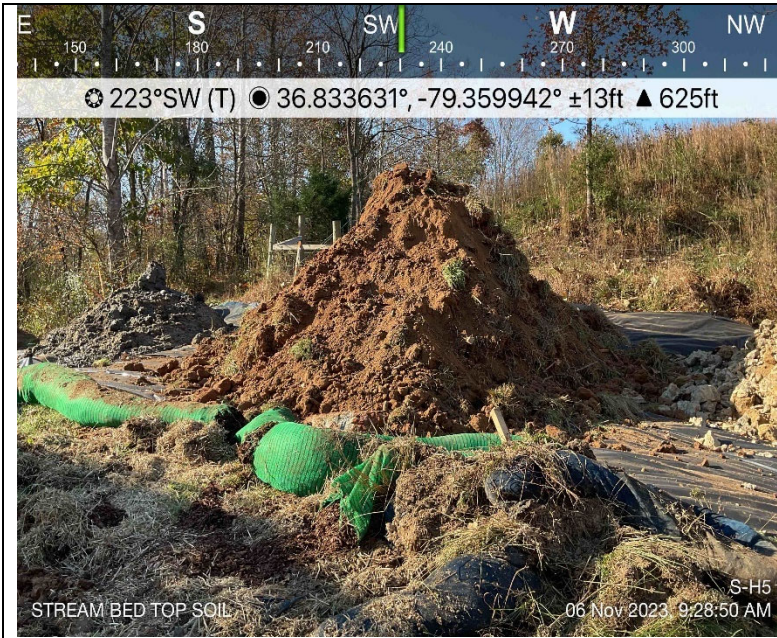
**Photo Description:** Stream bed topsoil stockpiled separately on geotextile fabric.

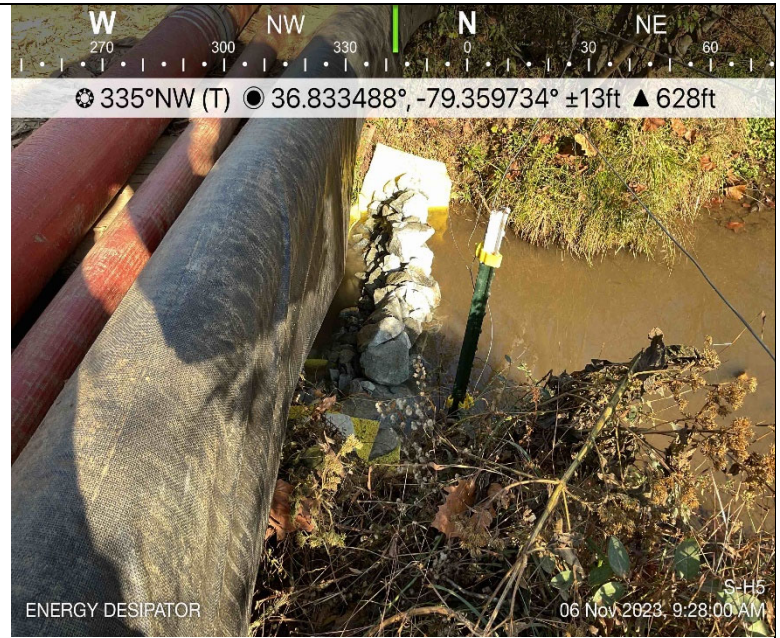
**Photo Description:** Energy dissipator installed and operating for pump around.

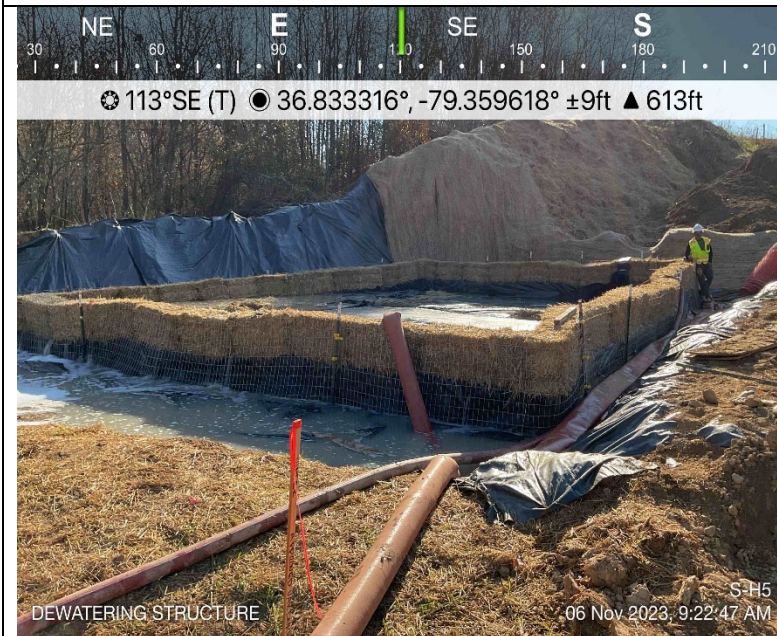
**Photo Description:** Dewatering structure installed and operational throughout crossing.

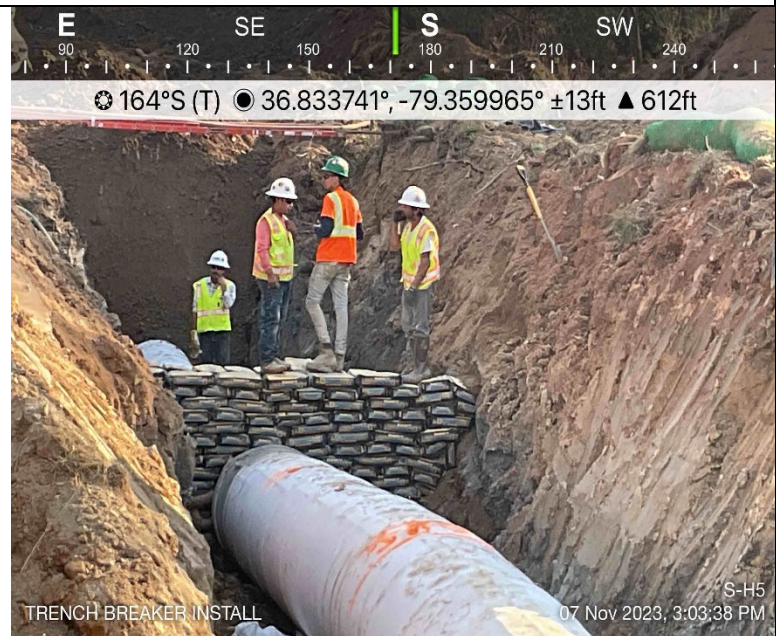
**Photo Description:** Trench breakers installed within trench prior to backfilling.
