STREAM BIOLOGICAL CONDITIONS ENVIRONMENTAL AUDITOR REPORT

Stream ID: S-HH4	Crossing Start Date: 11/06/2023	Crossing Completion Date: 11/13/2023
Milepost: 269	Pre-Con Assessment Date: 11/04/2023	Post-Con Assessment Date: 11/13/2023
Station: 14213+75	Stream Classification: Intermittent (Perennial, Intermittent, Ephemeral)	Bankfull Width (ft.): 9
County: Franklin	303(d) Impairment Listing: Not Impaired	Riffle:Pool Complexes Present? No

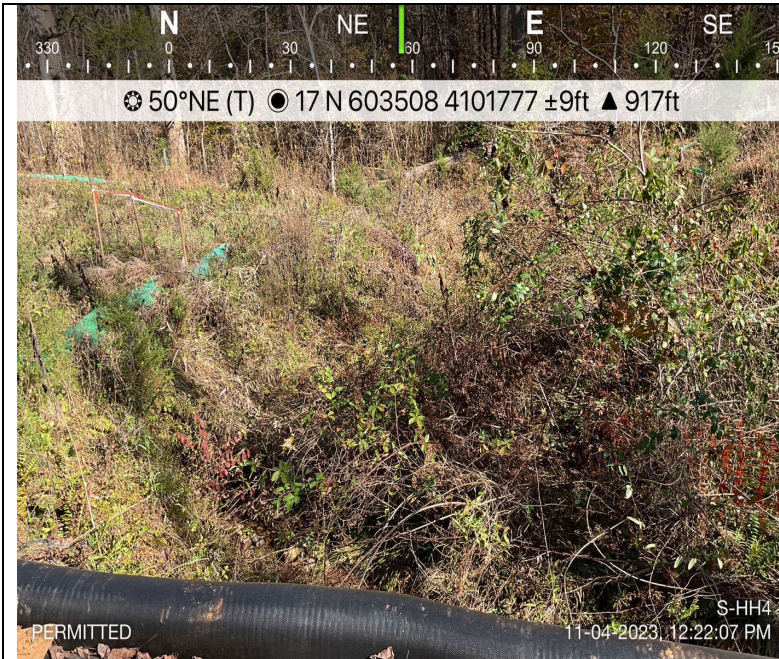
Photo Description: Downstream view of permitted impact area during pre-construction assessment.

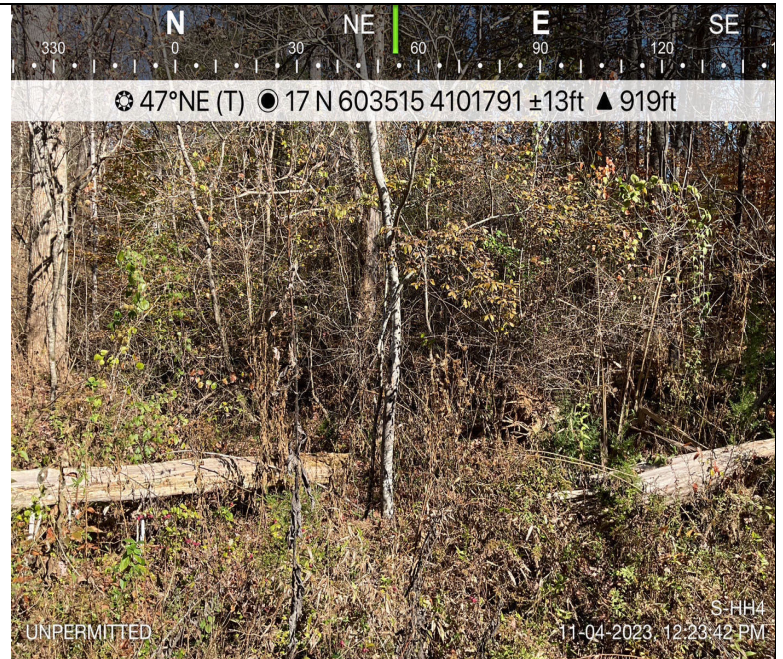
Photo Description: Conditions of the downstream area outside the ROW during pre-construction assessment.

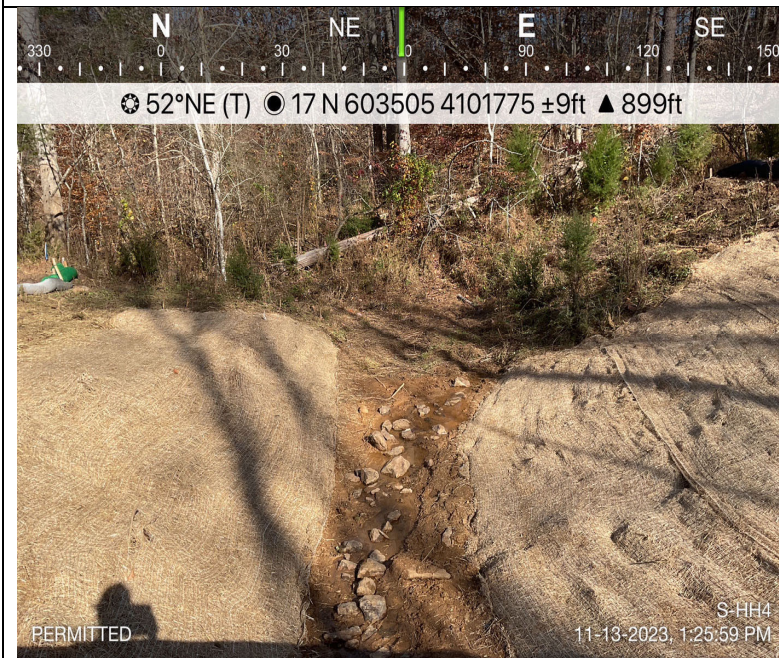
Photo Description: Downstream view of permitted impact area during post-construction assessment.

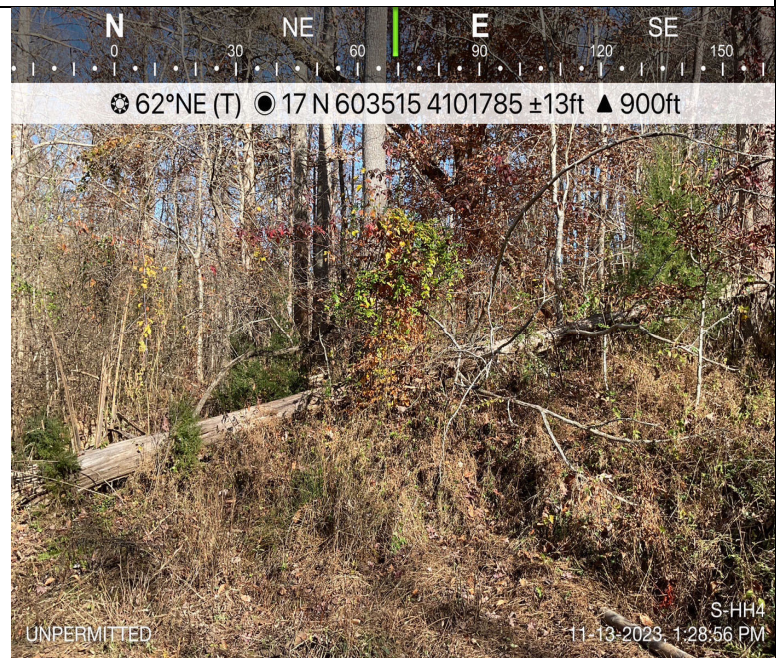
Photo Description: Conditions of the downstream area outside the ROW during post-construction assessment.

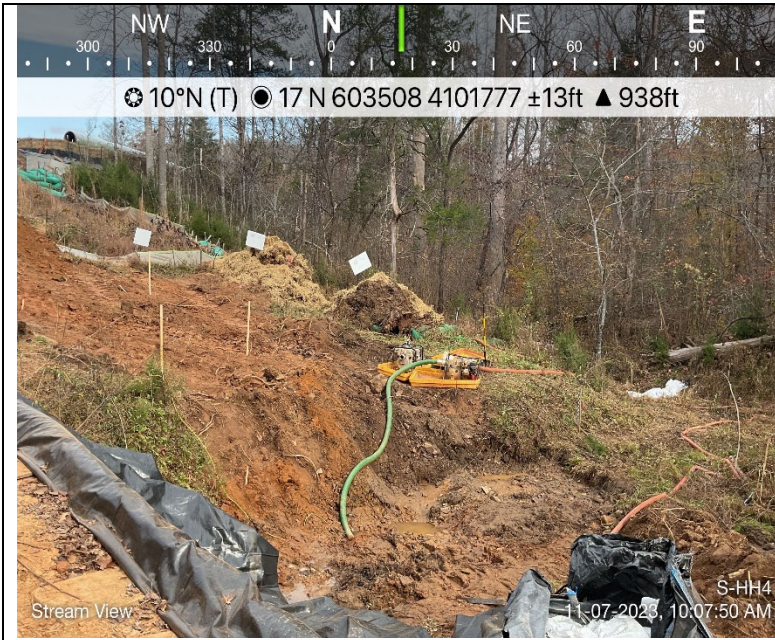
Photo Description: The stream pump around after installation.

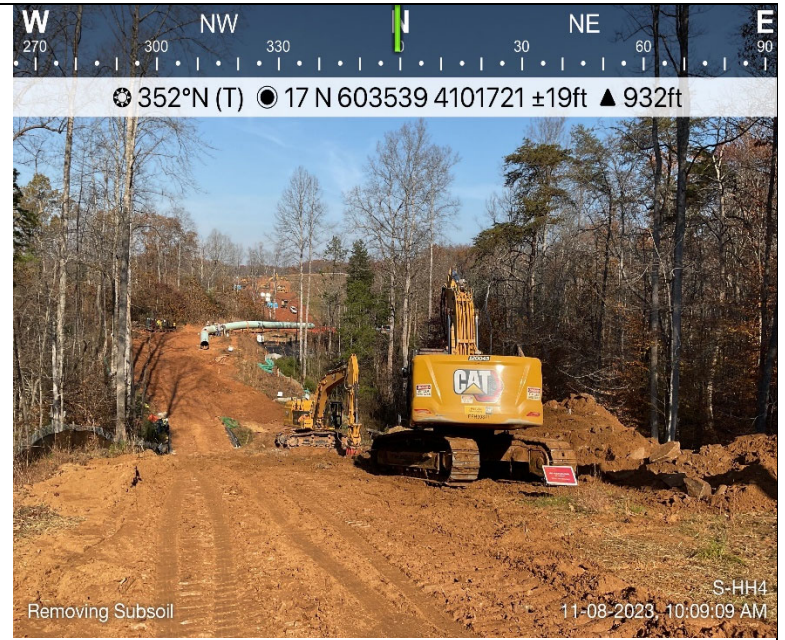
Photo Description: Excavation of the subsoil.

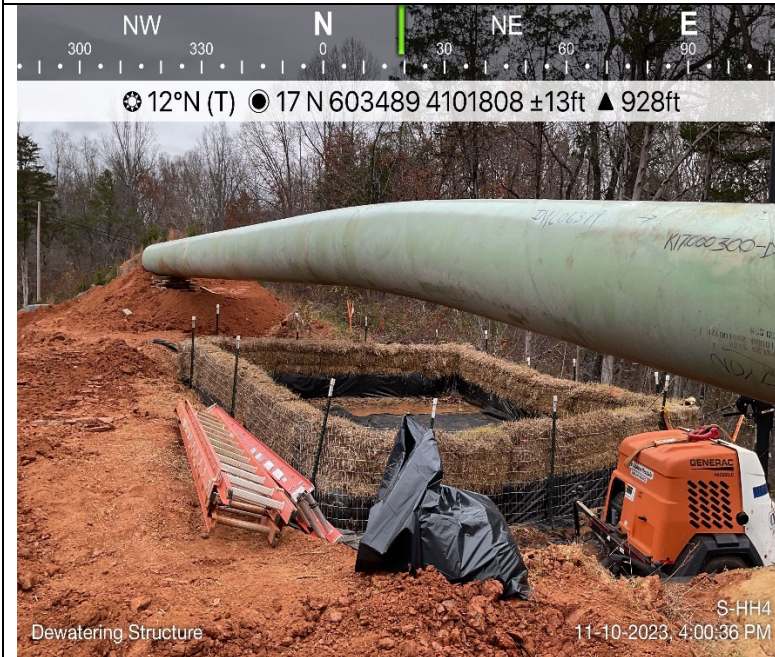
Photo Description: An overview of the dewatering structure.

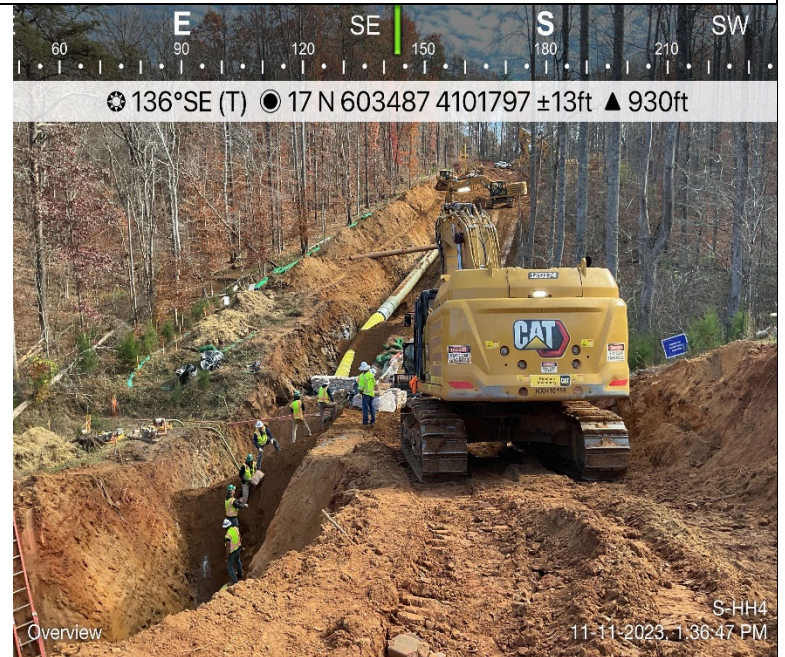
Photo Description: The crew installing a trench breaker.
