STREAM BIOLOGICAL CONDITIONS ENVIRONMENTAL AUDITOR REPORT

Stream ID: S-IJ16-b	Crossing Start Date: 11/08/2023	Crossing Completion Date: 11/18/2023
Milepost: 209.1	Pre-Con Assessment Date: 11/06/2023	Post-Con Assessment Date: 11/20/2023
Station: 11050+00	Stream Classification: Ephemeral (Perennial, Intermittent, Ephemeral)	Bankfull Width (ft.): 10
County: Giles	303(d) Impairment Listing: Not Impaired	Riffle:Pool Complexes Present? No

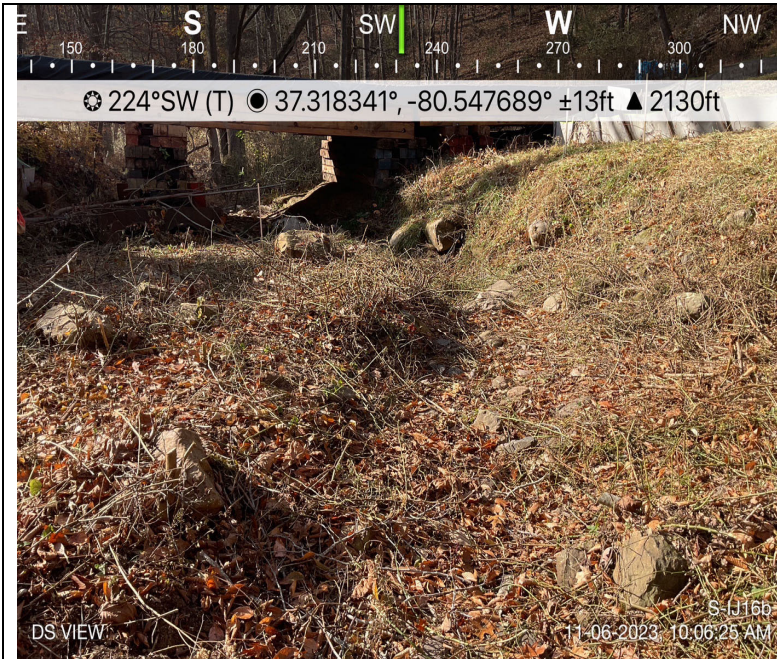
Photo Description: Downstream view of permitted impact area during pre-construction assessment.

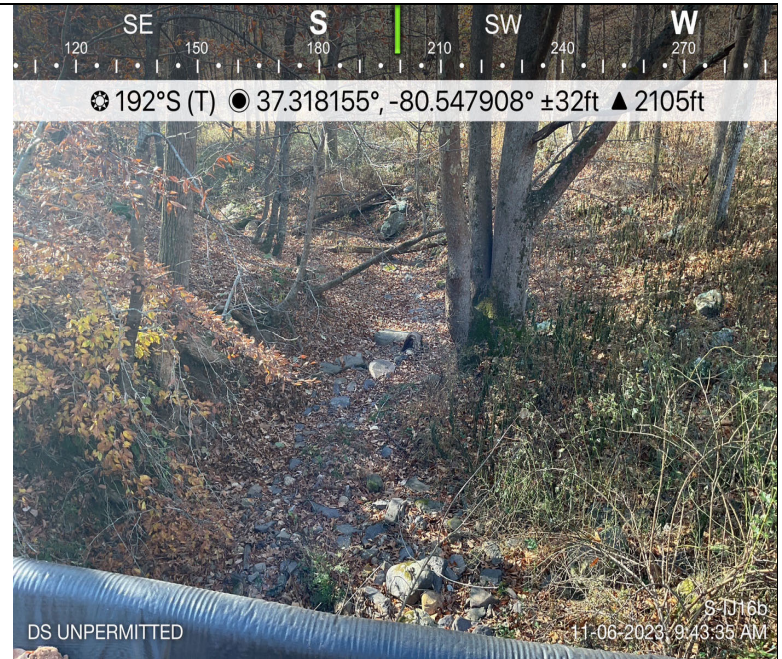
Photo Description: Conditions of the downstream area outside the ROW during pre-construction assessment.

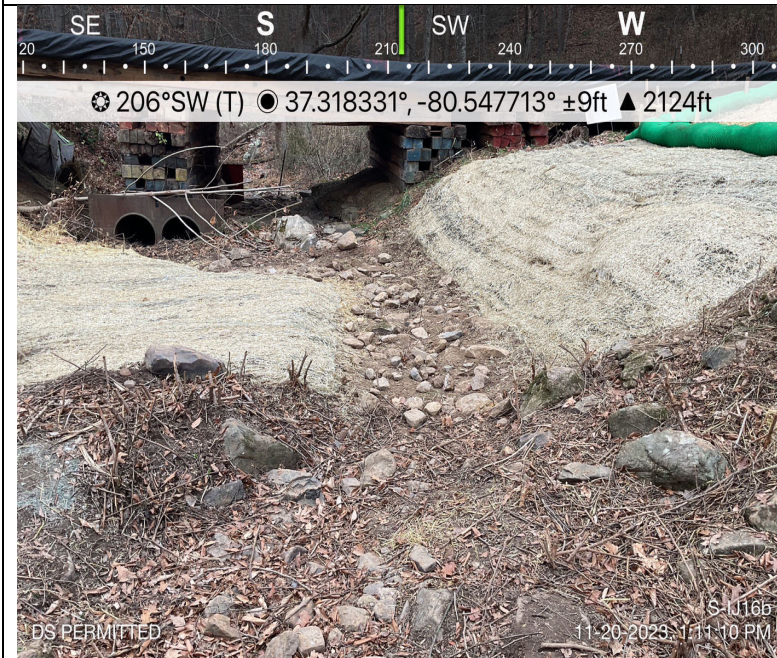
Photo Description: Downstream view of permitted impact area during post-construction assessment.

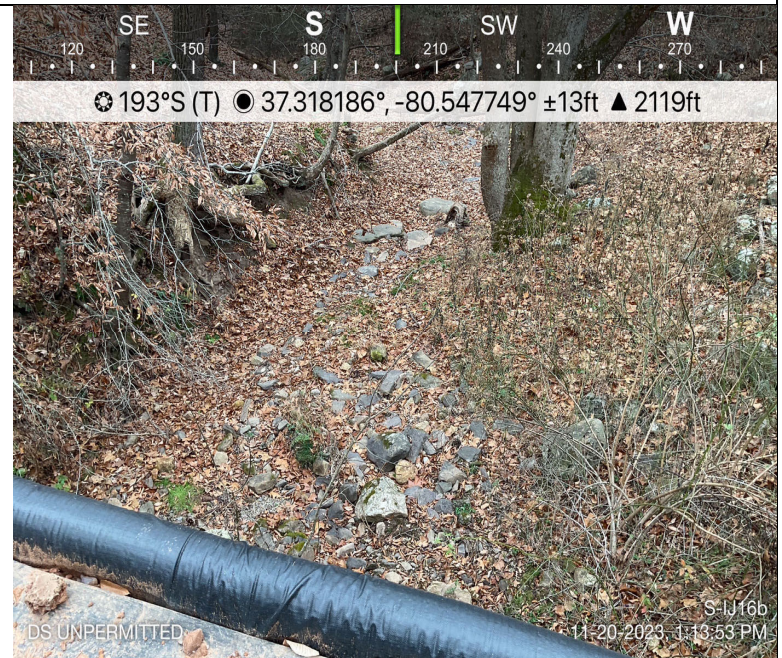
Photo Description: Conditions of the downstream area outside the ROW during post-construction assessment.

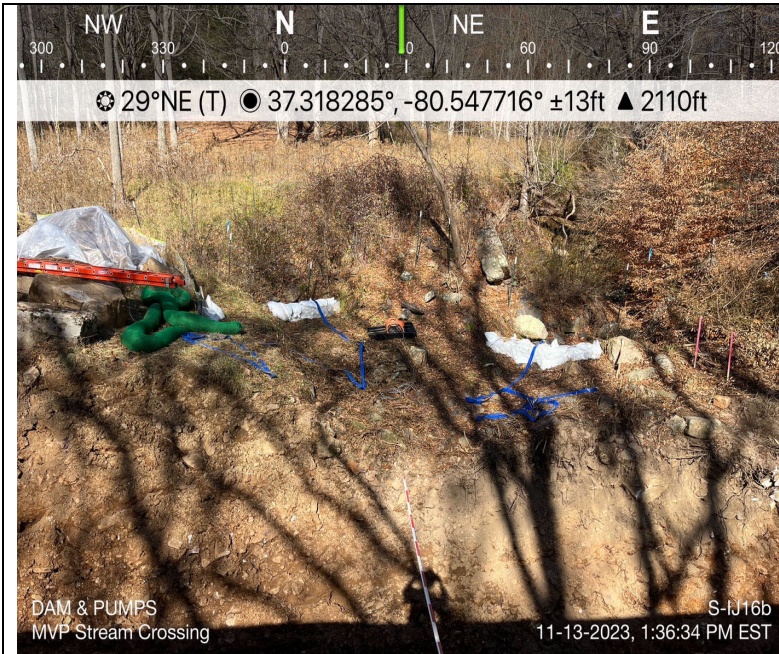
Photo Description: Dams & pumps

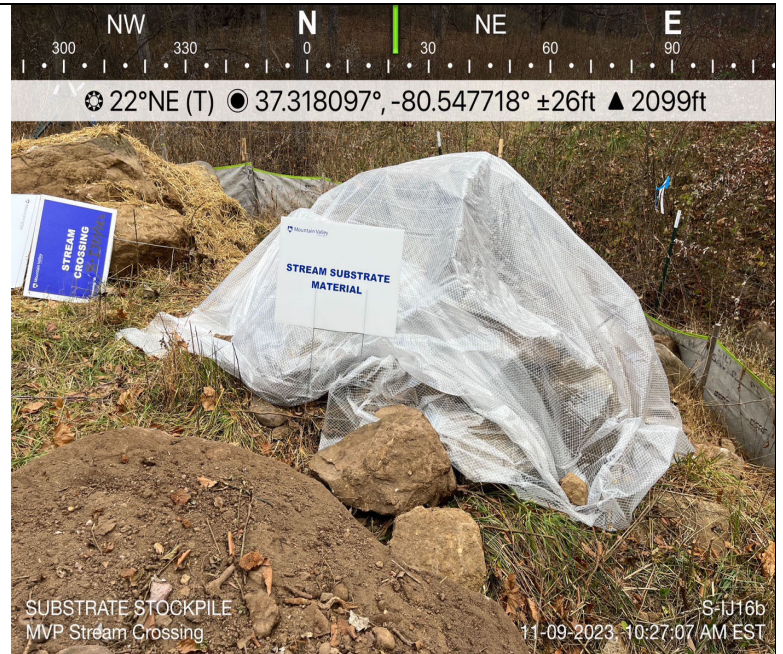
Photo Description: Stream substrate stockpile

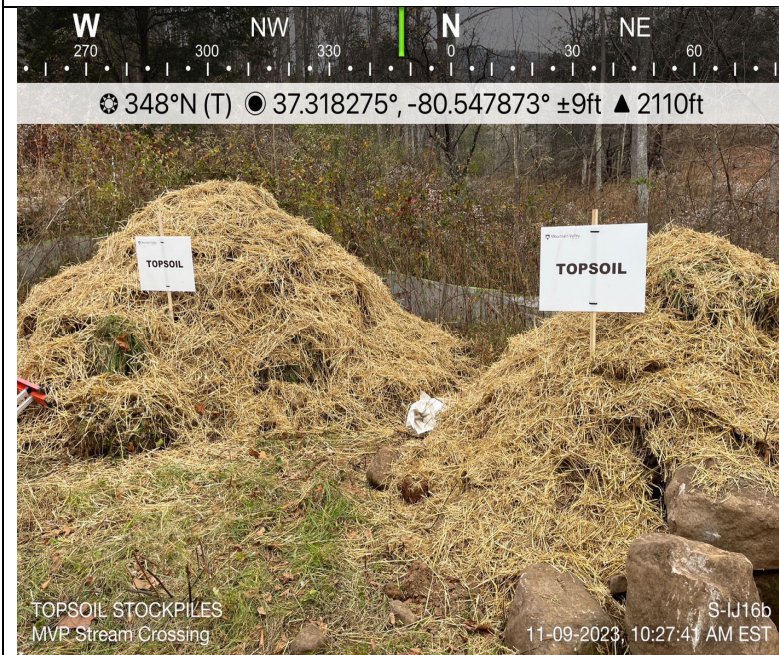
Photo Description: Topsoil stockpiles

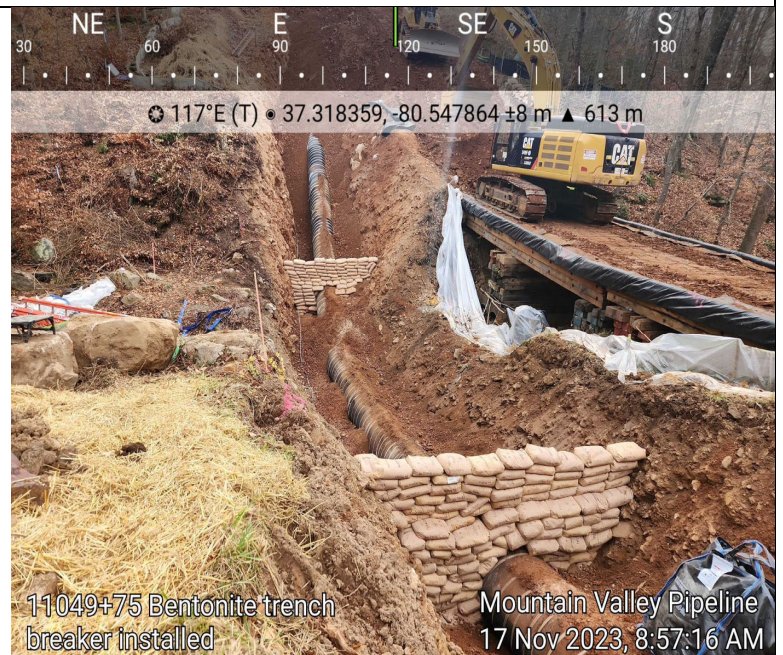
Photo Description: Trench breakers
