STREAM BIOLOGICAL CONDITIONS ENVIRONMENTAL AUDITOR REPORT

Stream ID: S-IJ18-EPH	Crossing Start Date: 11/24/2023	Crossing Completion Date: 11/30/2023
Milepost: 208.6	Pre-Con Assessment Date: 11/20/2023	Post-Con Assessment Date: 11/30/2023
Station: 11025+50	Stream Classification: Ephemeral (Perennial, Intermittent, Ephemeral)	Bankfull Width (ft.): 3
County: Giles	303(d) Impairment Listing: Not Impaired	Riffle:Pool Complexes Present? No

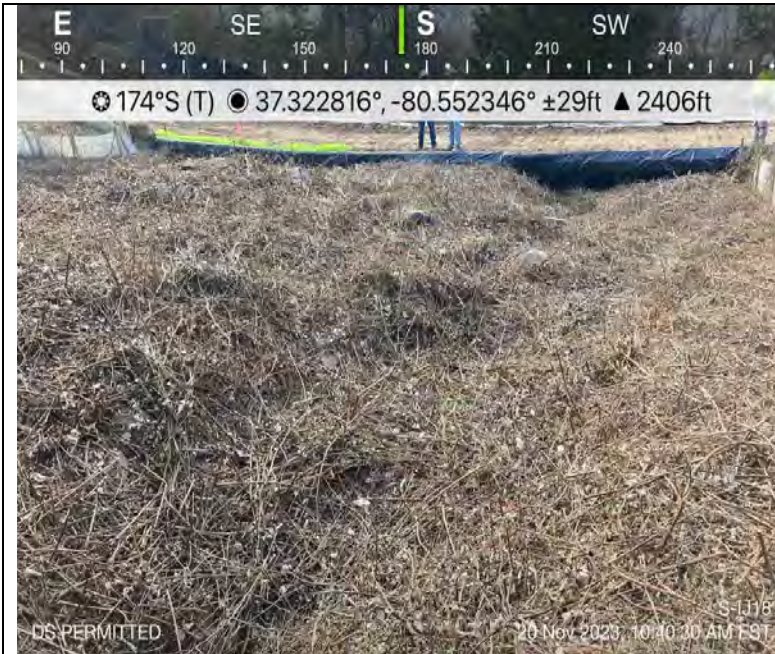
Photo Description: Downstream view of permitted impact area during pre-construction assessment.

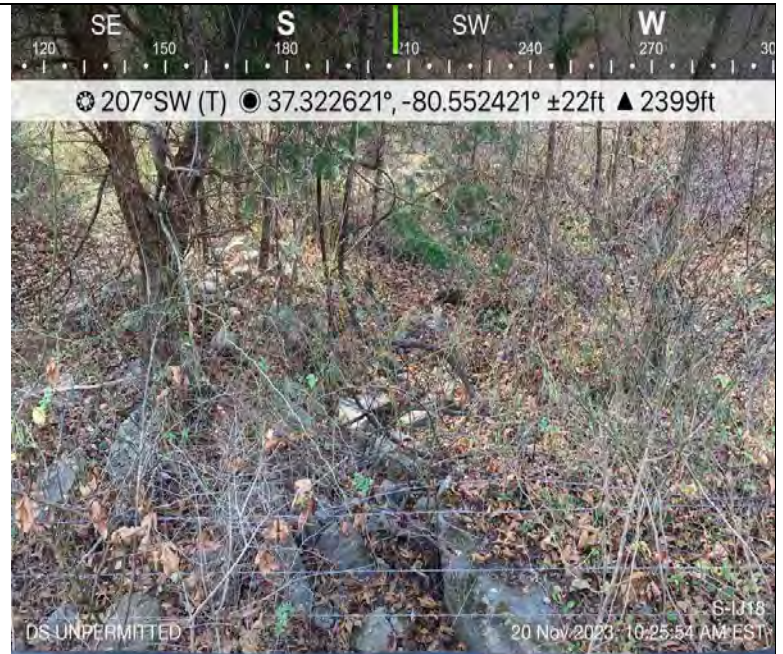
Photo Description: Conditions of the downstream area outside the ROW during pre-construction assessment.

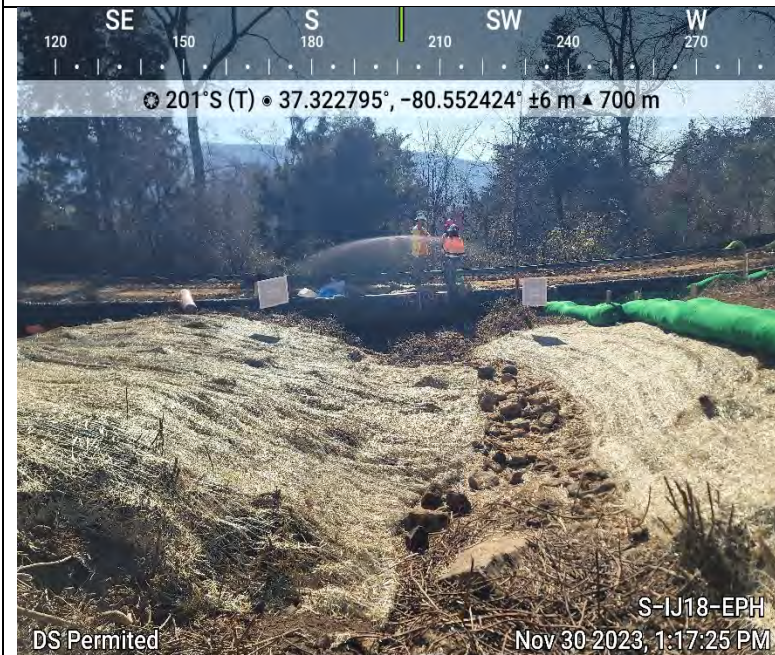
Photo Description: Downstream view of permitted impact area during post-construction assessment.

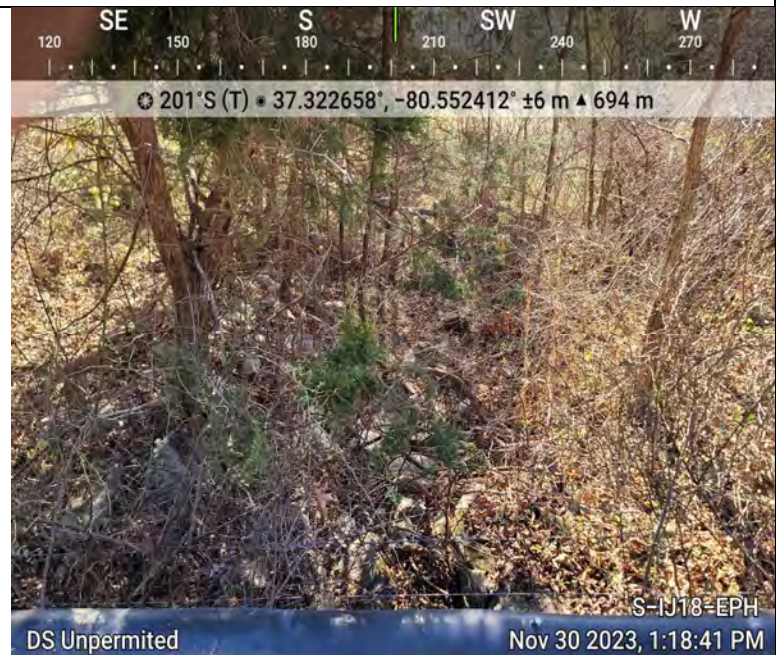
Photo Description: Conditions of the downstream area outside the ROW during post-construction assessment.

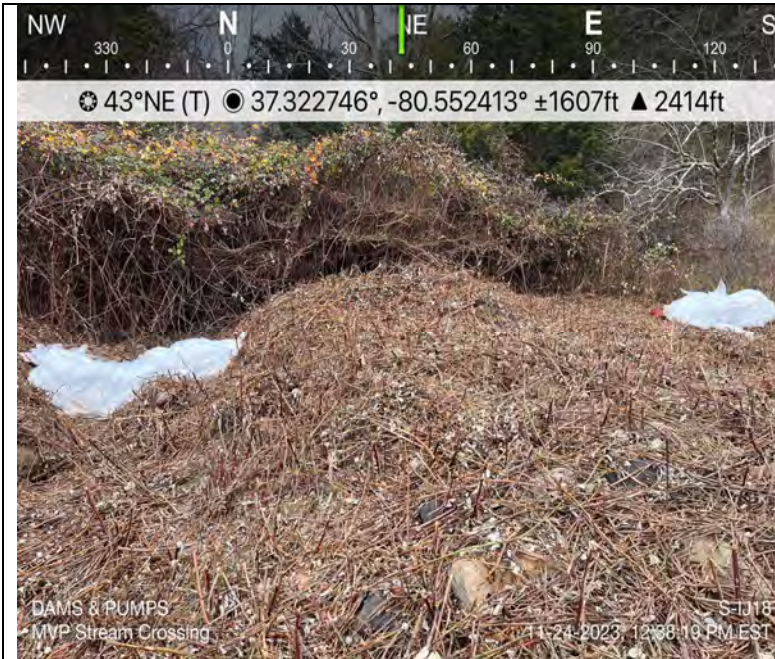
Photo Description: Dam and pump installed and available for operation throughout crossing.

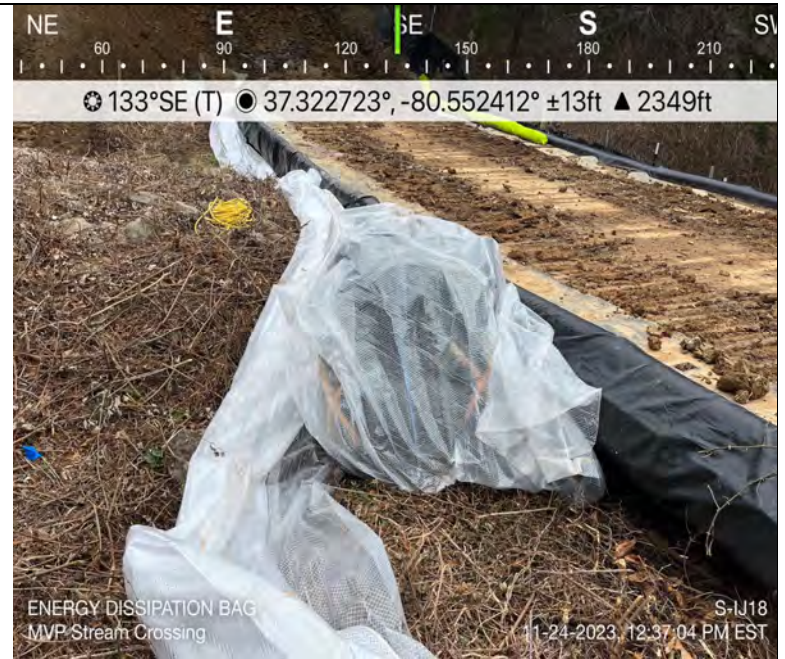
Photo Description: Energy dissipator (covered in plastic).

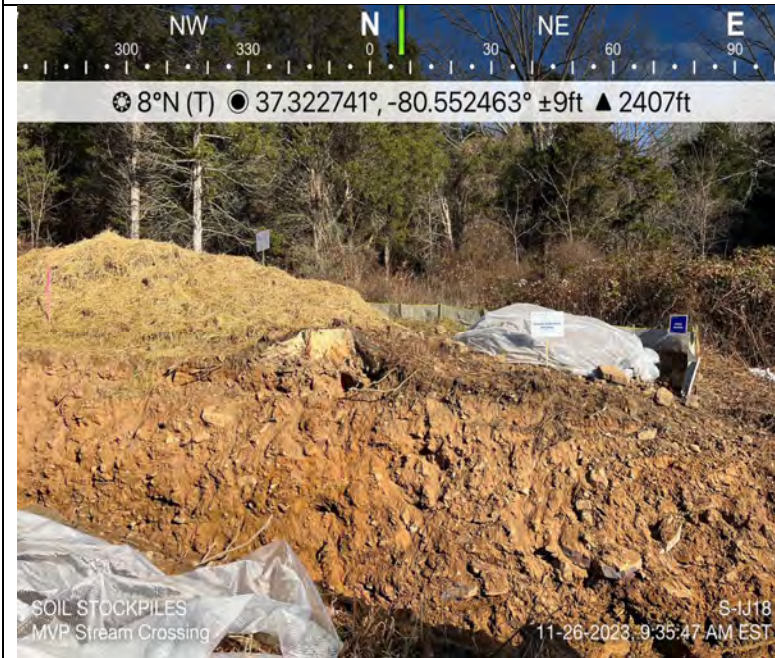
Photo Description: Substrate, topsoil, and subsoil were all stockpiled separately as required.

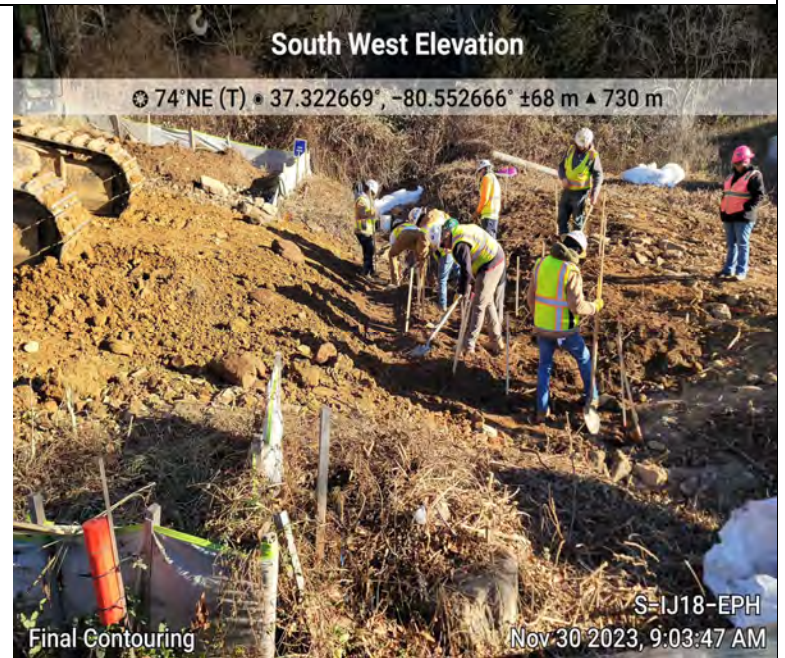
Photo Description: Final contouring of resource during restoration.
