Stream Biological Conditions EA Report

Project Name	H-600 Pipeline Spread D	AFE	124300132	Spread	H-600 Pipeline Spread D
Contractor	Precision	Report #	426		
Environmental Auditor	Kyle Gillow	Date/Time	12/5/2023 9:56 AM		
Stream ID	S-J23-EPH	Crossing Start Date	12/5/2023	Crossing Completion Date	12/15/2023
Milepost	122.42	Pre-Con Assessment Date	11/29/2023	Post-Con Assessment Date	12/15/2023
Station	6463+74	Bankfull Width (ft.)	1.5	Riffle:Pool Complexes Present?	No
State	WV	Stream Classification	Ephemeral		
County	Nicholas	303(d) Impairment Listing	No

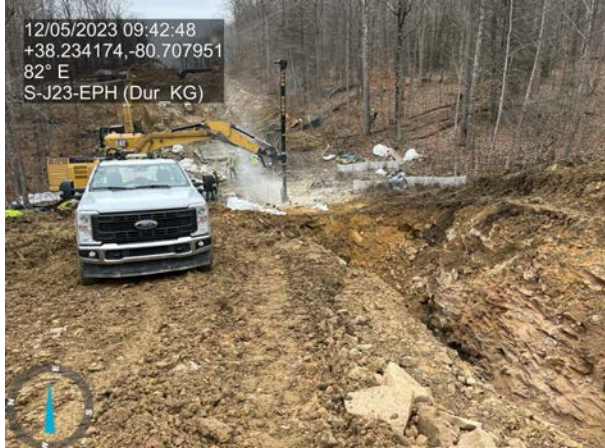
GPS Location	See caption in photo.	GPS Location	See caption in photo.
Description	Blasting crew drilling through feature.	Description	Start of trenching through feature.

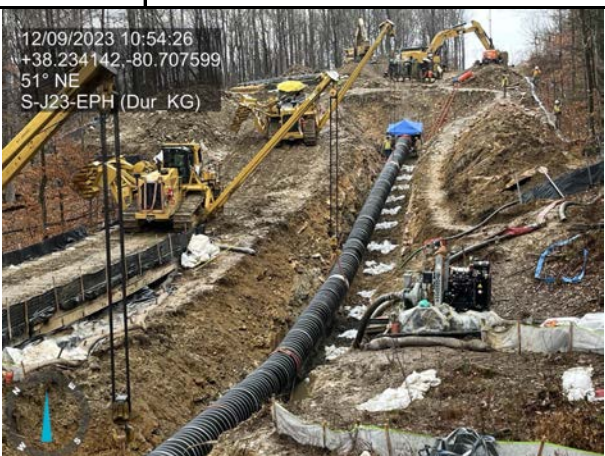
GPS Location	See caption in photo.	GPS Location	See caption in photo.
Description	Making weld on the CIS of the stream.	Description	Breakers built on both the coming in and going away sides of feature.

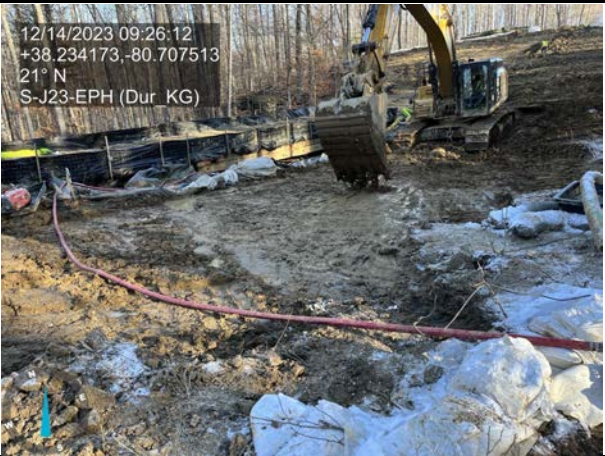
GPS Location	See caption in photo.	GPS Location	See caption in photo.
Description	Re-establishing stream bed and banks.	Description	Placing stream substrate back into feature.
