# Stream Biological Conditions EA Report

<b>Project Name</b>	H-600 Pipeline Spread F	<b>AFE</b>	124300135	<b>Spread</b>	H-600 Pipeline Spread F
<b>Contractor</b>	Price Gregory	<b>Report #</b>	362		
<b>Environmental Auditor</b>	Luke Fultz	<b>Date/Time</b>	11/16/2023 11:03 AM		
<b>Stream ID</b>	S-K21	<b>Crossing Start Date</b>	11/25/2023	<b>Crossing Completion Date</b>	12/7/2023
<b>Milepost</b>	155.42	<b>Pre-Con Assessment Date</b>	11/16/2023	<b>Post-Con Assessment Date</b>	12/7/2023
<b>Station</b>	8206+18	<b>Bankfull Width (ft.)</b>	8.3	<b>Riffle:Pool Complexes Present?</b>	No
<b>State</b>	WV	<b>Stream Classification</b>	Perennial		
<b>County</b>	Greenbrier	<b>303(d) Impairment Listing</b>	No

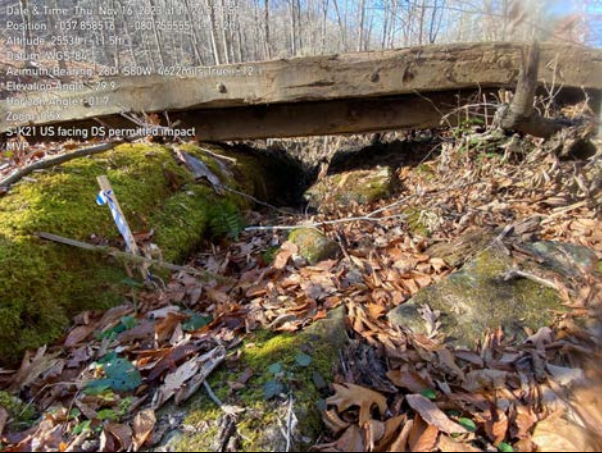
<p>Date &amp; Time: Thu, Nov 16, 2023 at 11:03:58 EST  Position: +037.858577 / -080.755473 (+37.86°N, -80.76°W)  Altitude: 2531ft (+771.9m)  Datum: WGS-84  Azimuth Bearing: 260.580W 4622mils True (+13.1°)  Elevation Angle: -18.3  Horizon Angle: -01.3  Zoom: 0.5X  S-K21 US facing DS permitted impact MVP</p>		  <p>Date &amp; Time: Thu, Nov 16, 2023 at 11:26:17 EST  Position: +037.858624 / -080.755369 (+37.86°N, -80.76°W)  Altitude: 2521ft (+768.6m)  Datum: WGS-84  Azimuth Bearing: 276.184W 4907mils True (+13.2°)  Elevation Angle: -18.3  Horizon Angle: -01.3  Zoom: 0.5X  S-K21 US facing DS unimpacted MVP</p>		<p><b>GPS Location</b> See Photo</p> <p><b>Description</b> Downstream view of permitted impact area during pre-construction assessment.</p>		<p><b>GPS Location</b> See Photo</p> <p><b>Description</b> Downstream view of unimpacted area during pre-construction assessment.</p>

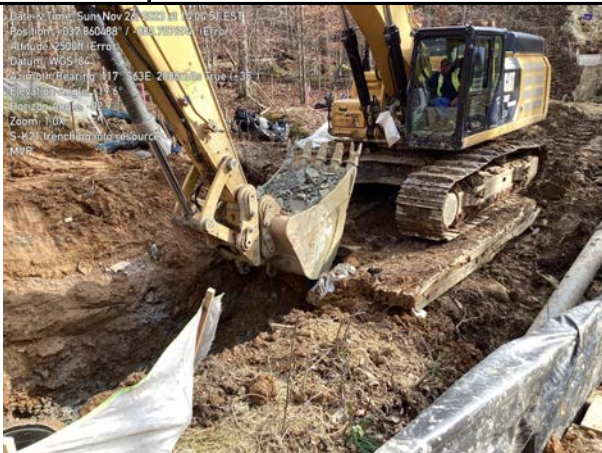
<p>Date &amp; Time: Sun, Nov 26, 2023 at 10:00:51 EST  Position: +037.860668 / -080.758361 (+37.86°N, -80.76°W)  Altitude: 2508ft (+764.5m)  Datum: WGS-84  Azimuth Bearing: 117.163E 240mils True (+13.1°)  Elevation Angle: -18.3  Horizon Angle: -01.3  Zoom: 0.5X  S-K21 US facing DS aquatic resource MVP</p>		<p><b>GPS Location</b> See Photo</p> <p><b>Description</b> Photo 1: Excavating top 12 inches of substrate.</p>		<p><b>GPS Location</b> See Photo</p> <p><b>Description</b> Photo 2: Excavating towards the aquatic resource.</p>
