Stream Biological Conditions EA Report

Project Name	H-600 Pipeline Spread C	AFE	124300131	Spread	H-600 Pipeline Spread C
Contractor	Precision	Report #	439		
Environmental Auditor	Paul Hixon	Date/Time	12/12/2023 5:45 PM		
Stream ID	S-KK2	Crossing Start Date	12/4/2023	Crossing Completion Date	12/12/2023
Milepost	82.12	Pre-Con Assessment Date	11/15/2023	Post-Con Assessment Date	12/12/2023
Station	4335+96	Bankfull Width (ft.)	3.0	Riffle:Pool Complexes Present?	No
State	WV	Stream Classification	Ephemeral		
County	Webster	303(d) Impairment Listing	No

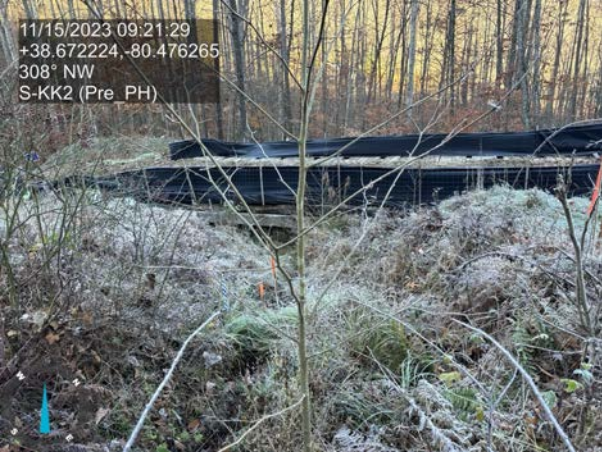
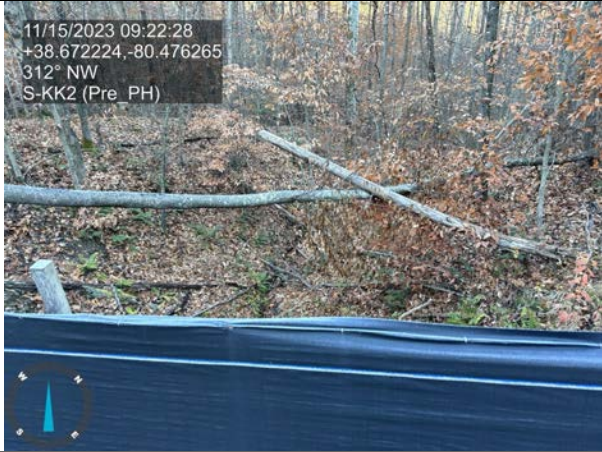
GPS Location	See Photo	GPS Location	See Photo
Description	Downstream view of permitted impact area during pre-construction assessment.	Description	Downstream view of unimpacted area during pre-construction assessment.

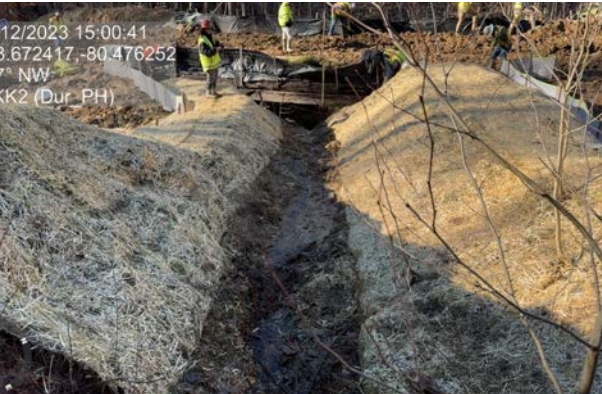
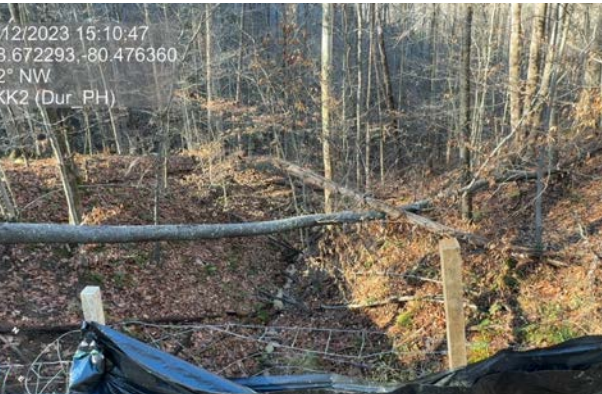
GPS Location	See Photo	GPS Location	See Photo
Description	Downstream view of permitted impact area during post-construction assessment.	Description	Downstream view of unimpacted area during post-construction assessment.

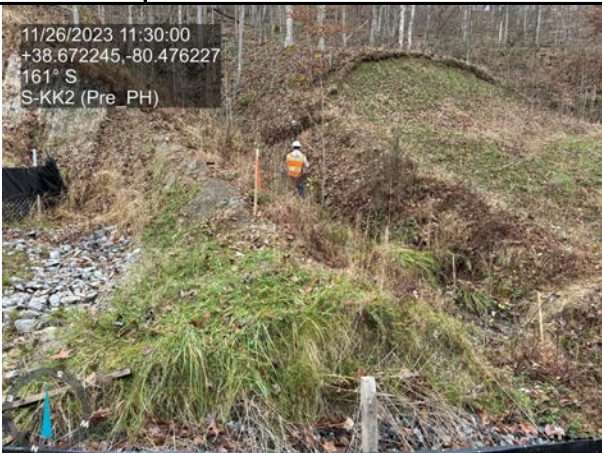
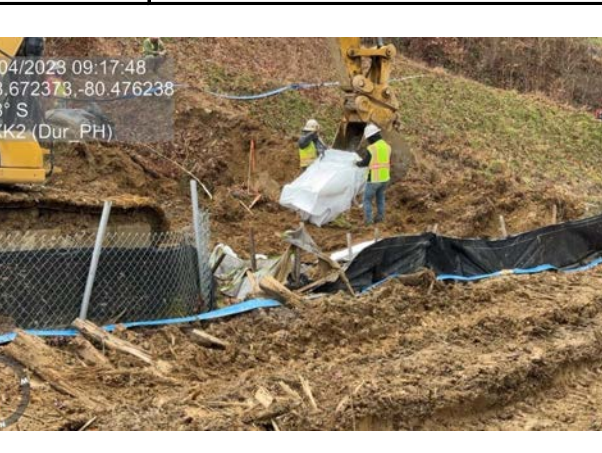
GPS Location	See Photo	GPS Location	See Photo
Description	Pre-construction survey of S-KK2 was done due to conflicting data.	Description	The soil substrate was removed in numbered sacks for future restoration.

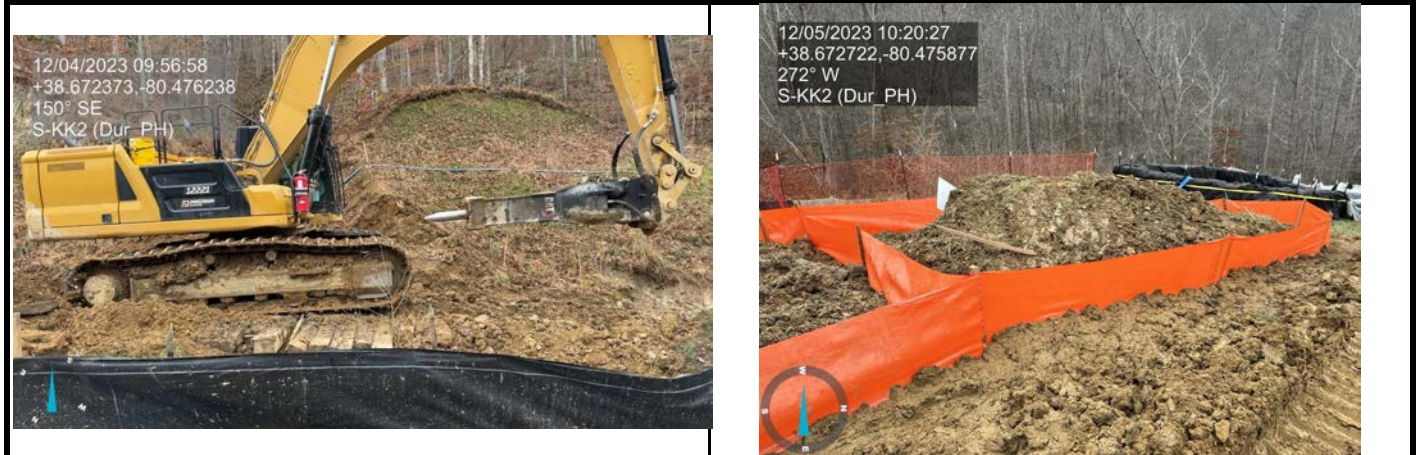
GPS Location See Photo	GPS Location See Photo
Description Using timber mats while rock hammering through S-KK2.	Description Segregation of the top 12" of stream bank soil.

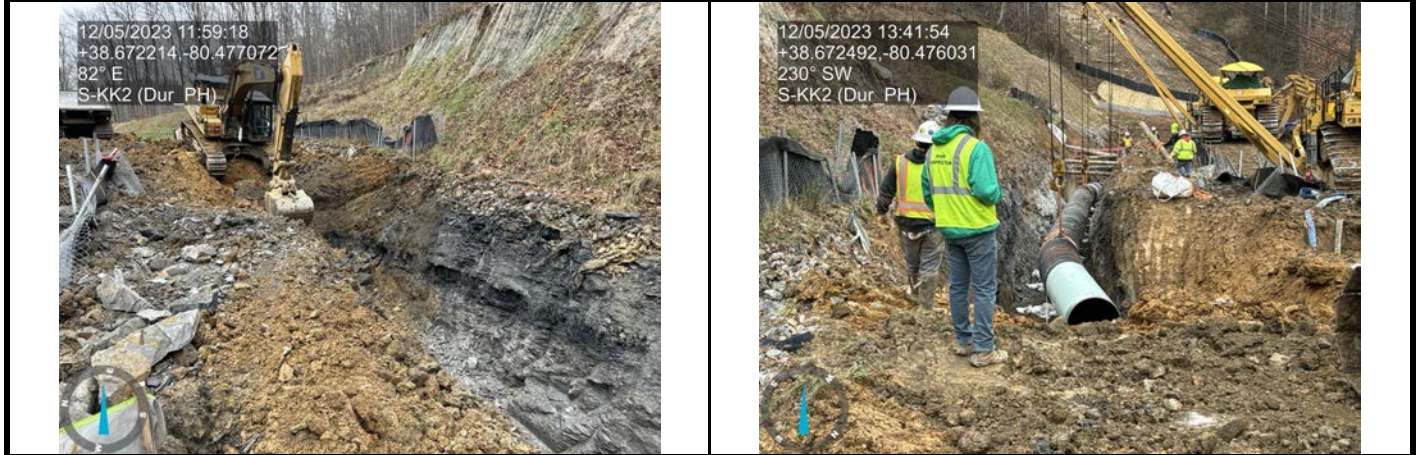
GPS Location See Photo	GPS Location See Photo
Description Excavation of the rock layer through S-KK2.	Description Lowered in a section of pipe through S-KK2.

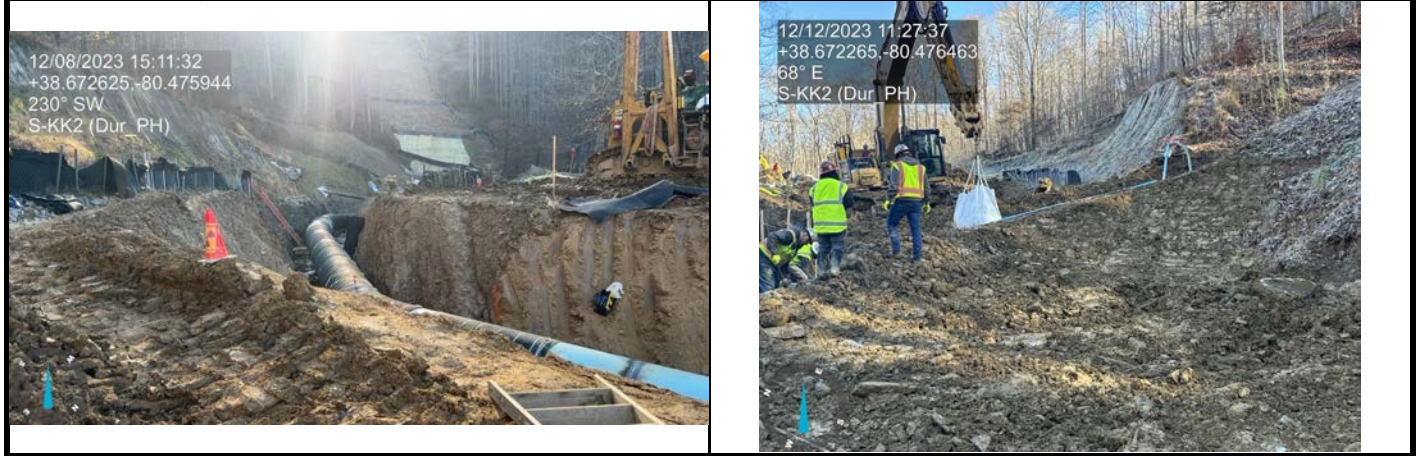
GPS Location See Photo	GPS Location See Photo
Description Pipe extending through the resource S-KK2.	Description Restoring of stream substrate using the numbered sacks.
