Stream Biological Conditions EA Report

Project Name	H-600 Pipeline Spread C	AFE	124300131	Spread	H-600 Pipeline Spread C
Contractor	Precision	Report #	434		
Environmental Auditor	Paul Hixon	Date/Time	12/11/2023 3:09 PM		
Stream ID	S-KK3b	Crossing Start Date	11/25/2023	Crossing Completion Date	12/9/2023
Milepost	82.13	Pre-Con Assessment Date	10/24/2023	Post-Con Assessment Date	12/11/2023
Station	4336+67	Bankfull Width (ft.)	3.0	Riffle:Pool Complexes Present?	No
State	WV	Stream Classification	Ephemeral		
County	Webster	303(d) Impairment Listing	No

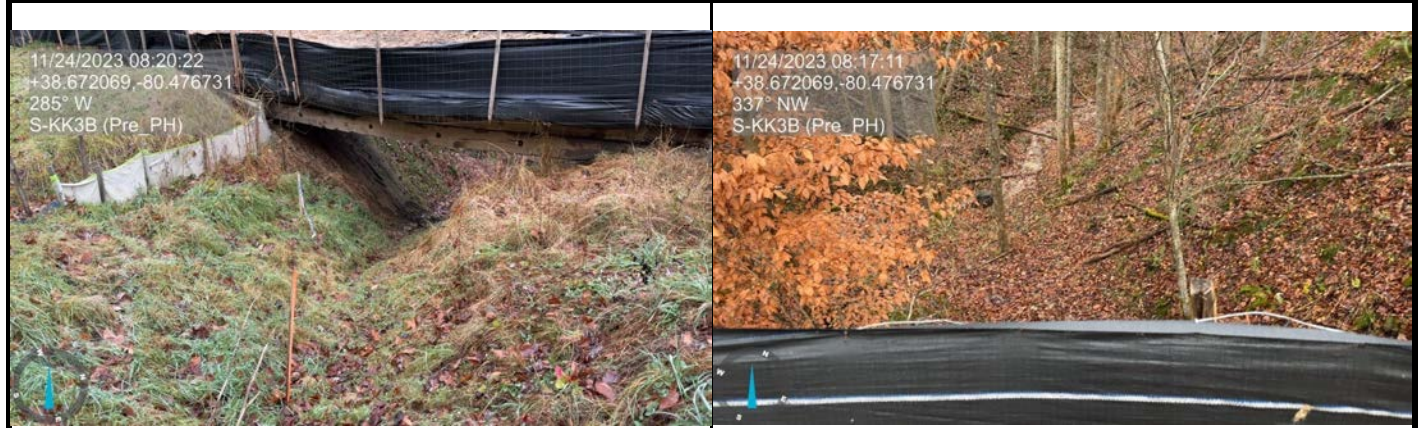
GPS Location See Photo	GPS Location See Photo
Description Downstream view of permitted impact area during pre-construction assessment.	Description Downstream view of unimpacted area during pre-construction assessment.

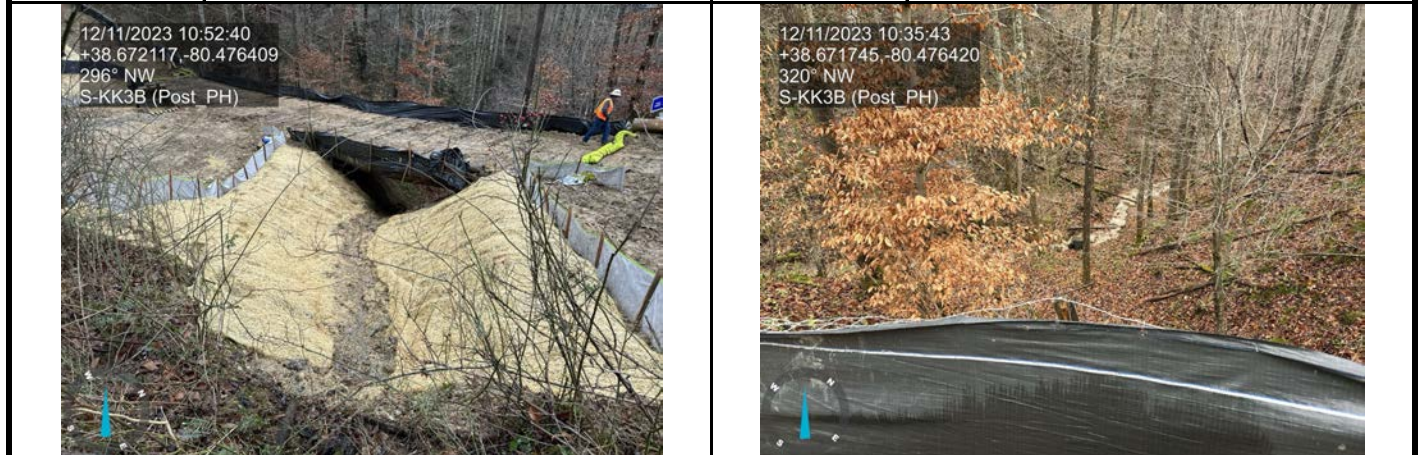
GPS Location See Photo	GPS Location See Photo
Description Downstream view of permitted impact area during post-construction assessment.	Description Downstream view of unimpacted area during post-construction assessment.

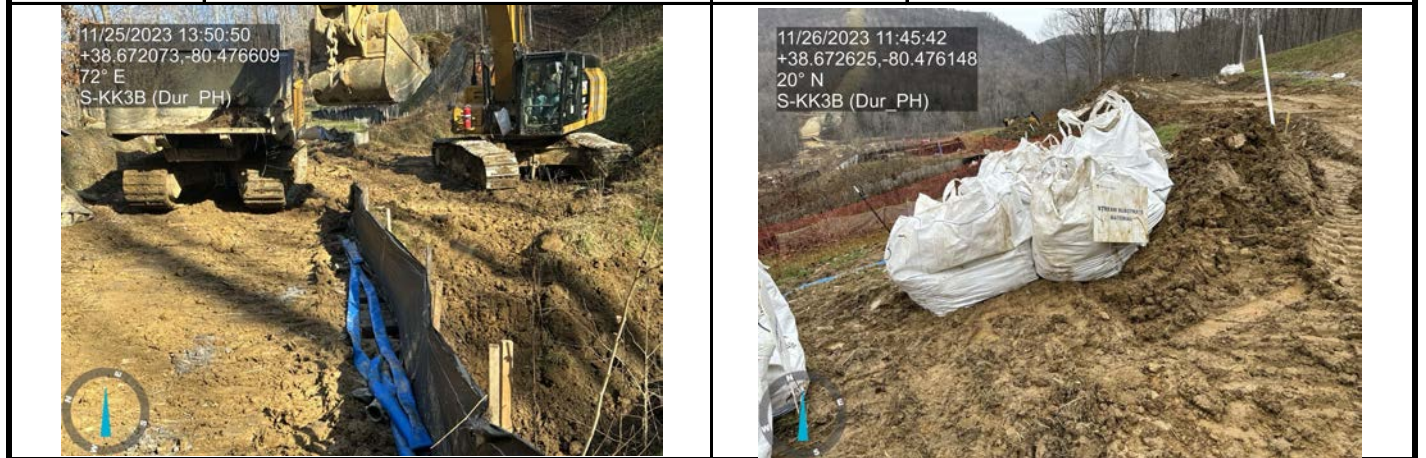
GPS Location See Photo	GPS Location See Photo
Description Segregation of topsoil.	Description Stream substrate placed in numbered super sacks for future restoration.
