STREAM BIOLOGICAL CONDITIONS ENVIRONMENTAL AUDITOR REPORT

Stream ID: S-KL27	Crossing Start Date: 11/14/2023	Crossing Completion Date: 11/15/2023
Milepost: 298.7	Pre-Con Assessment Date: 11/13/2023	Post-Con Assessment Date: 11/15/2023
Station: 15781+53	Stream Classification: Ephemeral (Perennial, Intermittent, Ephemeral)	Bankfull Width (ft.): 1
County: Pittsylvania	303(d) Impairment Listing: Not Impaired	Riffle:Pool Complexes Present? No

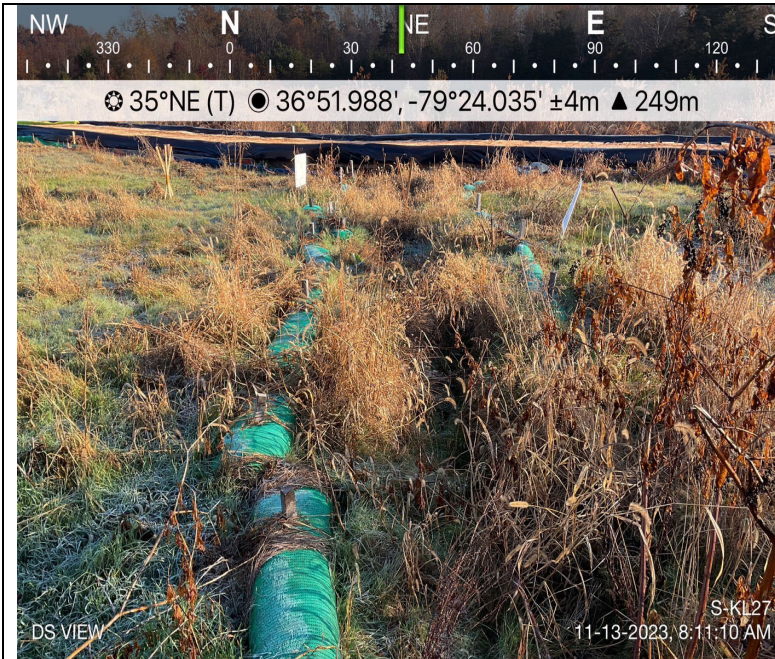
There was no water present in the stream. The resource appears to be a run-off drainage from the adjacent corn field. A flume will be used but also damming and pumping equipment will be on site and used if necessary.

Photo Description: Downstream view of permitted impact area during pre-construction assessment.

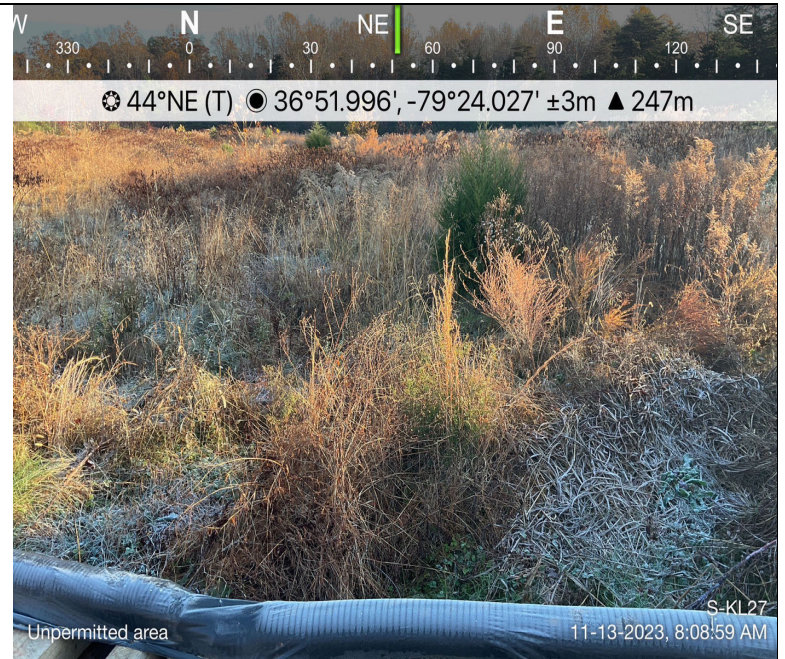
Photo Description: Conditions of the downstream area outside the ROW during pre-construction assessment.

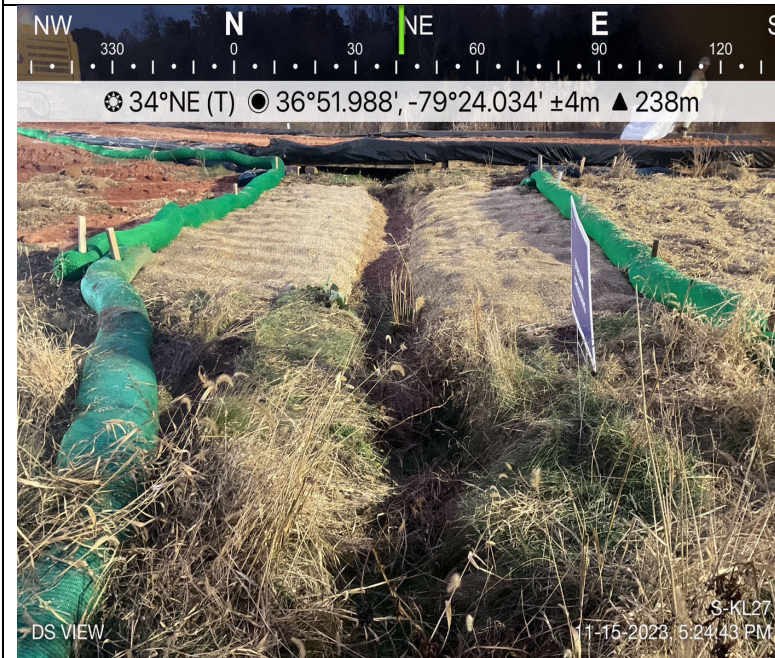
Photo Description: Downstream view of permitted impact area during post-construction assessment.

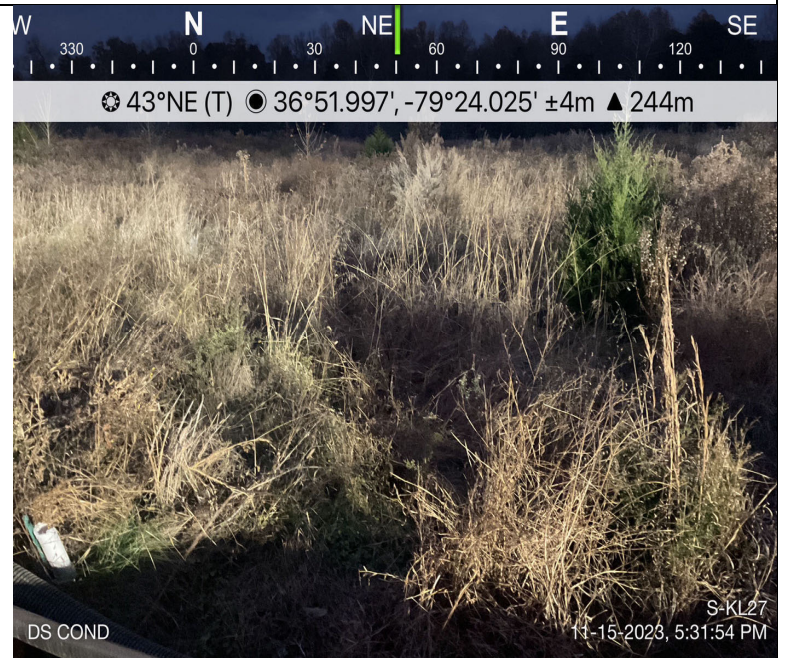
Photo Description: Conditions of the downstream area outside the ROW during post-construction assessment.

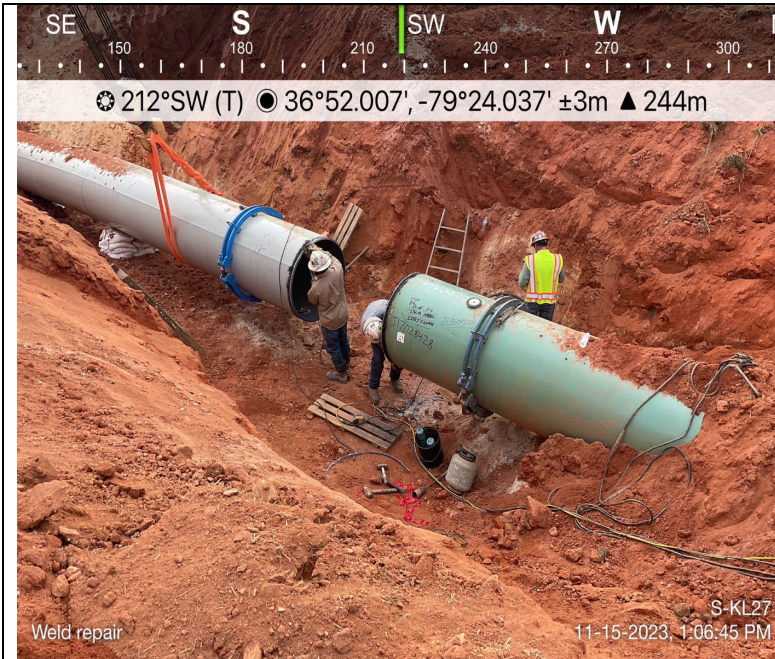
11-15-2023 The welds on the right bank and left bank were x-rayed. The right bank weld was repaired. The left bank weld had to be cut out and replaced. The 50-foot buffer on the right bank was backfilled with padding and subsoil. The topsoil was restored, seeded, and stabilized with straw. ECD socks were placed to mark the 50-foot buffer. -K. Bryant

Photo Description: The weld on the left bank was cut out and redone.

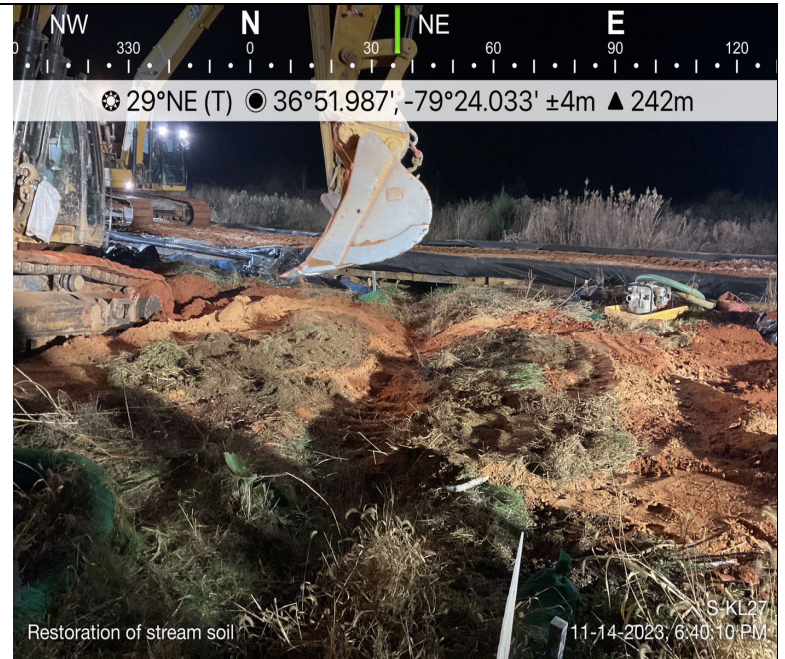
Photo Description: The stream bed soil was replaced. The resource was restored.

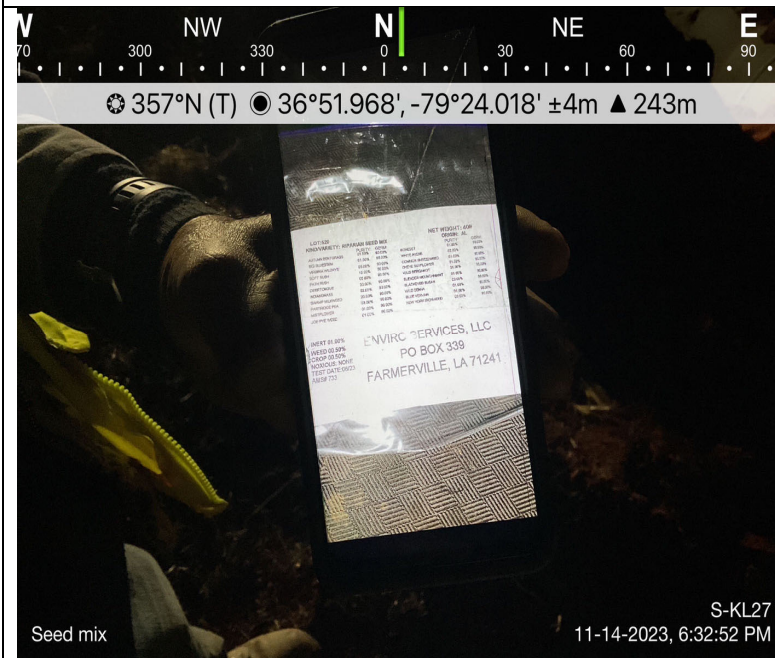
Photo Description: The seed mix.

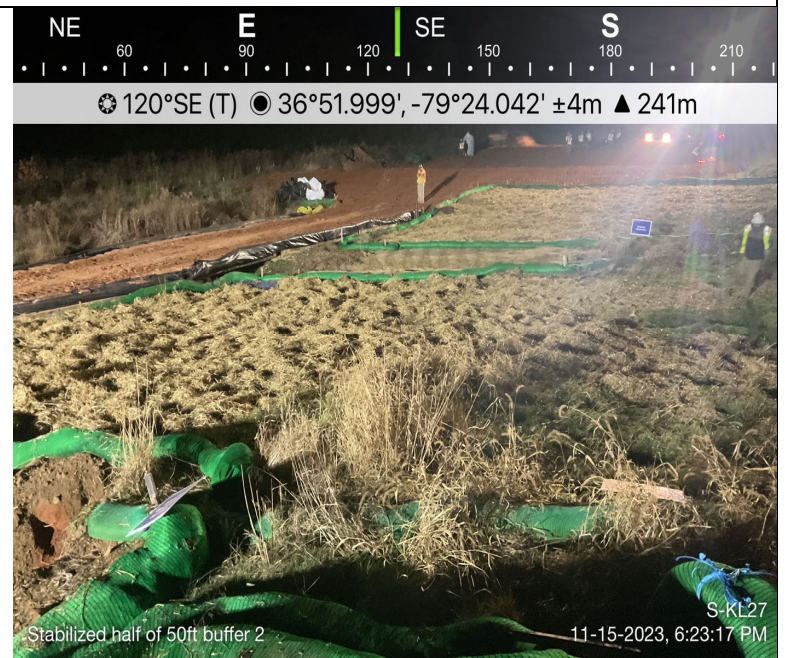
Photo Description: The 50 foot buffer was seeded and stabilized with straw.
