STREAM BIOLOGICAL CONDITIONS ENVIRONMENTAL AUDITOR REPORT

Stream ID: S-KL51	Crossing Start Date: 09/19/2023	Crossing Completion Date: 09/22/2023
Milepost: 267.9	Pre-Con Assessment Date: 09/07/2023	Post-Con Assessment Date: 09/24/2023
Station: 14156+55	Stream Classification: Perennial (Perennial, Intermittent, Ephemeral)	Bankfull Width (ft.): 5.5
County: Franklin	303(d) Impairment Listing: Not Impaired	Riffle:Pool Complexes Present? No

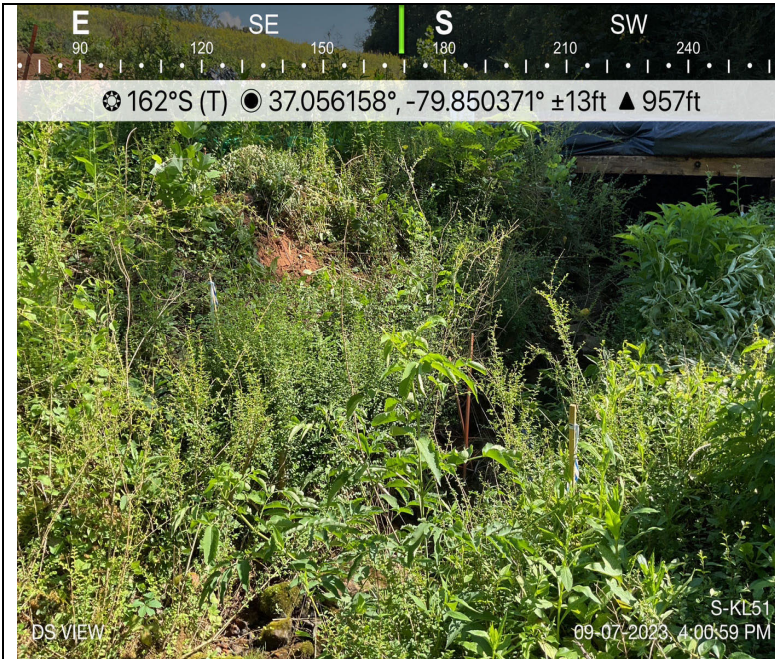
Photo Description: Downstream view of permitted impact area during pre-construction assessment.

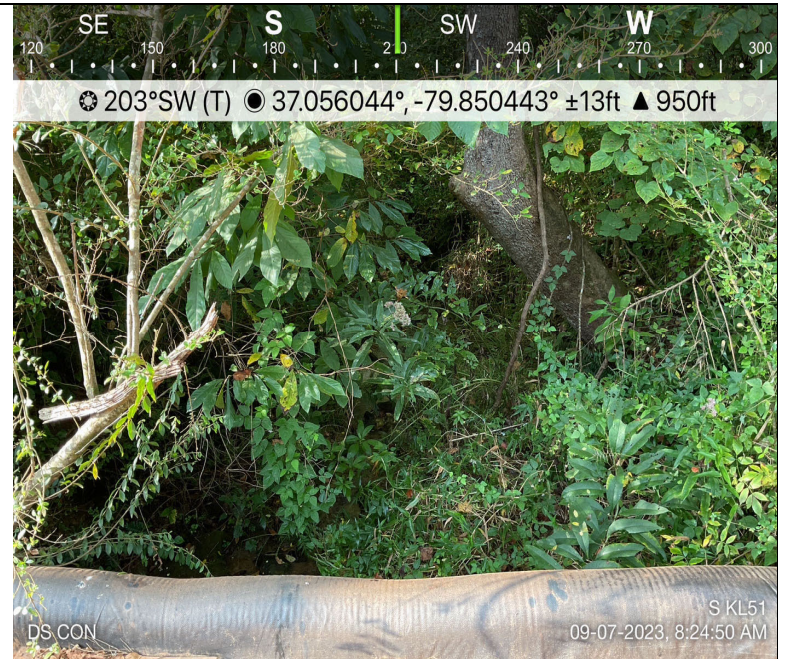
Photo Description: Conditions of the downstream area outside the ROW during pre-construction assessment.

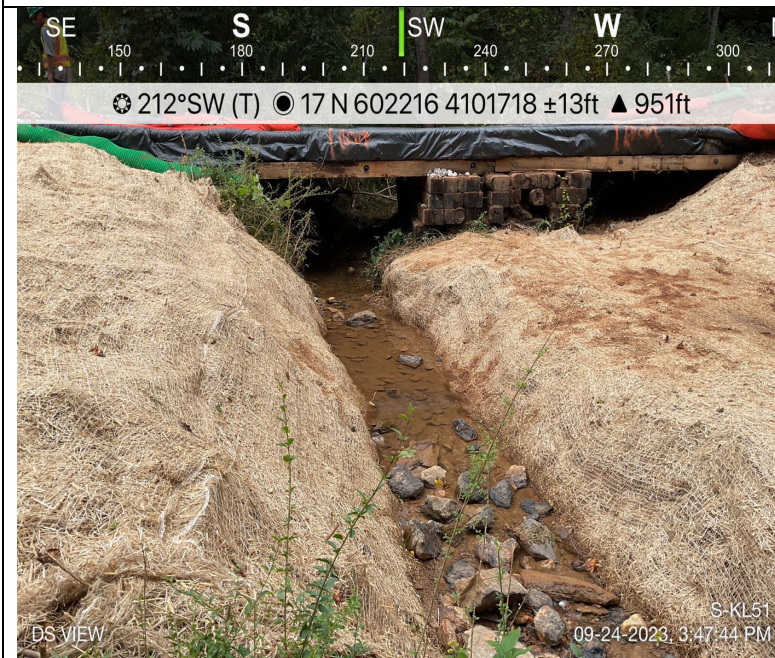
Photo Description: Downstream view of permitted impact area during post-construction assessment.

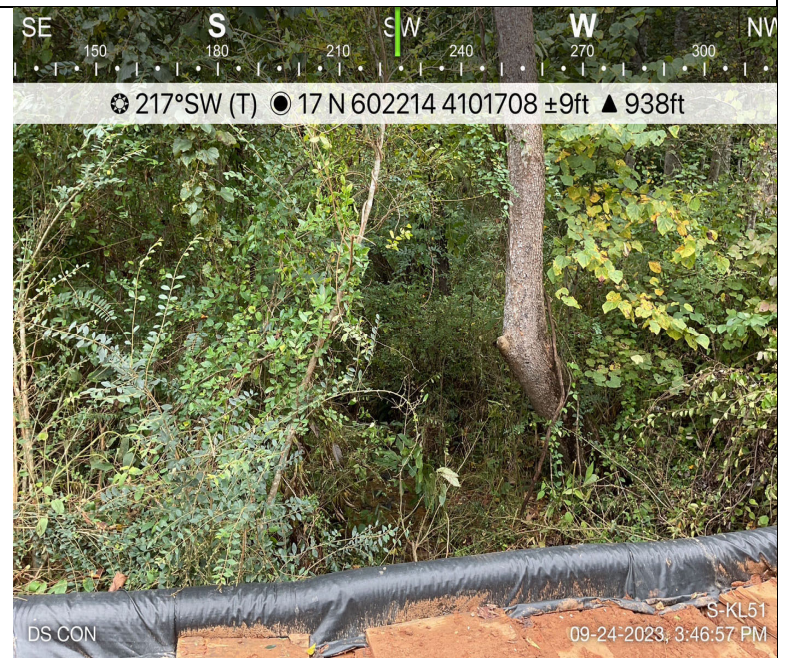
Photo Description: Conditions of the downstream area outside the ROW during post-construction assessment.

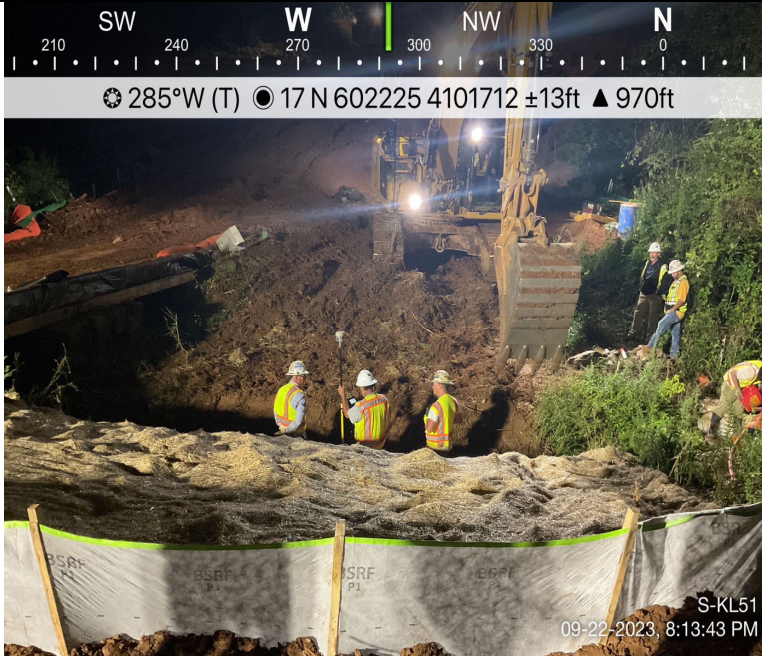
Photo Description: The survey crew providing levels to assist in the stream restoration.

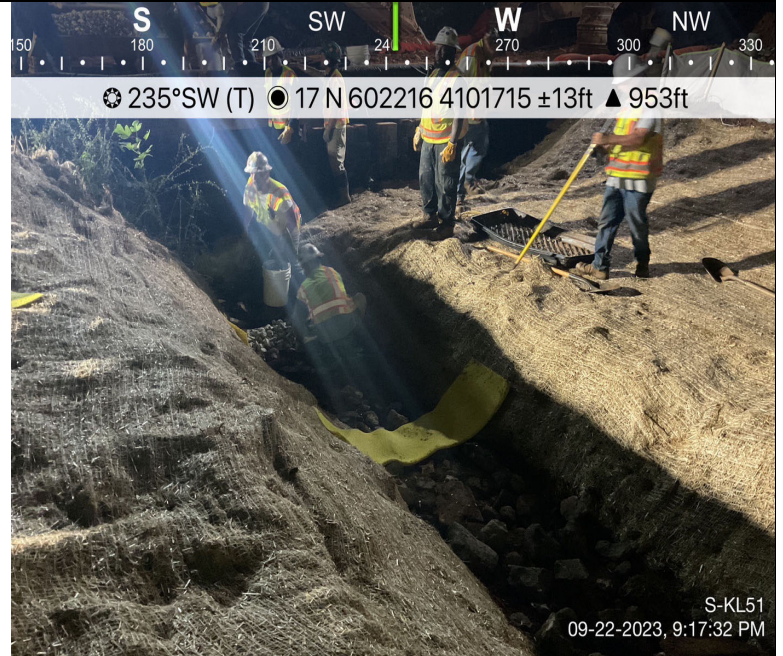
Photo Description: The crew in the process of removing the rock check dam after restoration was complete.

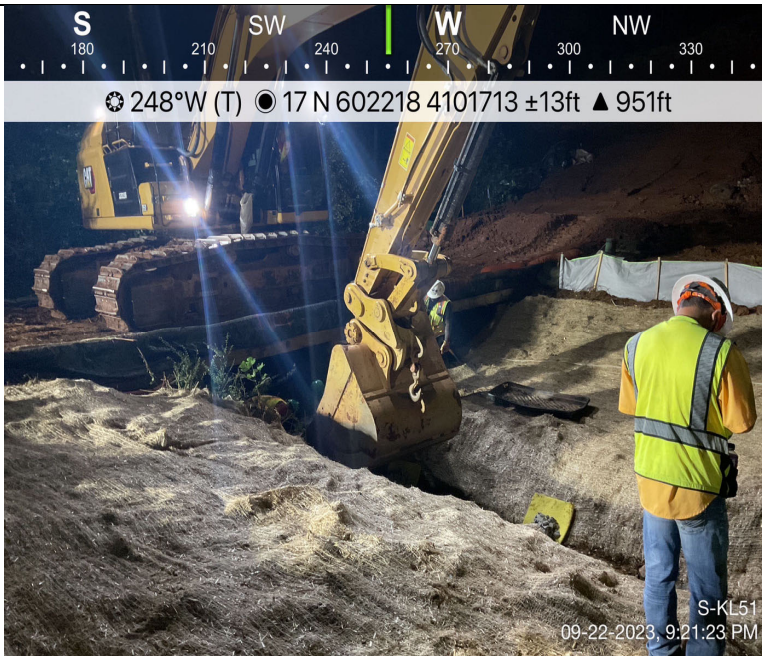
Photo Description: Stream substrate and cobble being returned to the stream bed.

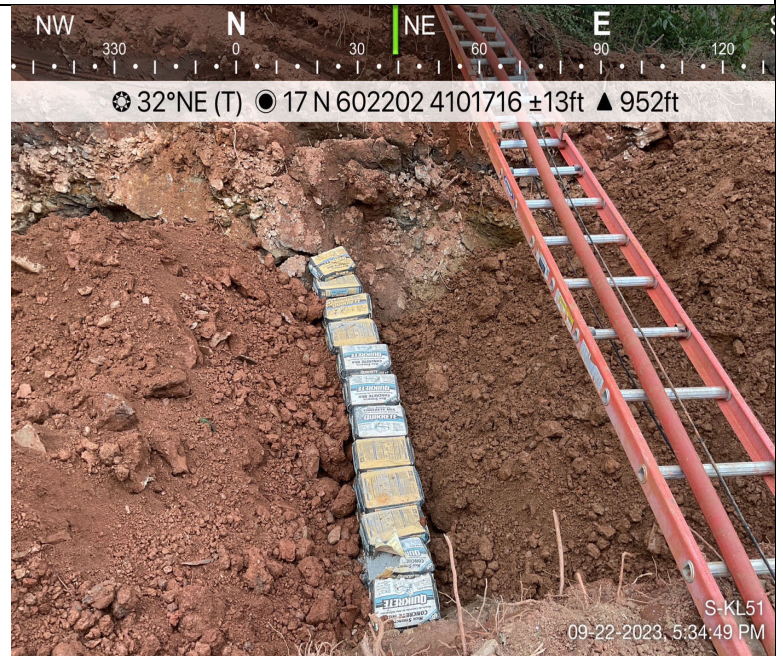
Photo Description: A trench breaker after installation.
