# STREAM BIOLOGICAL CONDITIONS ENVIRONMENTAL AUDITOR REPORT

<b>Stream ID:</b> S-MM11	<b>Crossing Start Date:</b> 10/24/2023	<b>Crossing Completion Date:</b> 11/01/2023
<b>Milepost:</b> 229	<b>Pre-Con Assessment Date:</b> 10/23/2023	<b>Post-Con Assessment Date:</b> 11/02/2023
<b>Station:</b> 12101+57	<b>Stream Classification:</b> Ephemeral (Perennial, Intermittent, Ephemeral)	<b>Bankfull Width (ft.):</b> 8
<b>County:</b> Montgomery	<b>303(d) Impairment Listing:</b> Not Impaired	<b>Riffle:Pool Complexes Present?</b> No

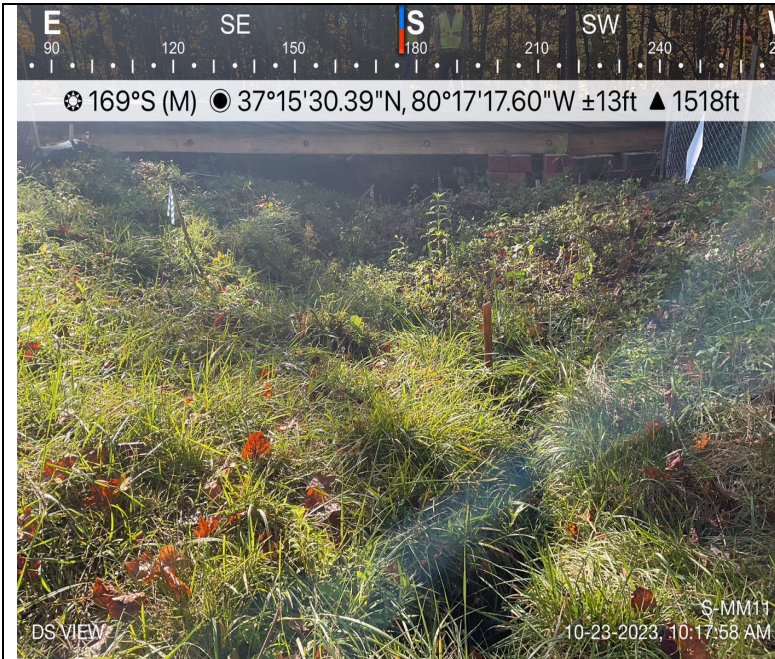
**Photo Description:** Downstream view of permitted impact area during pre-construction assessment.

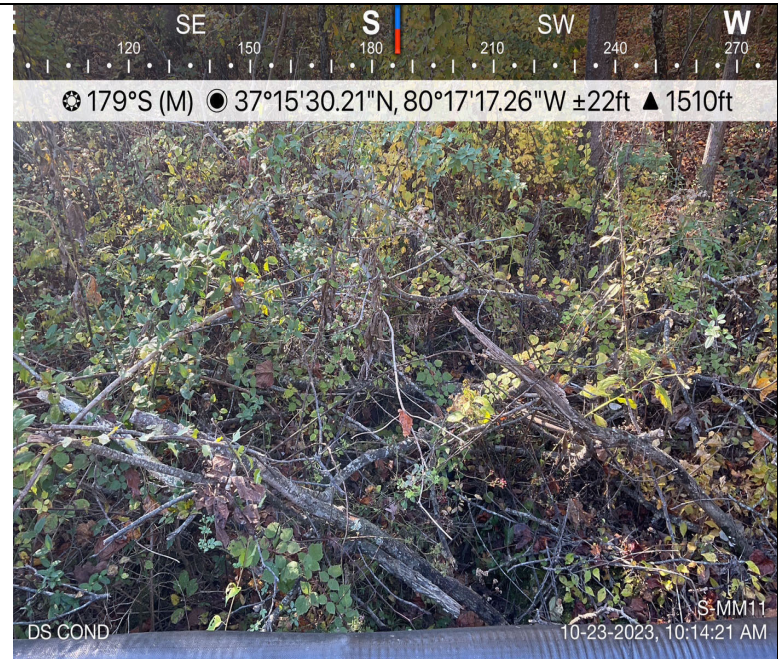
**Photo Description:** Conditions of the downstream area outside the ROW during pre-construction assessment.

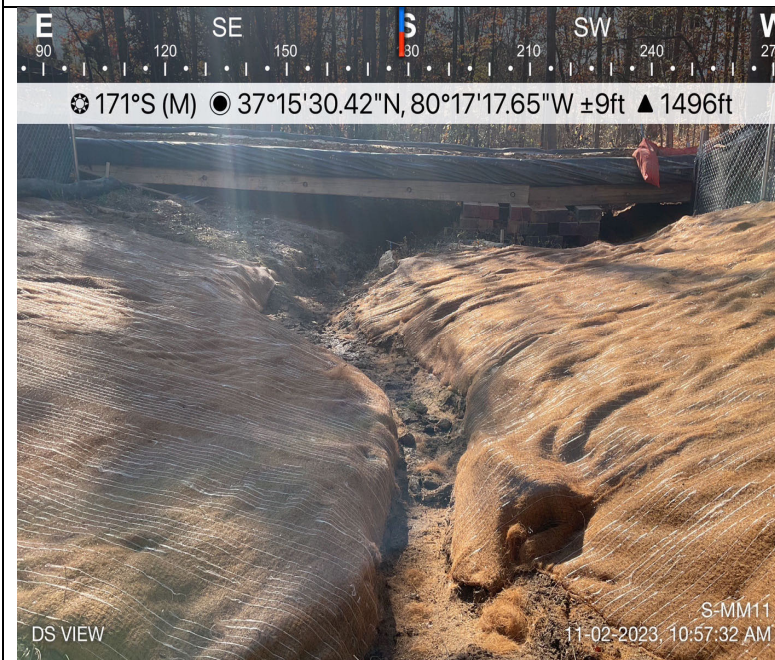
**Photo Description:** Downstream view of permitted impact area during post-construction assessment.

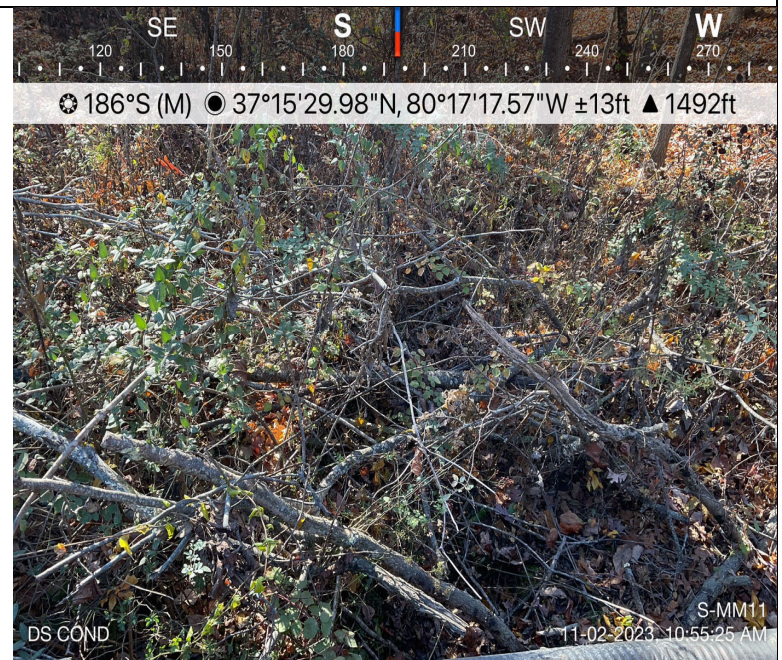
**Photo Description:** Conditions of the downstream area outside the ROW during post-construction assessment.

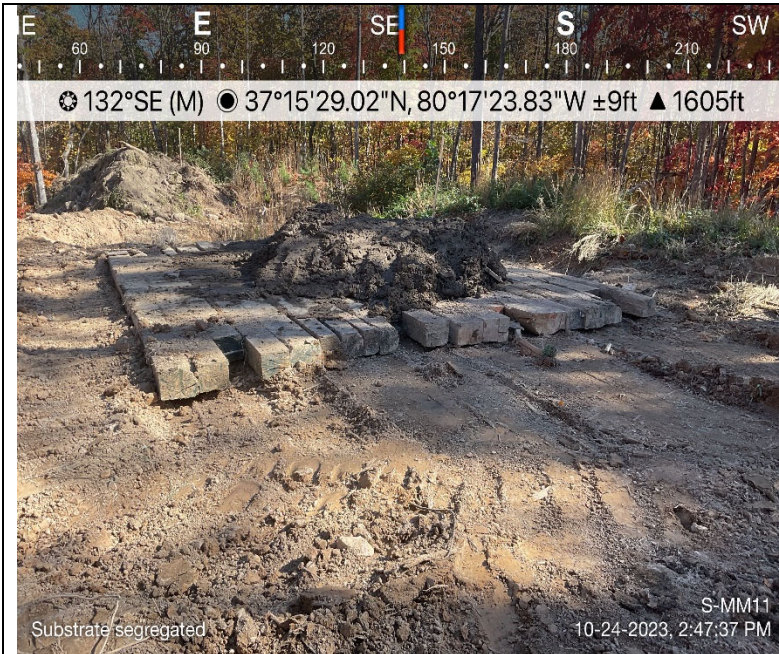
**Photo Description:** Stream substrate stripped, segregated, and stockpiled separately from subsoil.

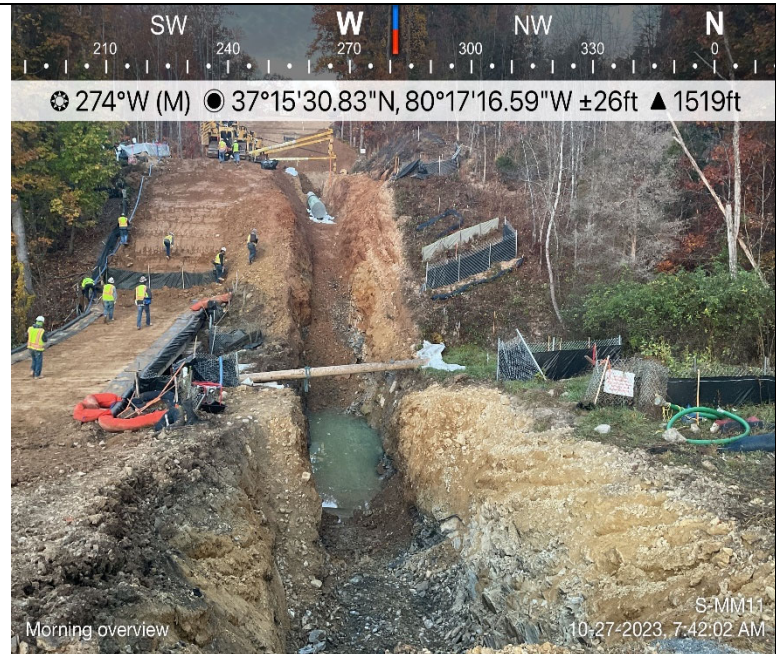
**Photo Description:** Overview of crossing area. Flume installed to convey any streamflow across the impact area throughout the crossing.

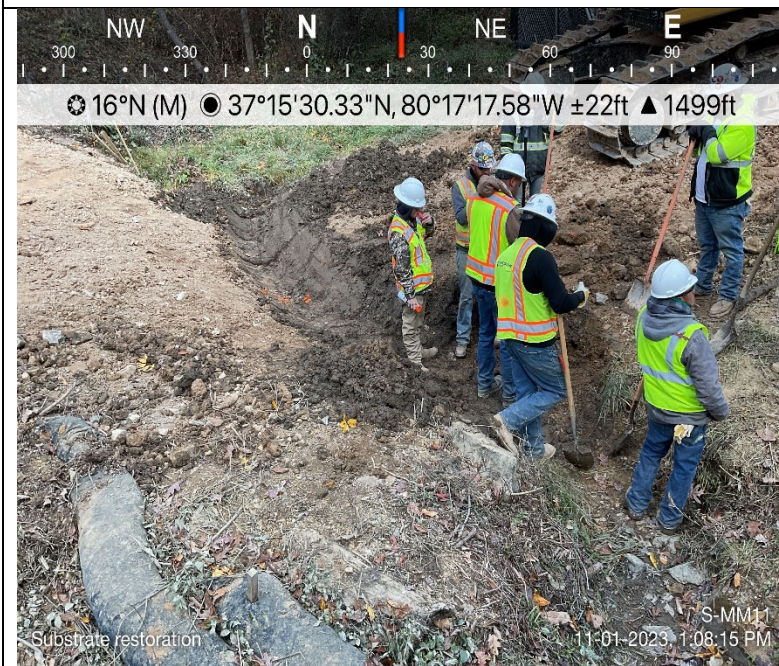
**Photo Description:** Survey team on-site assisting with restoration of pre-existing conditions.

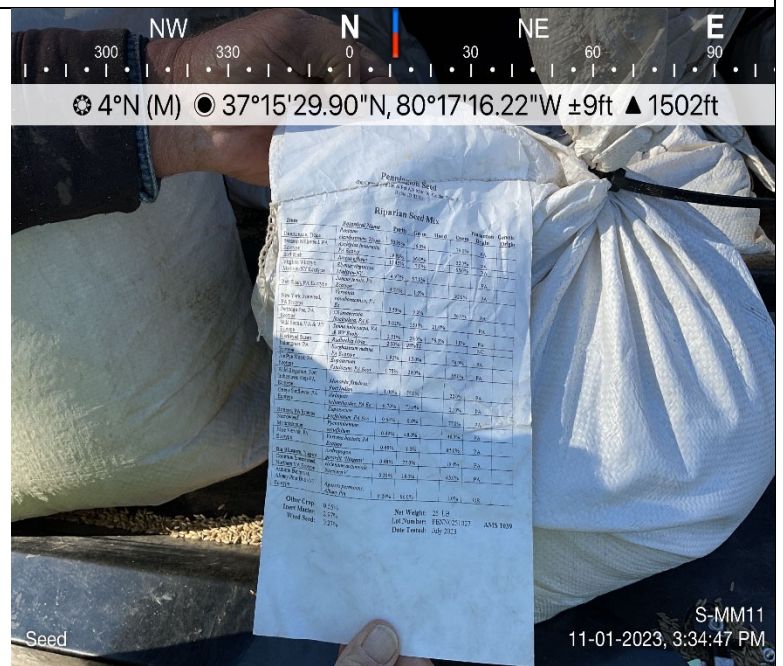
**Photo Description:** Seed-mix utilized within resource area during restoration.
