# STREAM BIOLOGICAL CONDITIONS ENVIRONMENTAL AUDITOR REPORT

<b>Stream ID:</b> S-MM13	<b>Crossing Start Date:</b> 10/18/2023	<b>Crossing Completion Date:</b> 10/23/2023
<b>Milepost:</b> 229	<b>Pre-Con Assessment Date:</b> 10/17/2023	<b>Post-Con Assessment Date:</b> 10/24/2023
<b>Station:</b> 12098+44	<b>Stream Classification:</b> Ephemeral (Perennial, Intermittent, Ephemeral)	<b>Bankfull Width (ft.):</b> 5
<b>County:</b> Montgomery	<b>303(d) Impairment Listing:</b> Not Impaired	<b>Riffle:Pool Complexes Present?</b> No

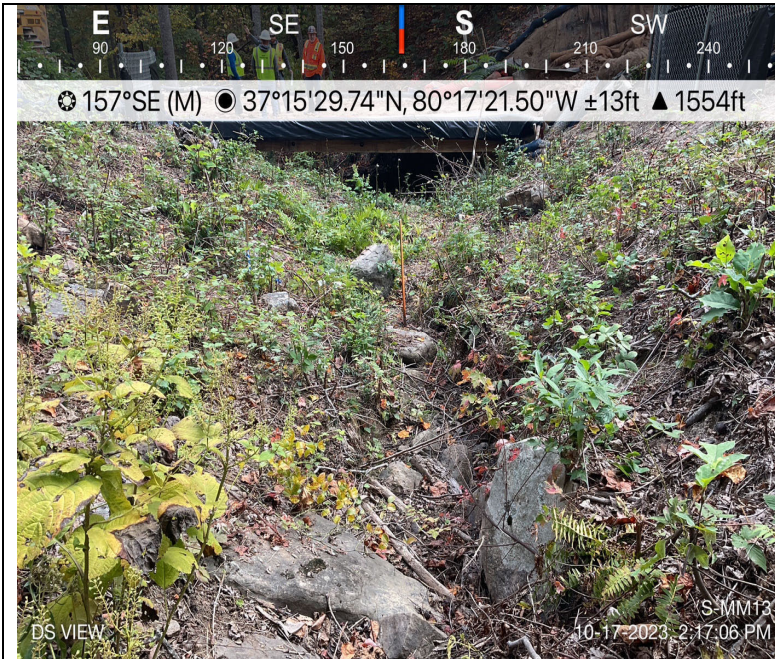
**Photo Description:** Downstream view of permitted impact area during pre-construction assessment.

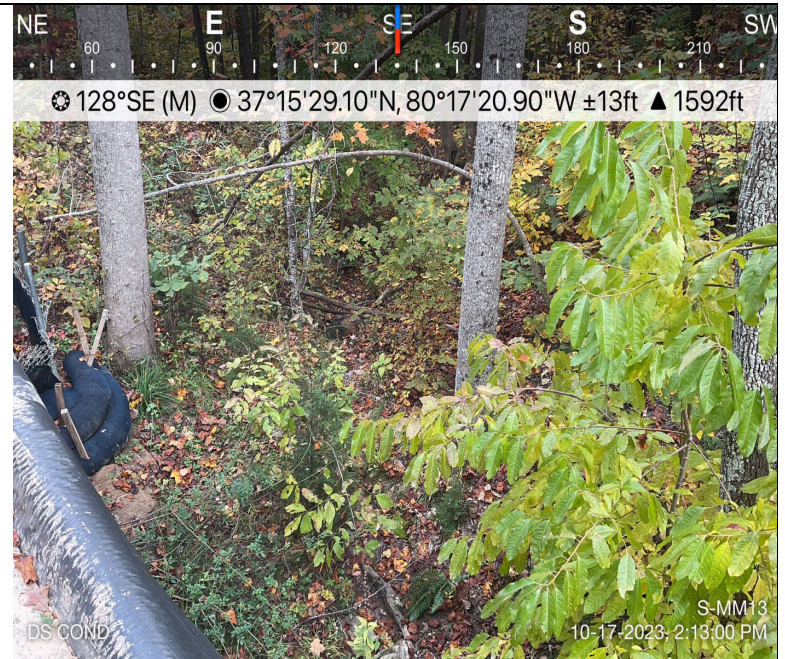
**Photo Description:** Conditions of the downstream area outside the ROW during pre-construction assessment.

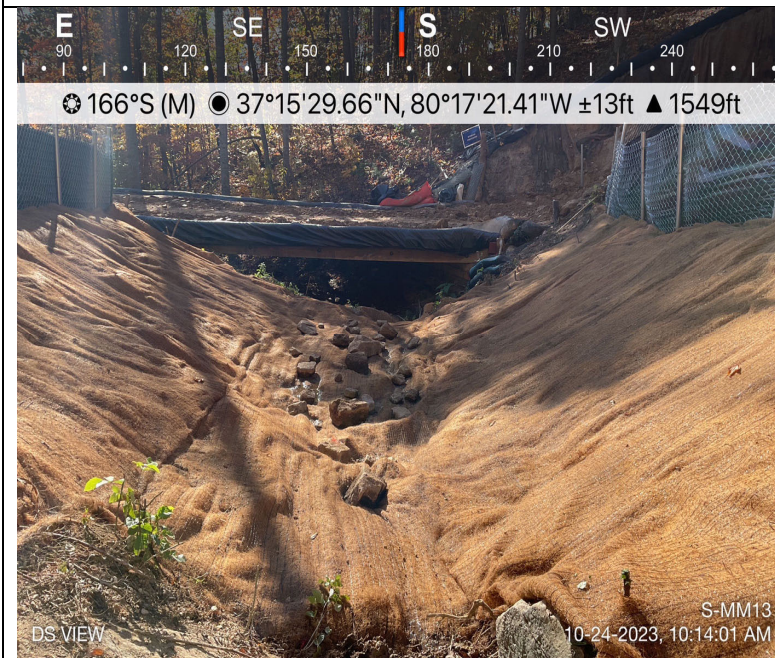
10/24/23 - Post-construction assessment completed. No impacts to biological conditions - S. Manzo

**Photo Description:** Downstream view of permitted impact area during post-construction assessment.

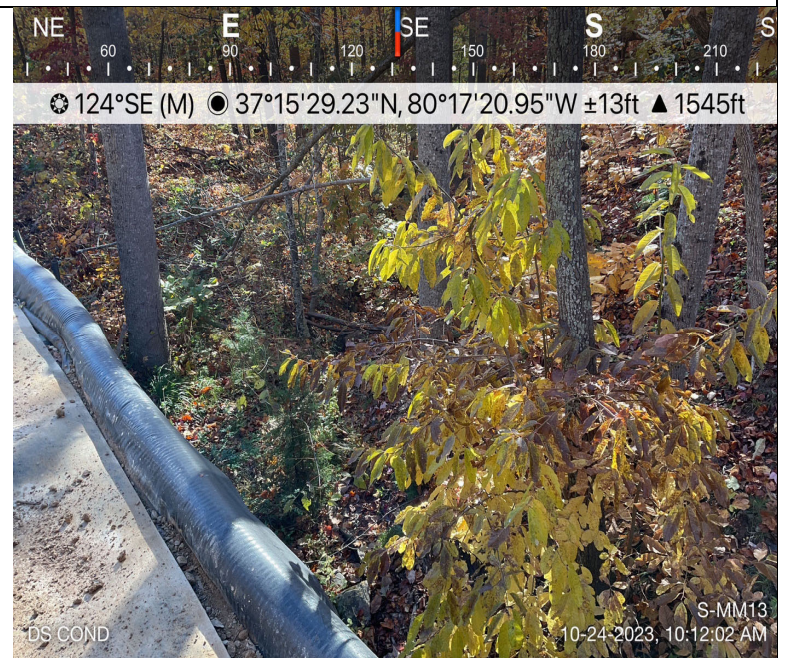
**Photo Description:** Conditions of the downstream area outside the ROW during post-construction assessment.
