STREAM BIOLOGICAL CONDITIONS ENVIRONMENTAL AUDITOR REPORT

Stream ID: S-NN19	Crossing Start Date: 10/05/2023	Crossing Completion Date: 10/23/2023
Milepost: 234.3	Pre-Con Assessment Date: 10/04/2023	Post-Con Assessment Date: 10/23/2023
Station: 12380+05	Stream Classification: Intermittent (Perennial, Intermittent, Ephemeral)	Bankfull Width (ft.): 3.5
County: Montgomery	303(d) Impairment Listing: Not Impaired	Riffle:Pool Complexes Present? No

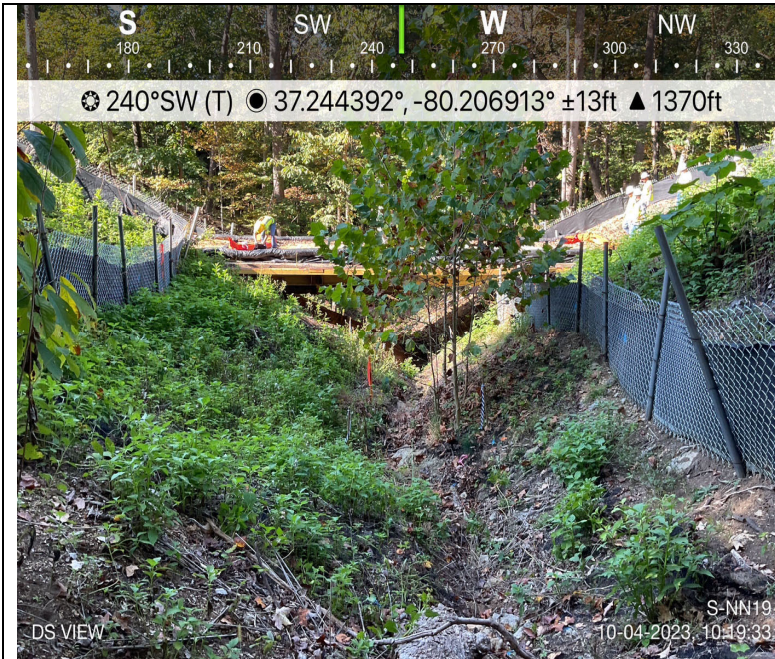
Photo Description: Downstream view of permitted impact area during pre-construction assessment.

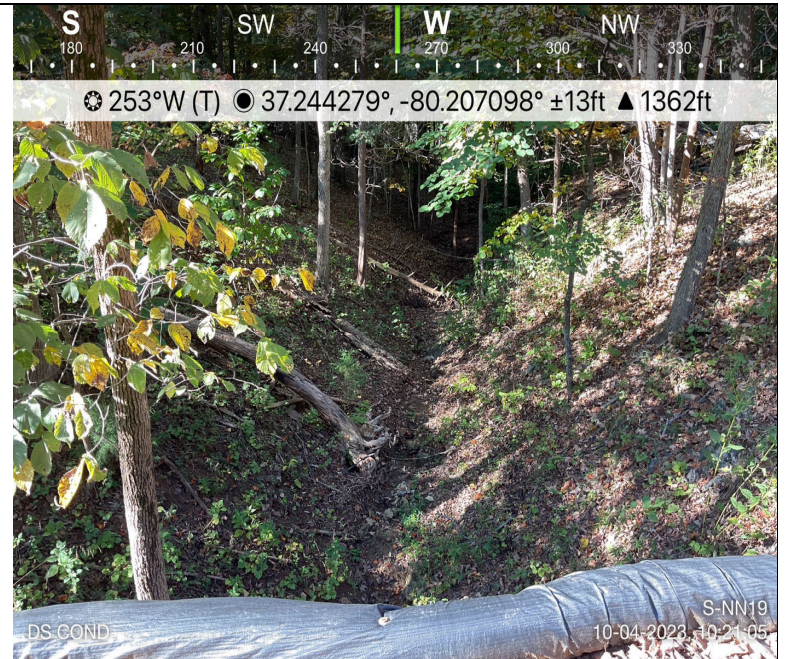
Photo Description: Conditions of the downstream area outside the ROW during pre-construction assessment.

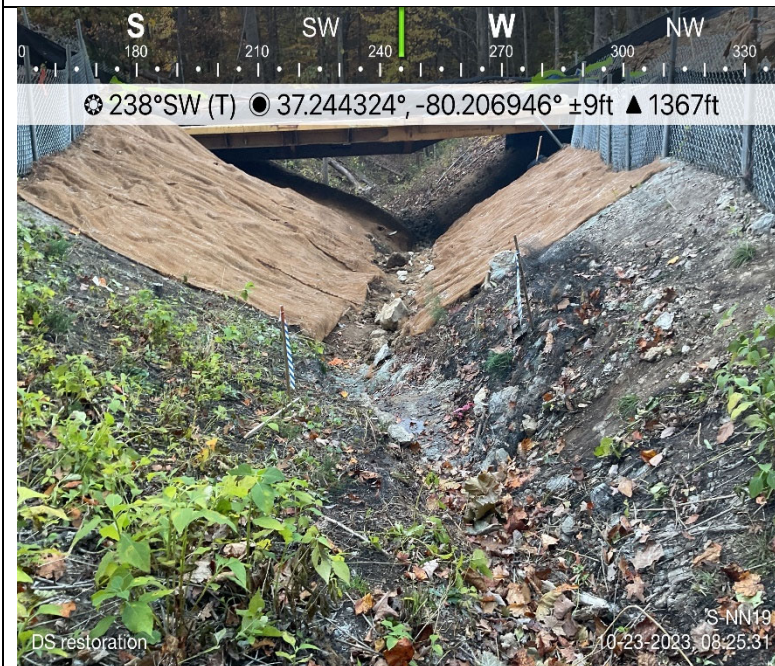
Photo Description: Downstream view of permitted impact area during post-construction assessment.

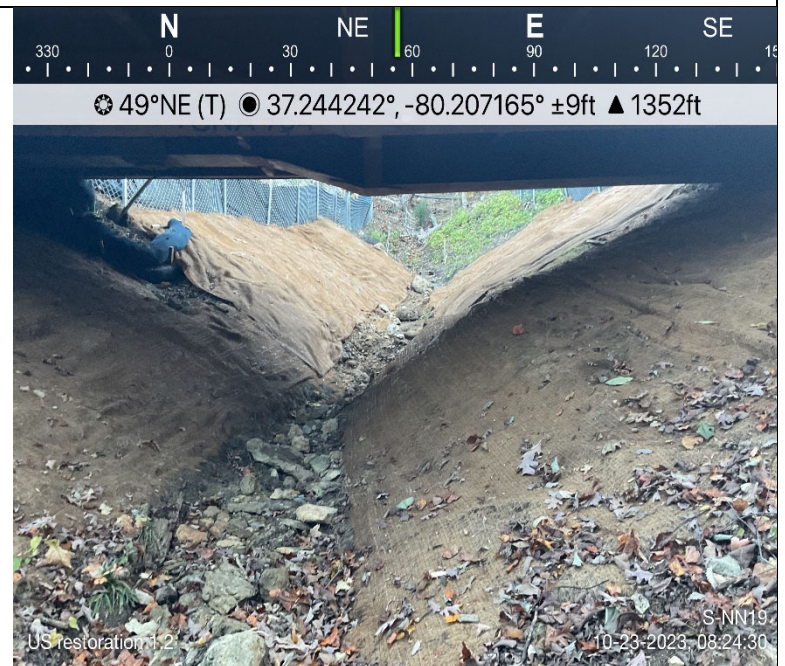
Photo Description: Conditions of the downstream area outside the impact area under the bridge during post-construction assessment.

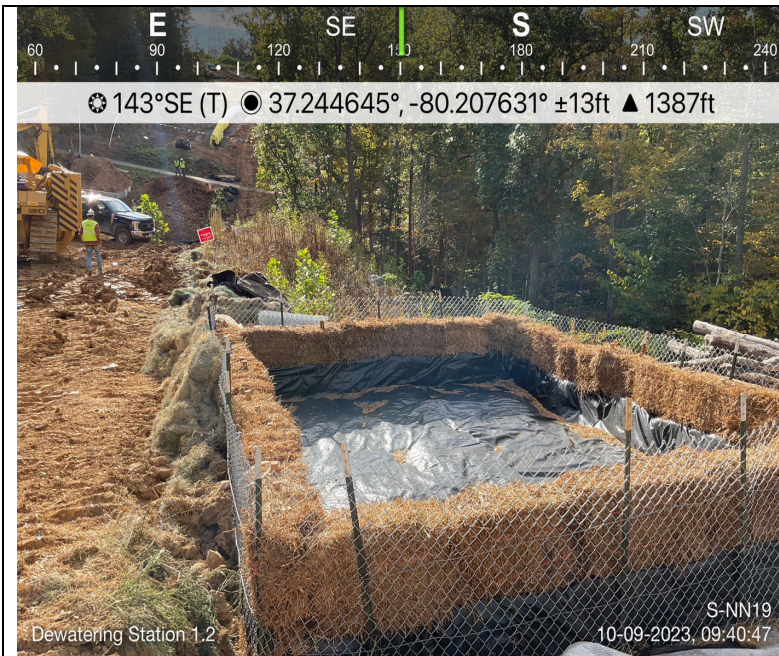
Photo Description: Dewatering structure installed and operation during crossing.

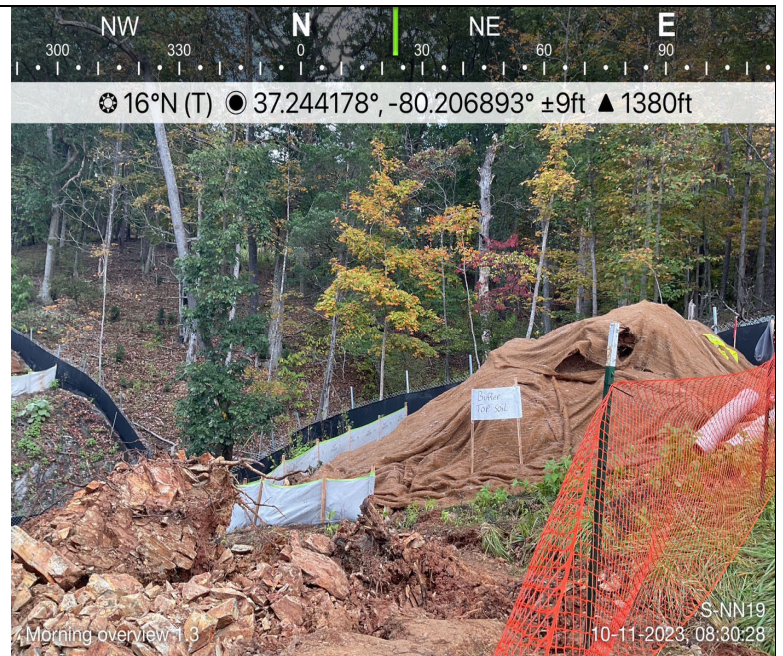
Photo Description: In-stream material stockpiled and covered from elements.

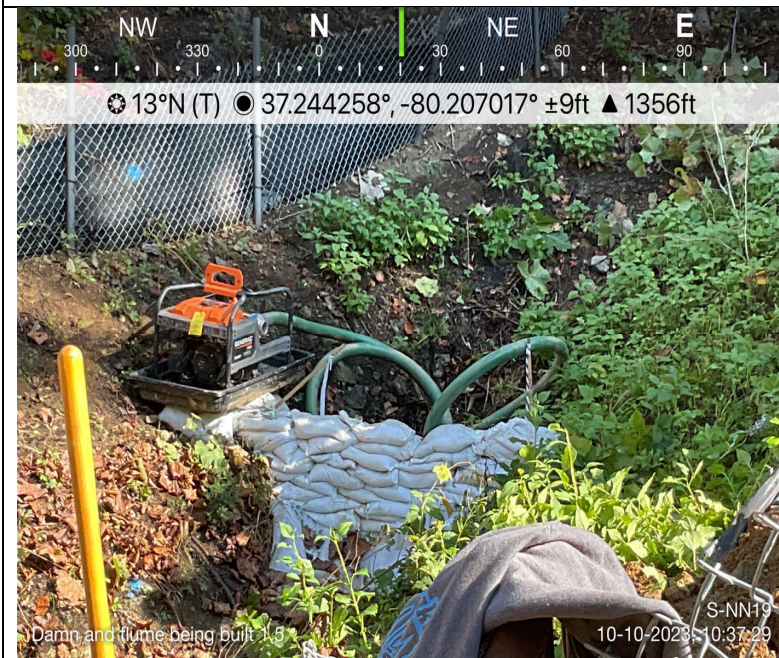
Photo Description: Dam and pump installed and operation during crossing activities.

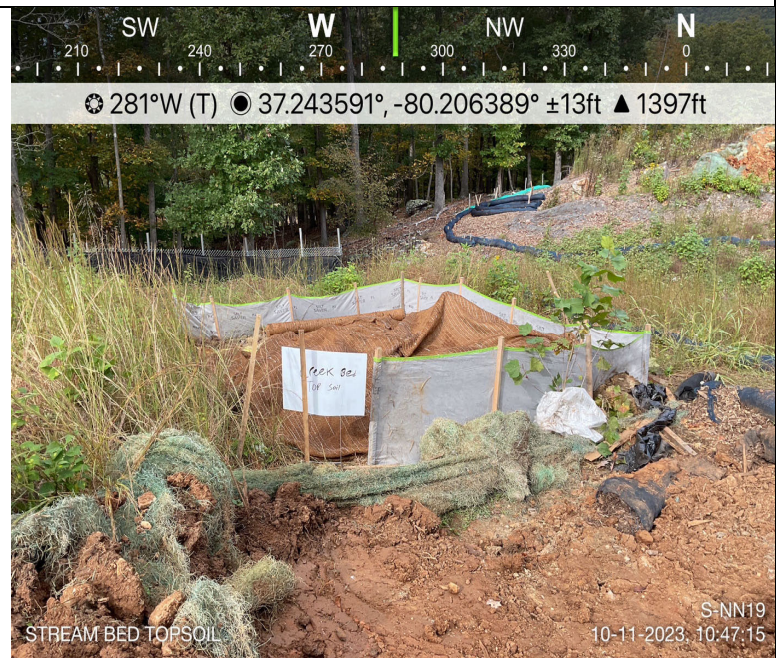
Photo Description: Stream substrate/topsoil stockpiled and stored separately from subsoil.
