STREAM BIOLOGICAL CONDITIONS ENVIRONMENTAL AUDITOR REPORT

Stream ID: S-PA07	Crossing Start Date: 10/30/2023	Crossing Completion Date: 11/18/2023
Milepost: 208.5	Pre-Con Assessment Date: 10/26/2023	Post-Con Assessment Date: 11/20/2023
Station: 11016+79	Stream Classification: Intermittent (Perennial, Intermittent, Ephemeral)	Bankfull Width (ft.): 1.5
County: Giles	303(d) Impairment Listing: Not Impaired	Riffle:Pool Complexes Present? No

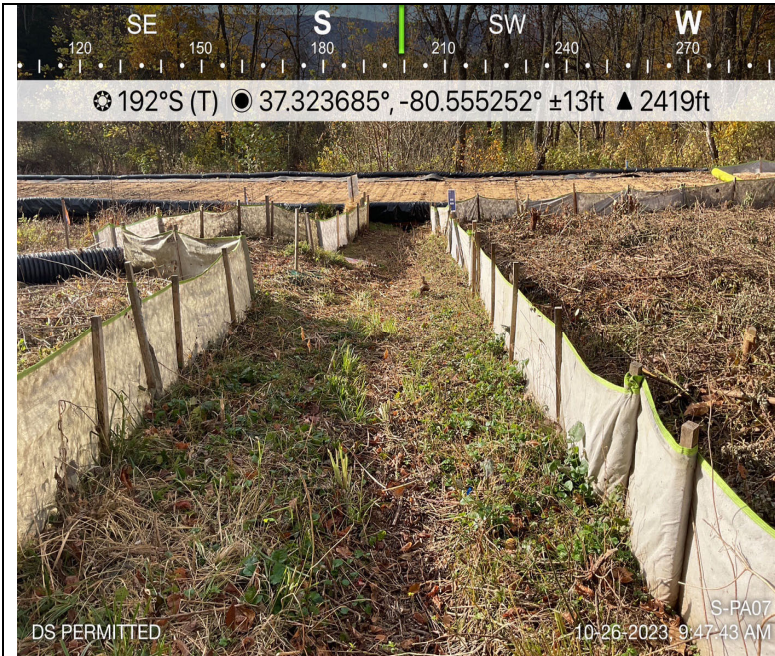
Photo Description: Downstream view of permitted impact area during pre-construction assessment.

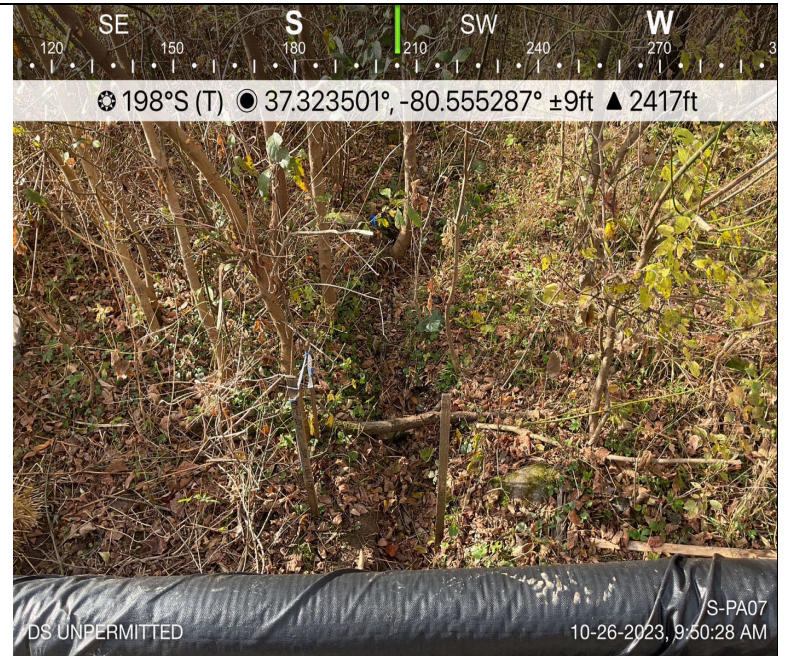
Photo Description: Conditions of the downstream area outside the ROW during pre-construction assessment.

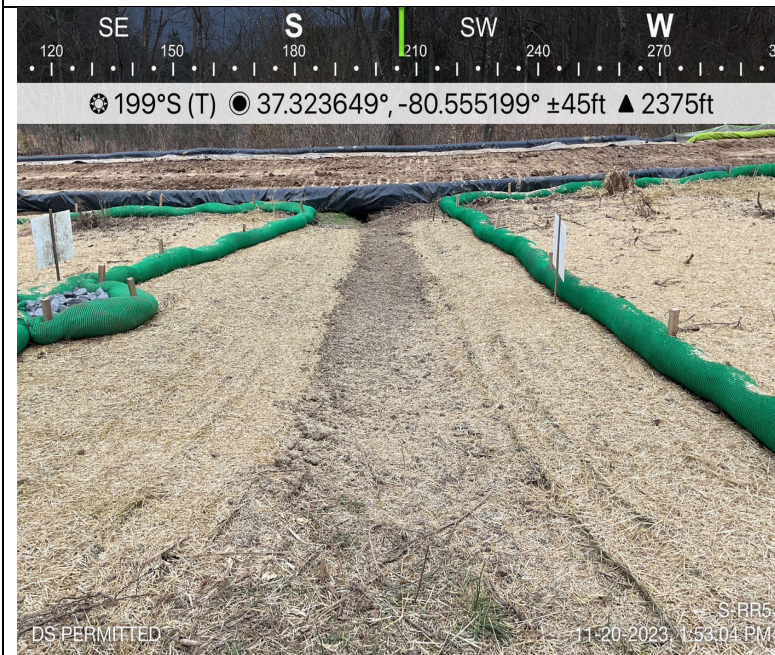
Photo Description: Downstream view of permitted impact area during post-construction assessment.

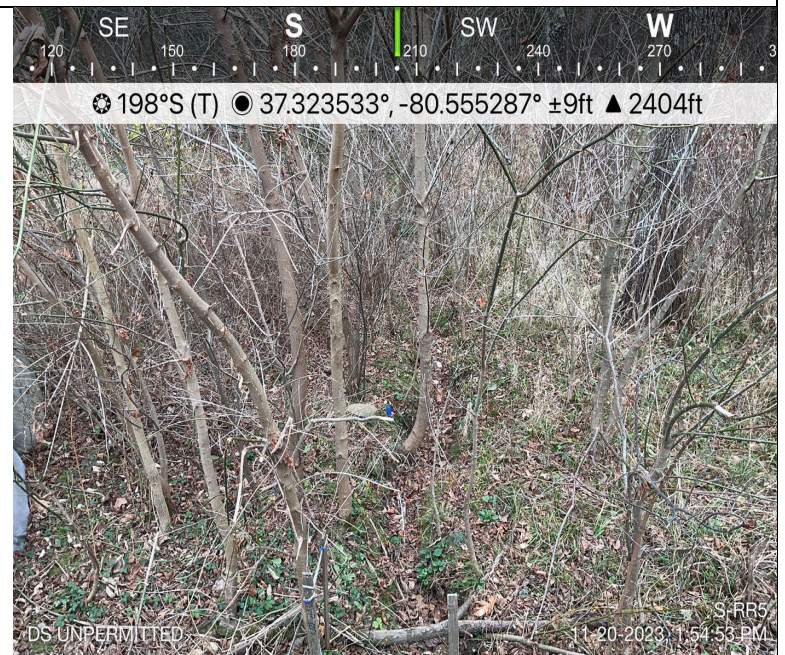
Photo Description: Conditions of the downstream area outside the ROW during post-construction assessment.

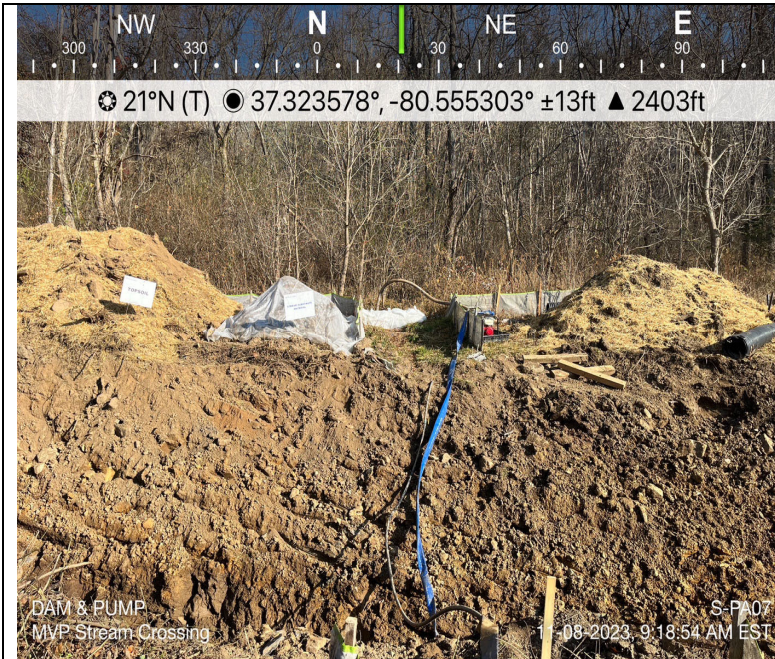
Photo Description: Dam & pump

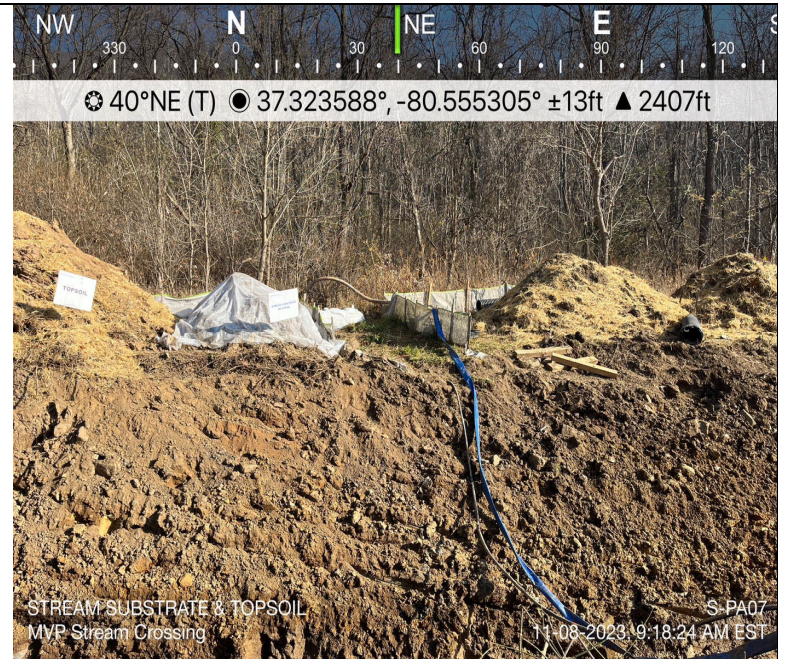
Photo Description: Soil stockpiles

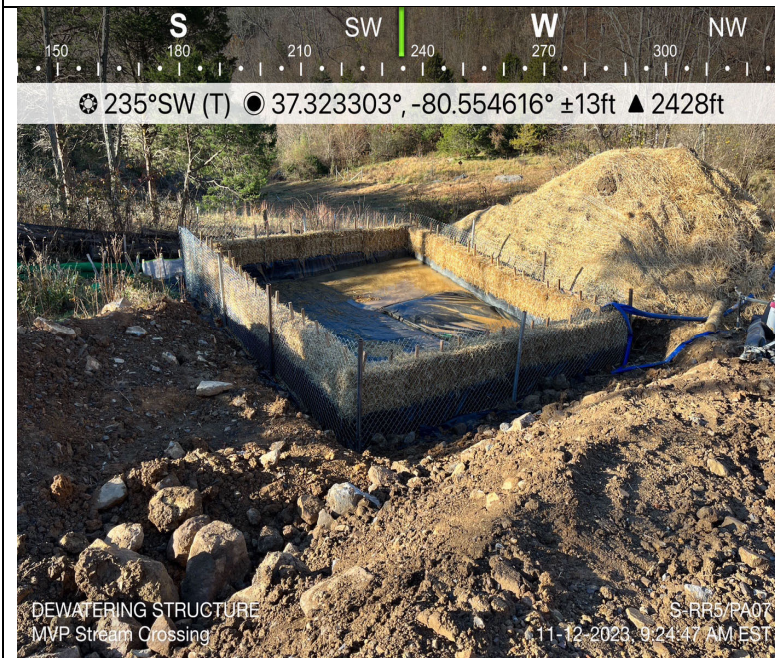
Photo Description: De-watering structure

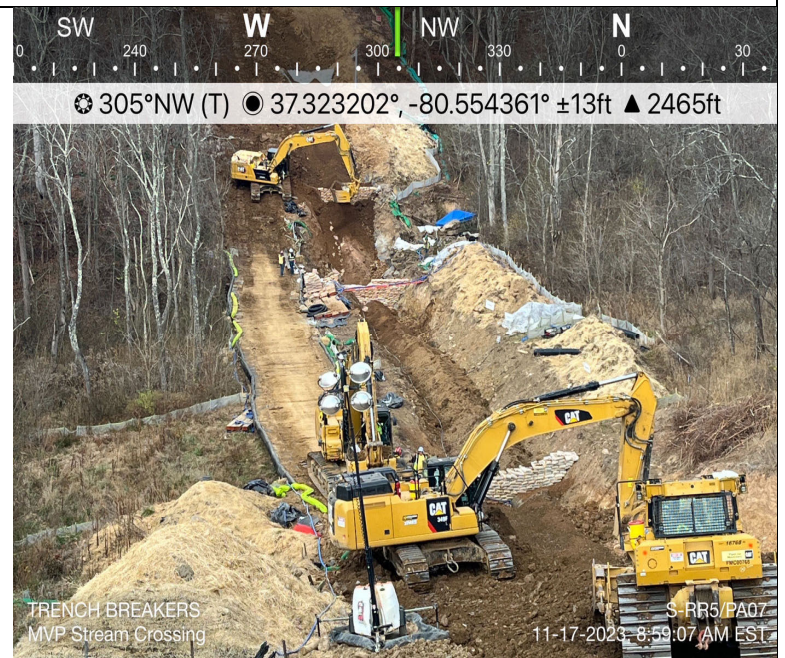
Photo Description: Trench breakers
