STREAM BIOLOGICAL CONDITIONS ENVIRONMENTAL AUDITOR REPORT

Stream ID: S-RR5	Crossing Start Date: 10/30/2023	Crossing Completion Date: 11/18/2023
Milepost: 208.4	Pre-Con Assessment Date: 10/26/2023	Post-Con Assessment Date: 11/20/2023
Station: 11015+52	Stream Classification: Perennial (Perennial, Intermittent, Ephemeral)	Bankfull Width (ft.): 10
County: Giles	303(d) Impairment Listing: Not Impaired	Riffle:Pool Complexes Present? No

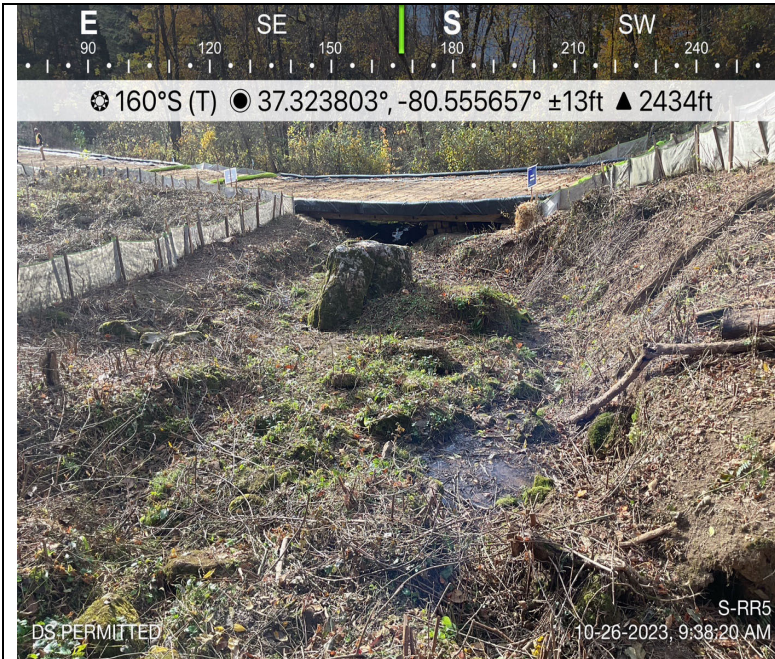
Photo Description: Downstream view of permitted impact area during pre-construction assessment.

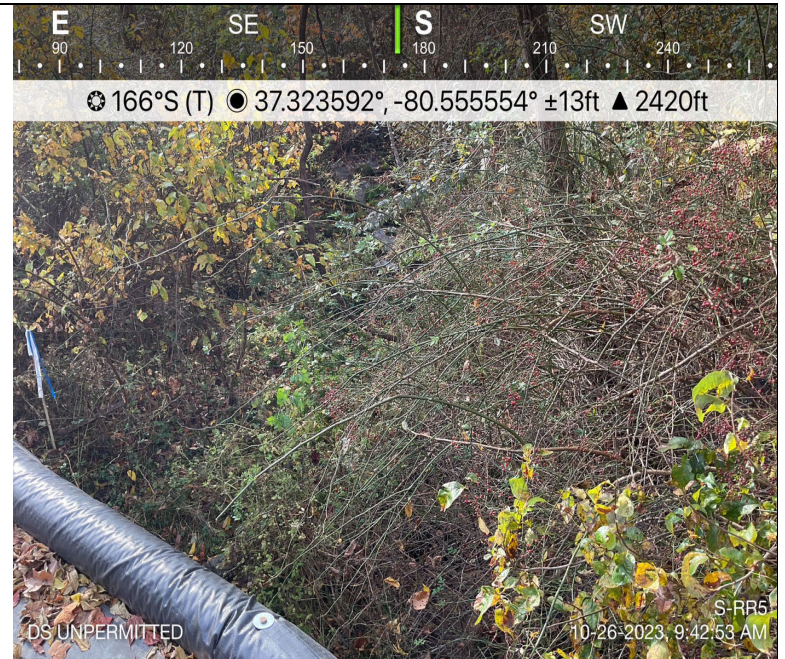
Photo Description: Conditions of the downstream area outside the ROW during pre-construction assessment.

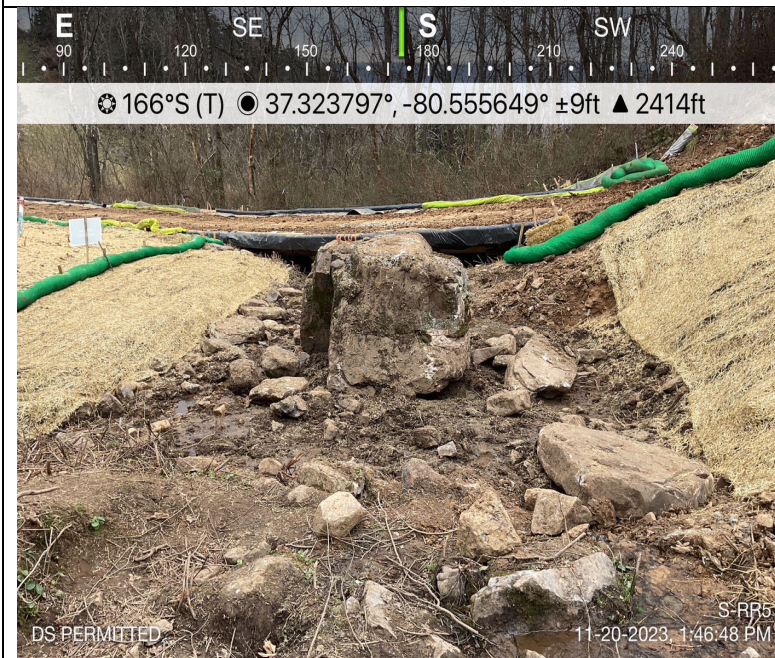
Photo Description: Downstream view of permitted impact area during post-construction assessment.

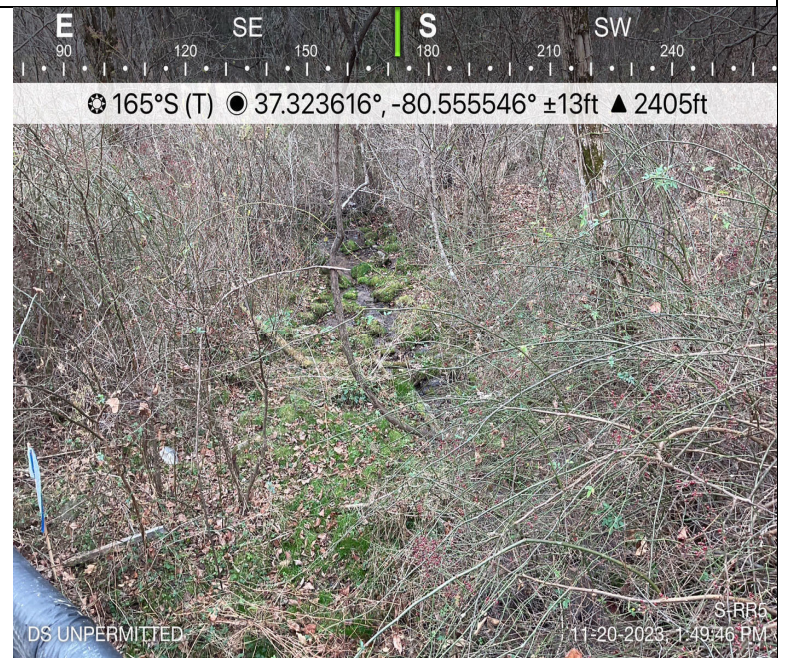
Photo Description: Conditions of the downstream area outside the ROW during post-construction assessment.

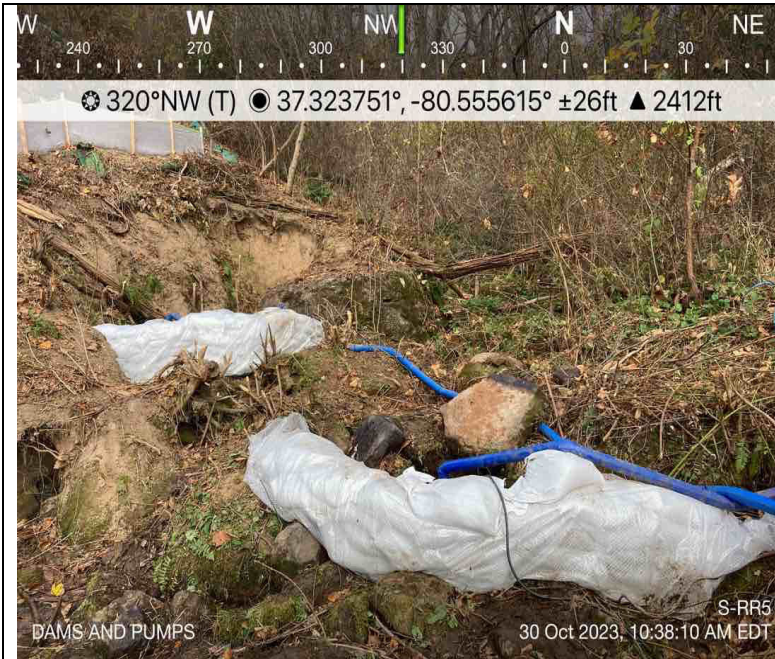
Photo Description: Dams & pumps

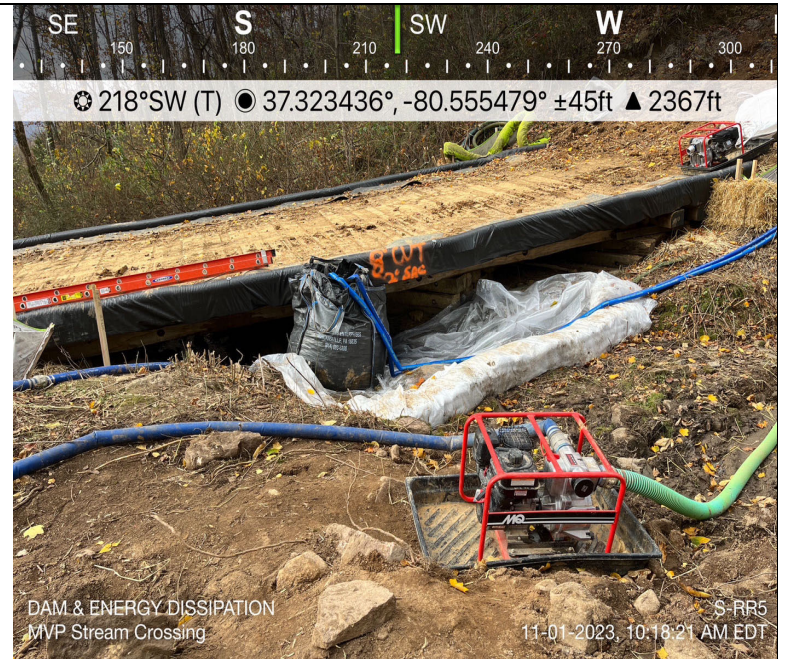
Photo Description: Dam & energy dissipation bag

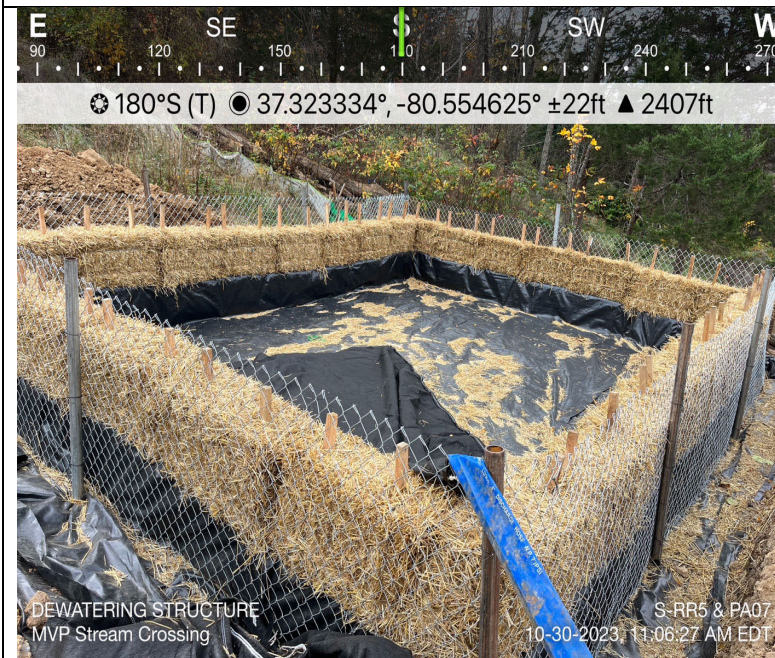
Photo Description: De-watering structure

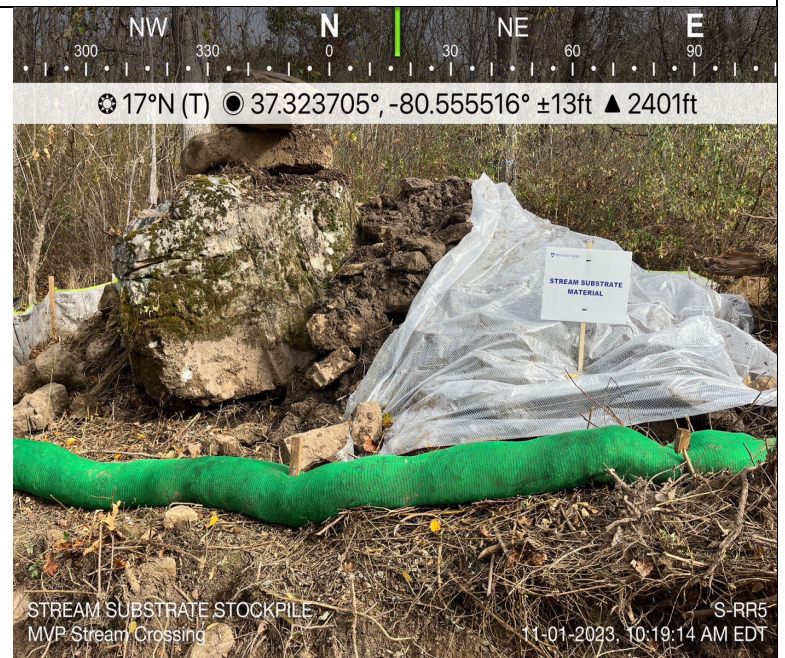
Photo Description: Stream substrate stockpile
