Wetland Biological Conditions EA Report

Project Name	H-600 Pipeline Spread F	A/E	124300135	Spread	H-600 Pipeline Spread F
Contractor	Price Gregory	Report #	114		
Environmental Auditor	Charles Haden			Date/Time	10/30/2023 3:53 PM
Wetland ID	W-A13	Crossing Start Date	11/1/2023	Crossing Completion Date	11/29/2023
Milepost	182.90	Pre-Con Assessment Date	10/30/2023	Post-Con Assessment Date	11/29/2023
Station	9657+32	Cowardin Classification	PEM	Wetland Impact Area(acs)	0.2991
State	WV				
County	Monroe

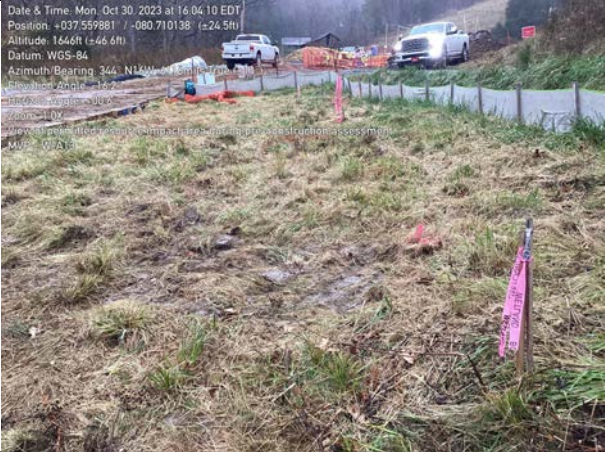
<p><small>Date & Time: Mon, Oct 30, 2023 at 16:04:10 EDT Position: +037.559881 / -080.710138 (+24.5ft) Altitude: 1646ft (+46.6ft) Datum: WGS-84 Azimuth Bearing: 344.1 N14W 1531mils True (+12) Elevation Angle: -16.2 Horizon Angle: -00.4 Zoom: 1.0X WA12: View of permitted resource impact area during pre-construction assessment MVP: S: A43</small></p>

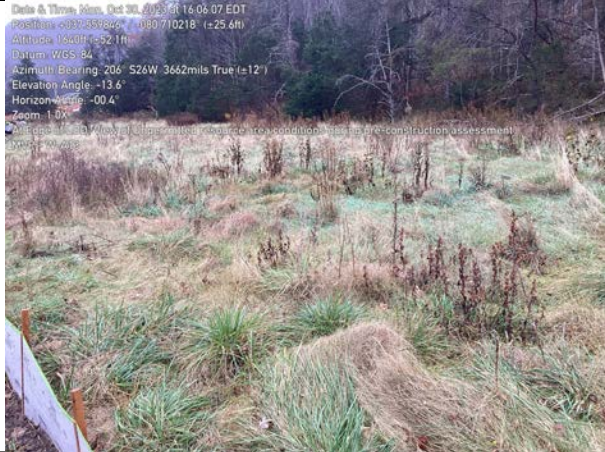
<p><small>Date & Time: Mon, Oct 30, 2023 at 16:06:07 EDT Position: +037.559881 / -080.710218 (+25.4ft) Altitude: 1630ft (+52.1ft) Datum: WGS-84 Azimuth Bearing: 206.526W 3662mils True (+12) Elevation Angle: -13.6 Horizon Angle: -00.4 Zoom: 1.0X WA12: View of unimpacted resource area conditions during pre-construction assessment MVP: S: A43</small></p>
GPS Location See Photo	GPS Location See Photo
Description View of permitted resource impact area during pre-construction assessment.	Description At edge of LOD, view of unimpacted resource area conditions during pre-construction assessment.

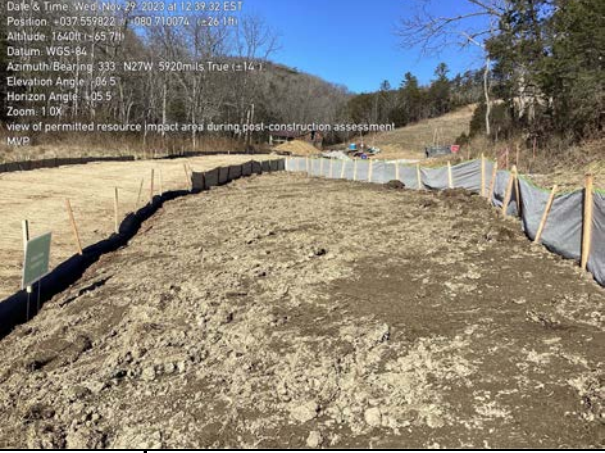
<p><small>Date & Time: Wed, Nov 29, 2023 at 12:39:32 EST Position: +037.559822 / -080.710074 (+26.1ft) Altitude: 1640ft (+57.7ft) Datum: WGS-84 Azimuth Bearing: 333.1 N27W 5920mils True (+14) Elevation Angle: -06.5 Horizon Angle: -00.5 Zoom: 1.0X WA13: View of permitted resource impact area during post-construction assessment MVP</small></p>

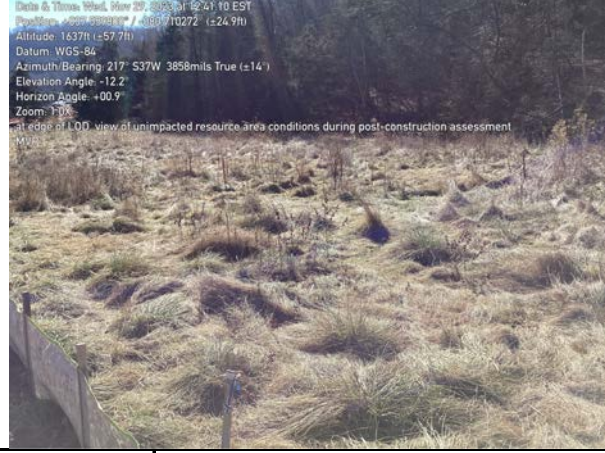
<p><small>Date & Time: Wed, Nov 29, 2023 at 12:41:10 EST Position: +037.559822 / -080.710272 (+24.9ft) Altitude: 1637ft (+57.7ft) Datum: WGS-84 Azimuth Bearing: 217.537W 3858mils True (+14) Elevation Angle: -12.2 Horizon Angle: -00.9 Zoom: 1.0X WA13: At edge of LOD, view of unimpacted resource area conditions during post-construction assessment MVP</small></p>
GPS Location See Photo	GPS Location See Photo
Description View of permitted resource impact area during post-construction assessment.	Description At edge of LOD, view of unimpacted resource area conditions during post-construction assessment.

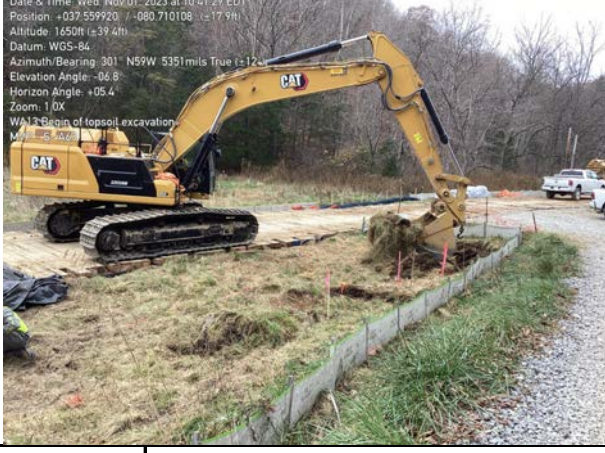
- 11/1/2023 - Top 12 inches of topsoil excavated (Photo 1) in first portion of the aquatic resource crossing. Topsoil was segregated and stored in work area. Plastic covering added on top of topsoil storage pile as well as signage.

<p><small>Date & Time: Wed, Nov 01, 2023 at 10:41:29 EDT Position: +037.559793 / -080.710108 (+17.9ft) Altitude: 1650ft (+59.4ft) Datum: WGS-84 Azimuth Bearing: 301.1 N59W 5351mils True (+12) Elevation Angle: -04.8 Horizon Angle: +05.4 Zoom: 1.0X WA13: Begin of topsoil excavation MVP: S: A43</small></p>

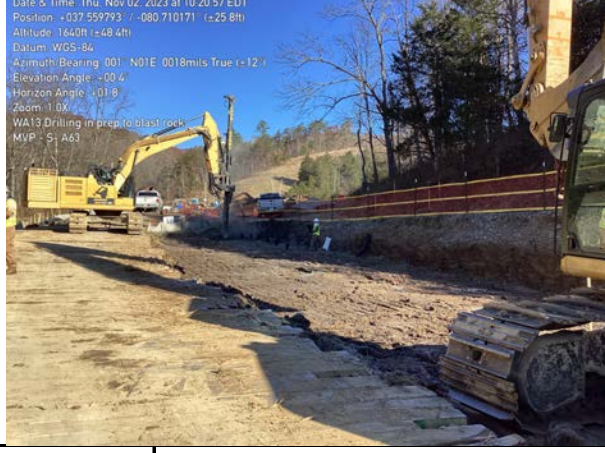
- 11/3/2023 - Bored for additional blasting (Photo 2). Blasted through aquatic resource area.
- 11/4/2023 - Bored for additional blasting. Blasted through access road and portion of aquatic resource area. Excavating started across road and steel plates and mats placed across road.

<p><small>Date & Time: Thu, Nov 02, 2023 at 10:20:57 EDT Position: +037.559793 / -080.710171 (+25.8ft) Altitude: 1640ft (+48.4ft) Datum: WGS-84 Azimuth Bearing: 001.1 N01E 0018mils True (+12) Elevation Angle: +00.4 Horizon Angle: -01.8 Zoom: 1.0X WA13: Drilling in prep to blast rock MVP: S: A43</small></p>
GPS Location See Photo	GPS Location See Photo
Description Photo 1: Removal of first 12 inches of topsoil.	Description Photo 2: Drilling in aquatic resource for blasting.
