Wetland Biological Conditions EA Report

Project Name	H-600 Pipeline Spread D	A/E	124300132	Spread	H-600 Pipeline Spread D
Contractor	Precision	Report #	143		
Environmental Auditor	Scott Wessel			Date/Time	11/18/2023 12:17 PM
Wetland ID	W-A17	Crossing Start Date	11/18/2023	Crossing Completion Date	12/1/2023
Milepost	114.83	Pre-Con Assessment Date	11/18/2023	Post-Con Assessment Date	12/1/2023
Station	6063+25	Cowardin Classification	PEM	Wetland Impact Area(acres)	0.1300
State	WV				
County	Nicholas

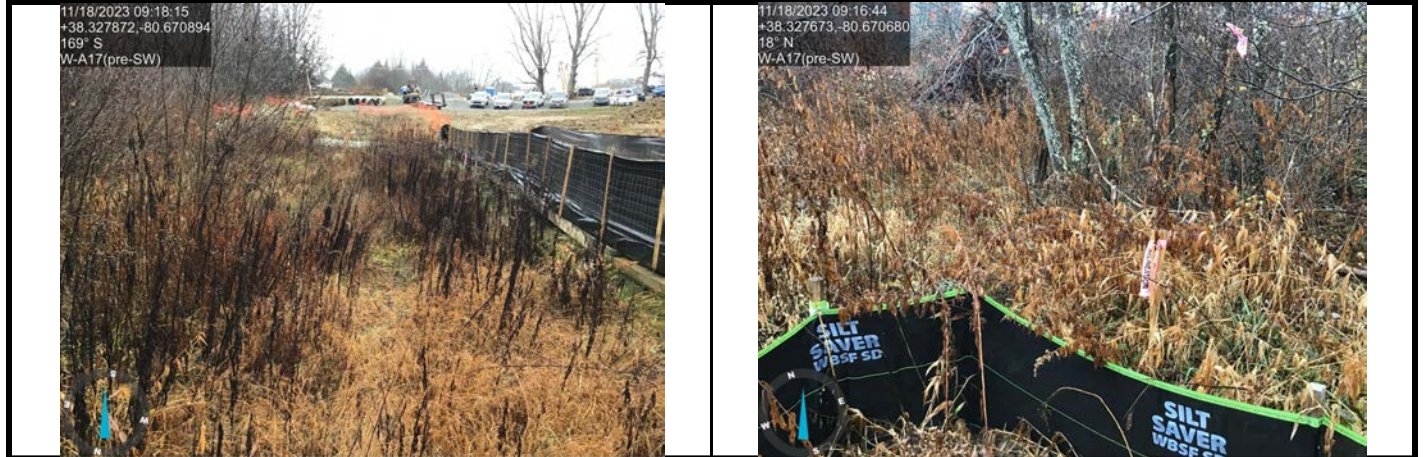
GPS Location See coordinates in above photo.	GPS Location See coordinates in above photo.
Description View of permitted resource impact area during pre-construction assessment.	Description At edge of LOD, view of unimpacted resource area conditions during pre-construction assessment.

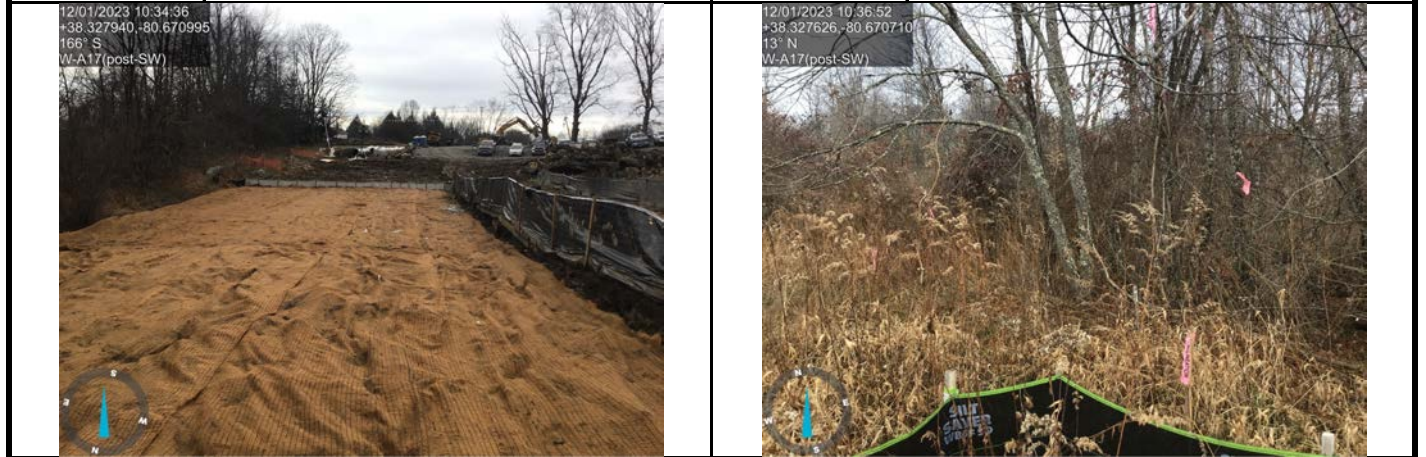
Conditions 18 and 19 were given a rating of 4 due to the lack of vegetation in the disturbed permitted impact area following completion of the crossing and restoration efforts. Wetland W-A17 topsoil was properly stabilized and the disturbed areas have been seeded with the appropriate permanent seed mix in accordance with Appendix B: Restoration Work Plan of the Mountain Valley Pipeline Comprehensive Stream and Wetland Monitoring, Restoration and Mitigation Framework.

GPS Location See coordinates in above photo.	GPS Location See coordinates in above photo.
Description View of permitted resource impact area during post-construction assessment.	Description At edge of LOD, view of unimpacted resource area conditions during post-construction assessment.

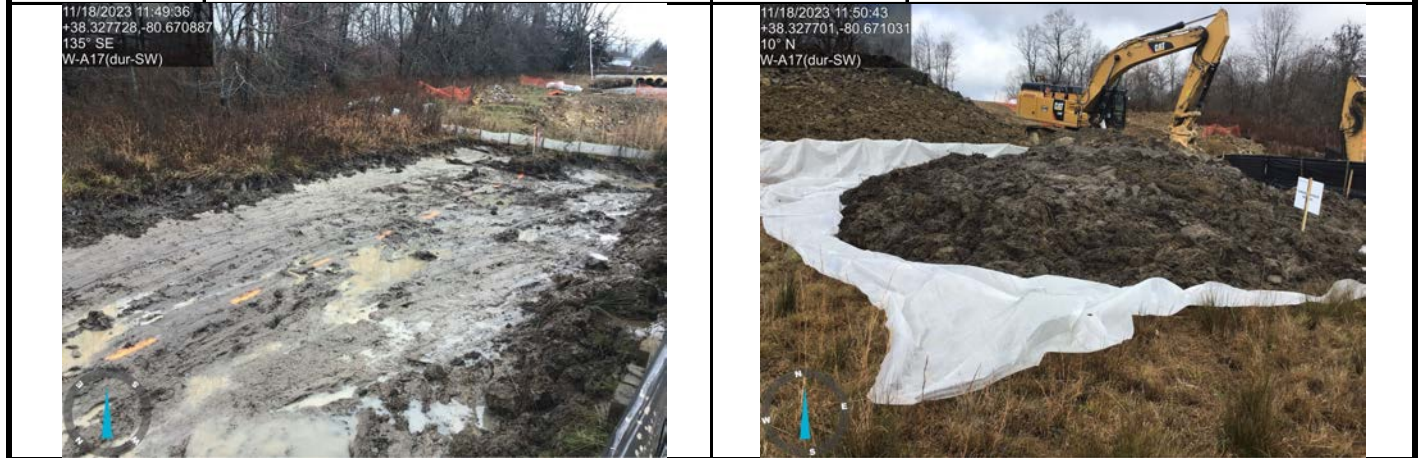
GPS Location See coordinates in above photo.	GPS Location See coordinates in above photo.
Description Topsoil being removed from wetland area.	Description Wetland topsoil staged on plastic and segregated from other spoils on the CIS of resource.
