WETLAND BIOLOGICAL CONDITIONS ENVIRONMENTAL AUDITOR REPORT

Wetland ID: W-AB3-PEM-2	Crossing Start Date: 11/24/2023	Crossing Completion Date: 11/29/2023
Milepost: 243.4	Pre-Con Assessment Date: 11/18/2023	Post-Con Assessment Date: 12/05/2023
Station: 12862+95	Cowardin Classification: PEM (PEM, PFO, PSS, POW)	Wetland Impact Area (sq ft.): 6738.73
County: Roanoke

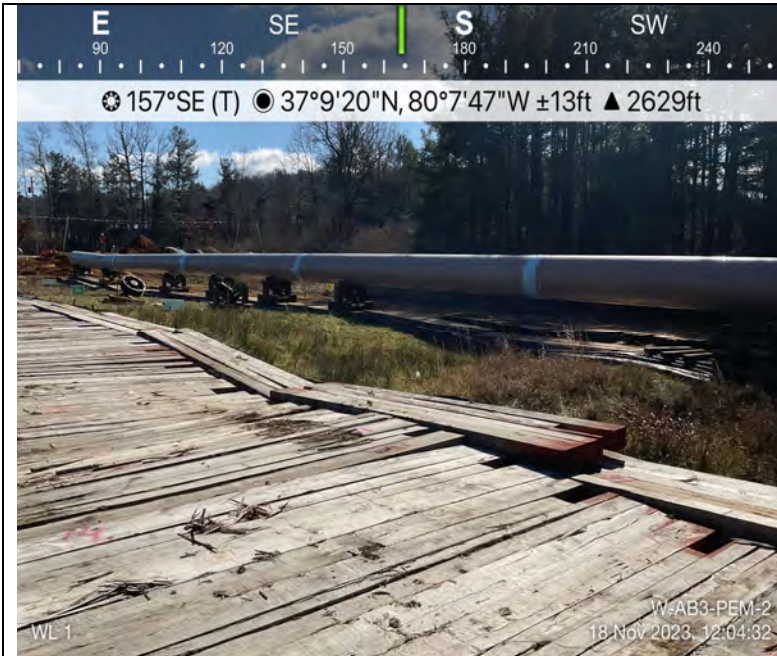
Photo Description: View of permitted resource impact area during pre-construction assessment.

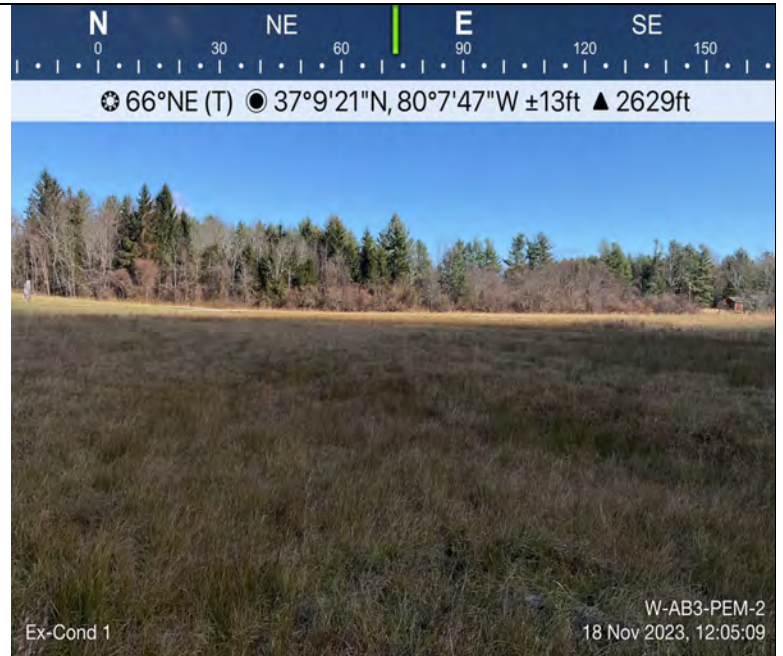
Photo Description: At edge of LOD, view of unpermitted resource area conditions during pre-construction assessment.

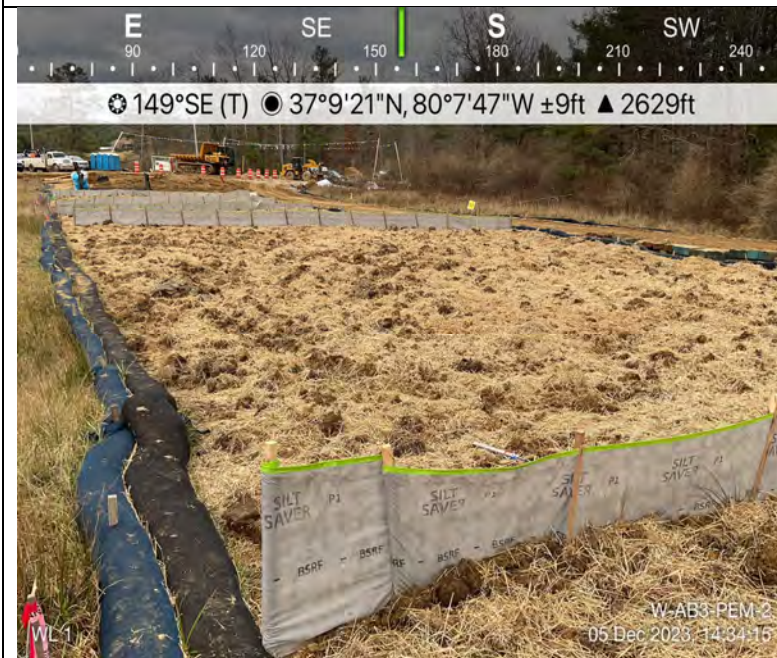
Photo Description: View of permitted resource impact area during post-construction assessment.

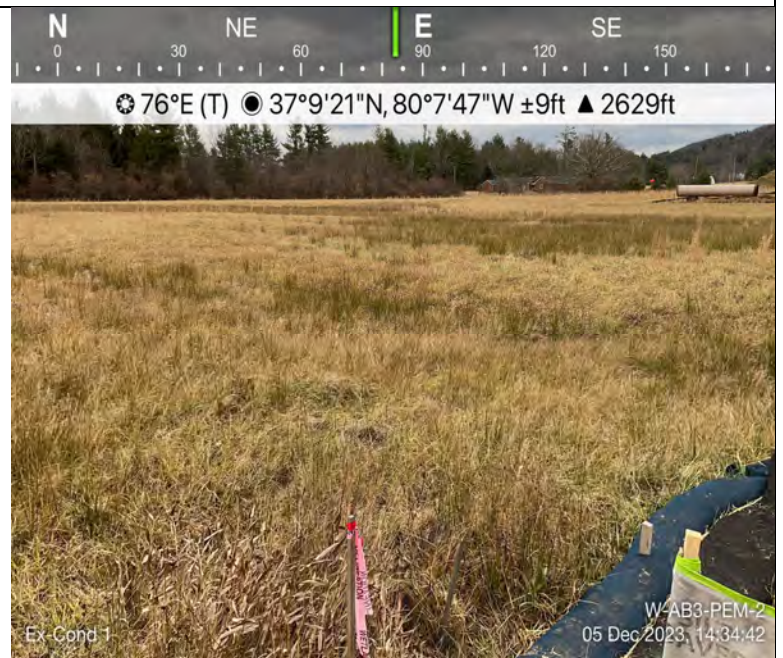
Photo Description: At edge of LOD, view of unpermitted resource area conditions during post-construction assessment.

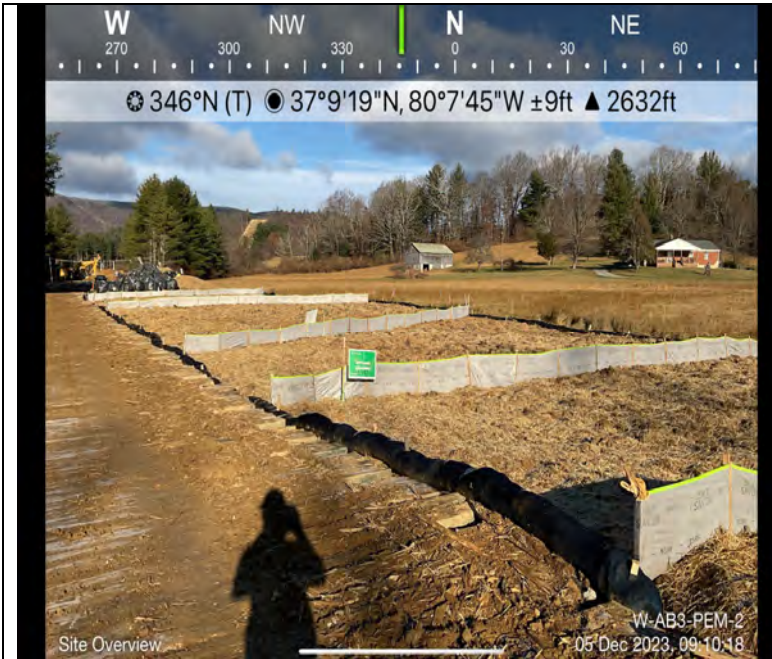
Photo Description: Site overview after restoration activities.

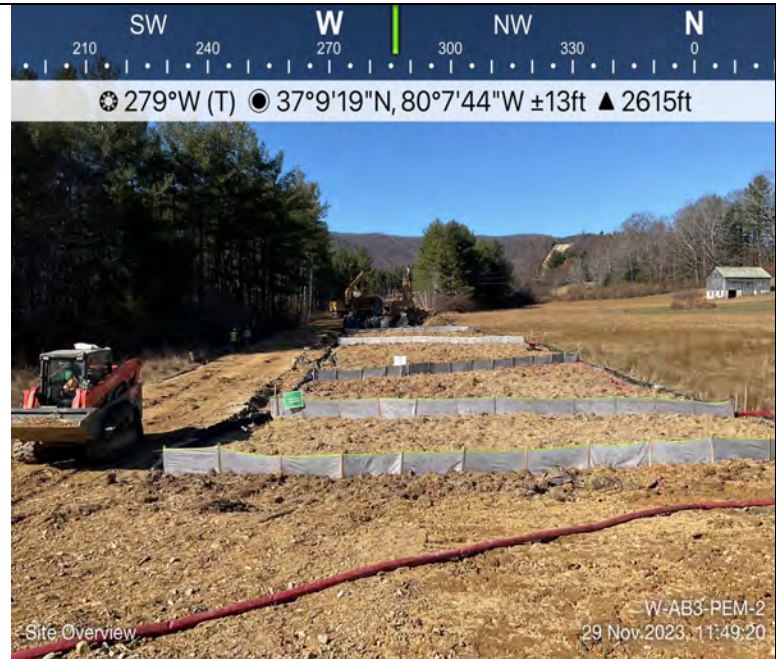
Photo Description: Site overview. Timber mats remain installed for access to upland areas and adjacent wetland areas.

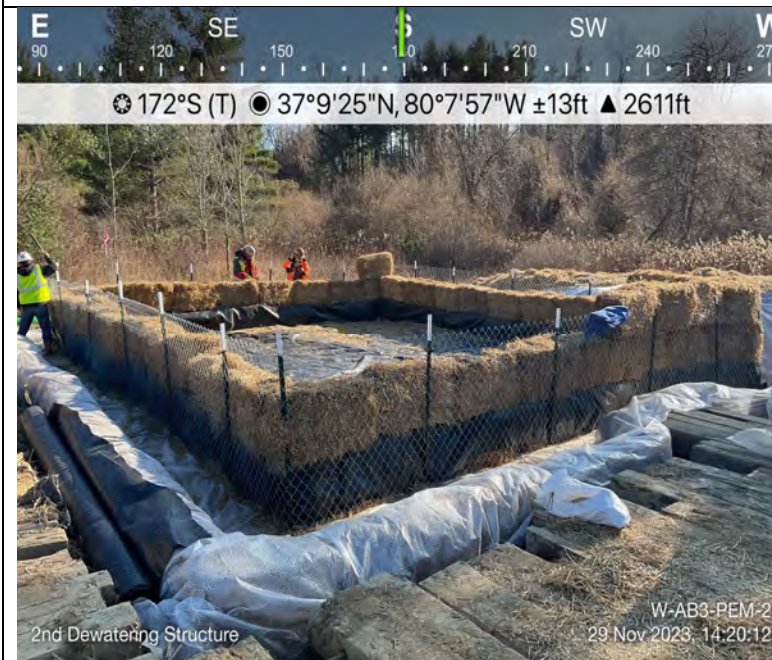
Photo Description: Second dewatering structure installed to assist with trench dewatering.

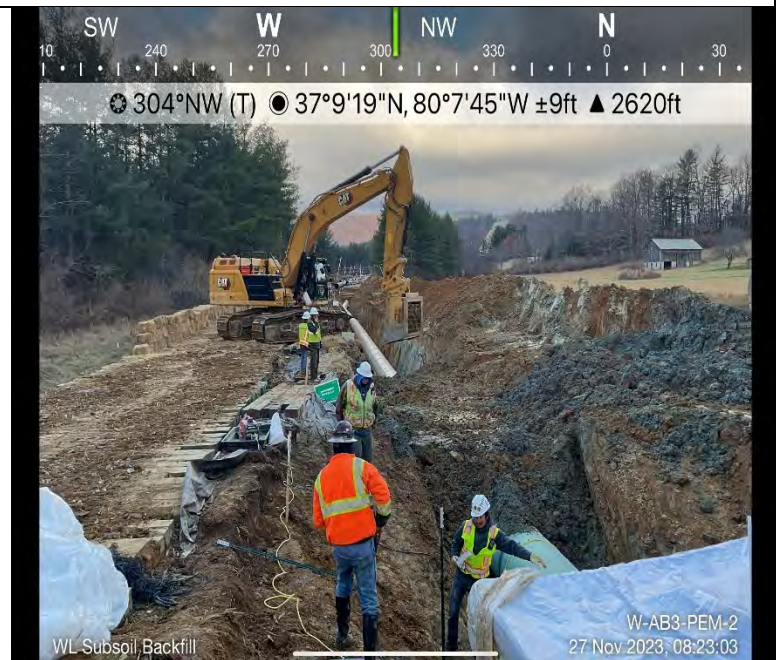
Photo Description: Backfill of subsoil through wetland impact area after pipe installation.
