Wetland

Wetland ID: W-AB6-PEM-1	Crossing Start Date: 11/23/2023	Crossing Completion Date: 12/02/2023
Milepost: 243.4	Pre-Con Assessment Date: 11/18/2023	Post-Con Assessment Date: 12/05/2023
Station: 1285921	Cowardin Classification: PEM (PEM, PFO, PSS, POW)	Wetland Impact Area (sq ft.): 2818.33
County: Roanoke

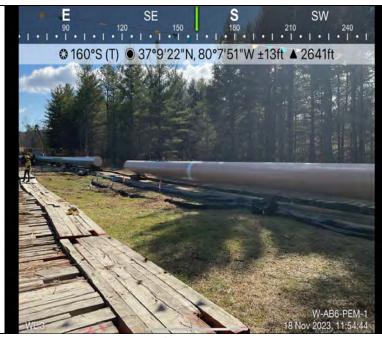
Photo Description: View of permitted resource impact area during pre-construction assessment.

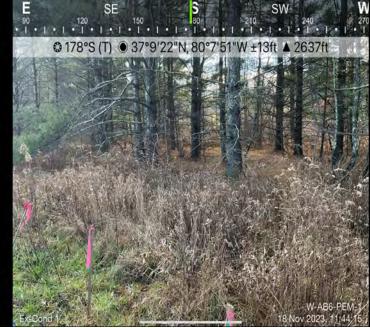
Photo Description: At edge of LOD, view of unpermitted resource area conditions during pre-construction assessment.

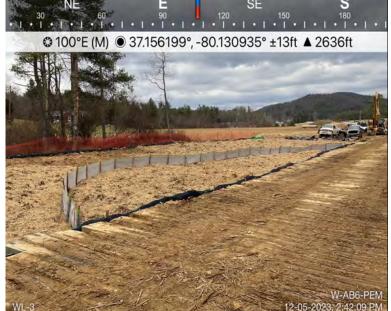
Photo Description: View of permitted resource impact area during post-construction assessment.

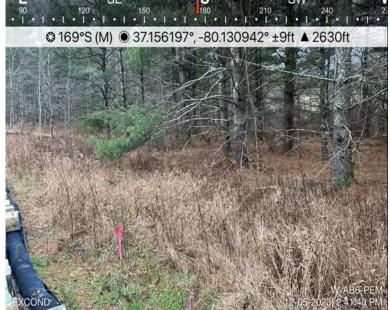
Photo Description: At edge of LOD, view of unpermitted resource area conditions during post-construction assessment.
