WETLAND BIOLOGICAL CONDITIONS ENVIRONMENTAL AUDITOR REPORT

Wetland ID: W-EF6	Crossing Start Date: 10/30/2023	Crossing Completion Date: 11/04/2023
Milepost: 303.2	Pre-Con Assessment Date: 10/28/2023	Post-Con Assessment Date: 11/04/2023
Station: 16	Cowardin Classification: PFO (PEM, PFO, PSS, POW)	Wetland Impact Area (sq ft.): 2905.45
County: Pittsylvania

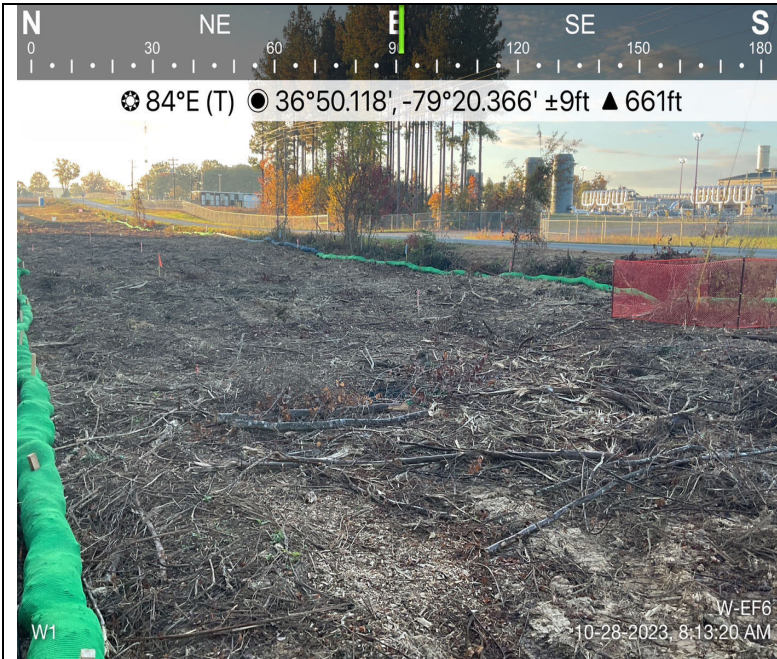
Photo Description: View of permitted resource impact area during pre-construction assessment.

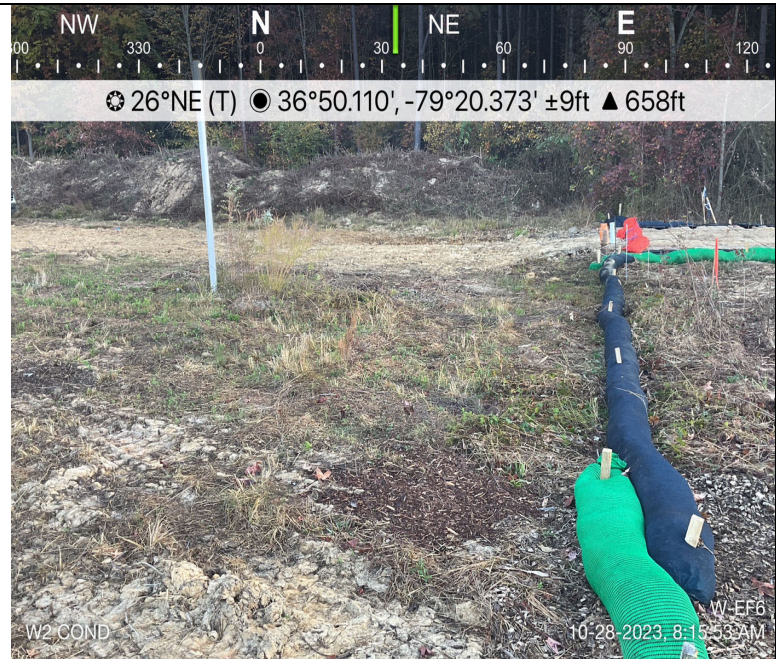
Photo Description: At edge of LOD, view of unpermitted resource area conditions during pre-construction assessment.

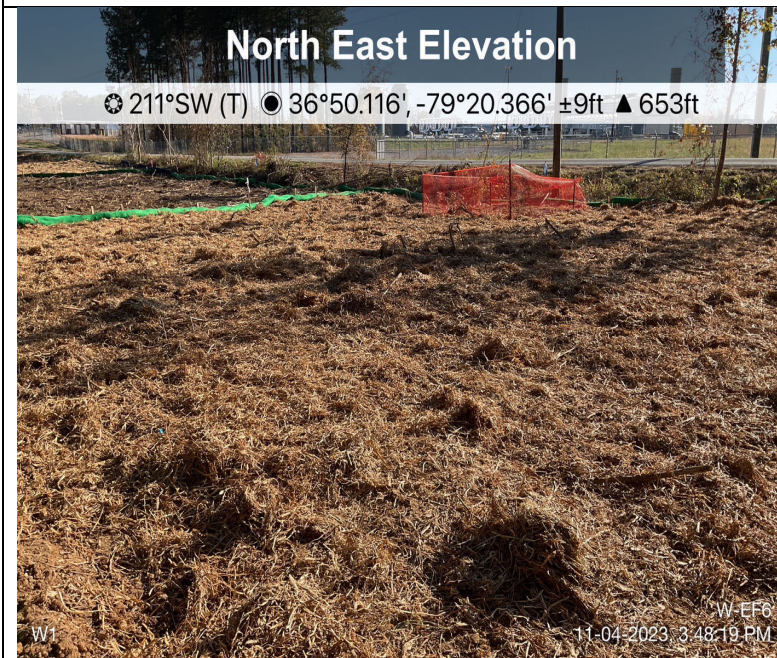
Photo Description: View of permitted resource impact area during post-construction assessment.

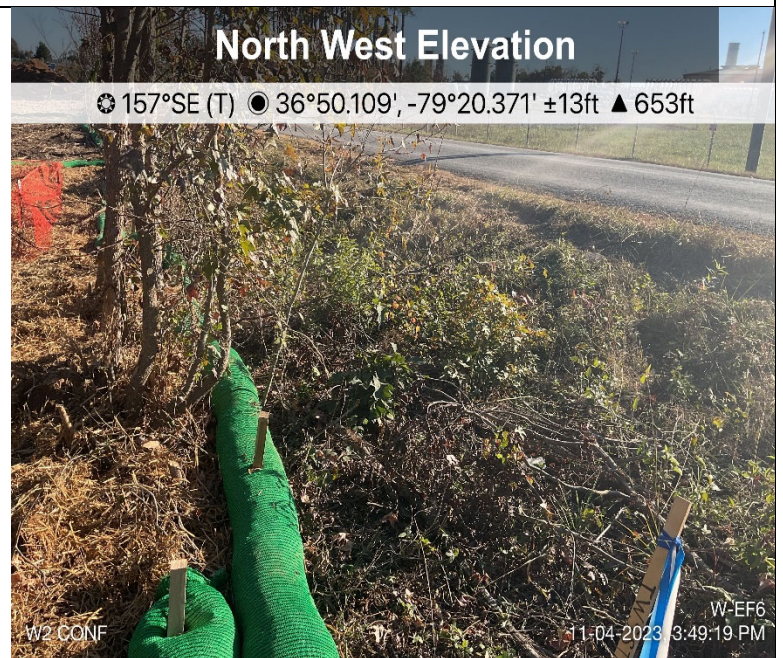
Photo Description: At edge of LOD, view of unpermitted resource area conditions during post-construction assessment.

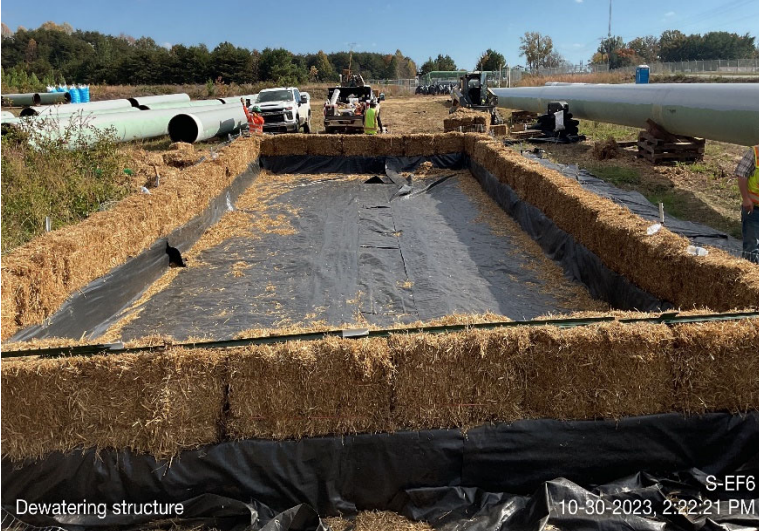
Dewatering structure

Photo Description: An overview of the dewatering structure.

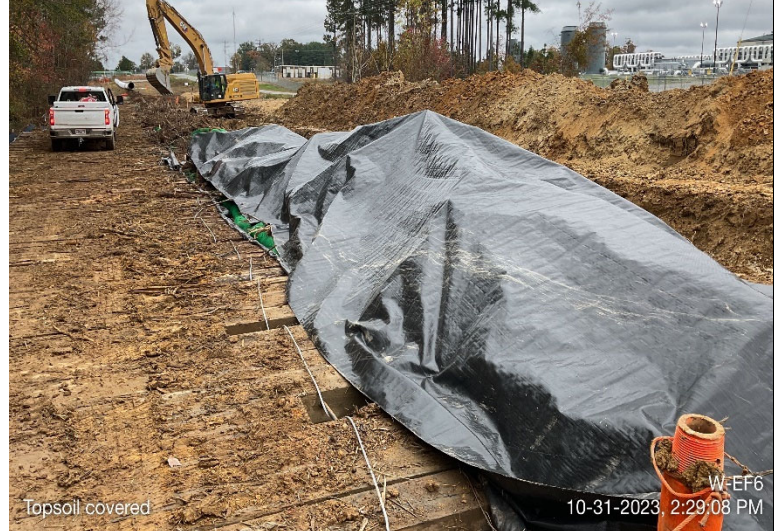
Topsoil covered

Photo Description: The wetland topsoil was excavated, stockpiled separately, and covered.

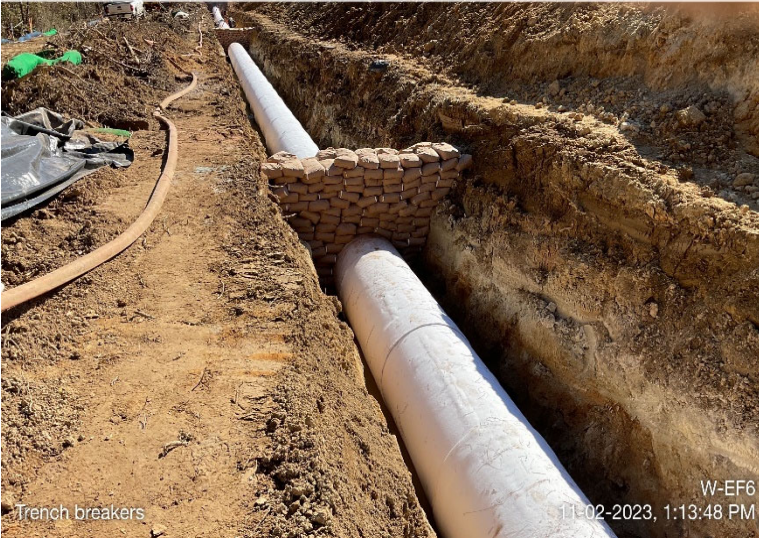
Trench breakers

Photo Description: A trench breaker was installed along the pipe.

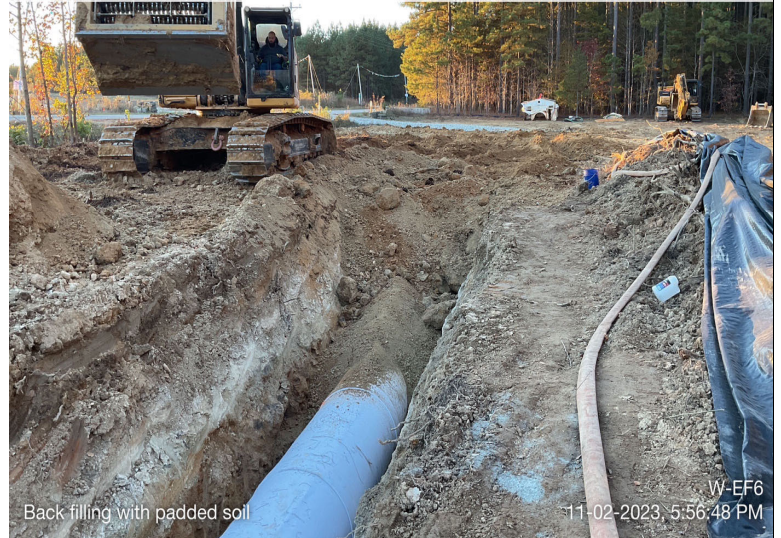
Back filling with padded soil

Photo Description: The trench in the process of being backfilled with padded soil.
