WETLAND BIOLOGICAL CONDITIONS ENVIRONMENTAL AUDITOR REPORT

Wetland ID: W-H1	Crossing Start Date: 11/01/2023	Crossing Completion Date: 11/09/2023
Milepost: 301.6	Pre-Con Assessment Date: 10/28/2023	Post-Con Assessment Date: 11/10/2023
Station: 15951+72	Cowardin Classification: PEM (PEM, PFO, PSS, POW)	Wetland Impact Area (sq ft.): 479.16
County: Pittsylvania

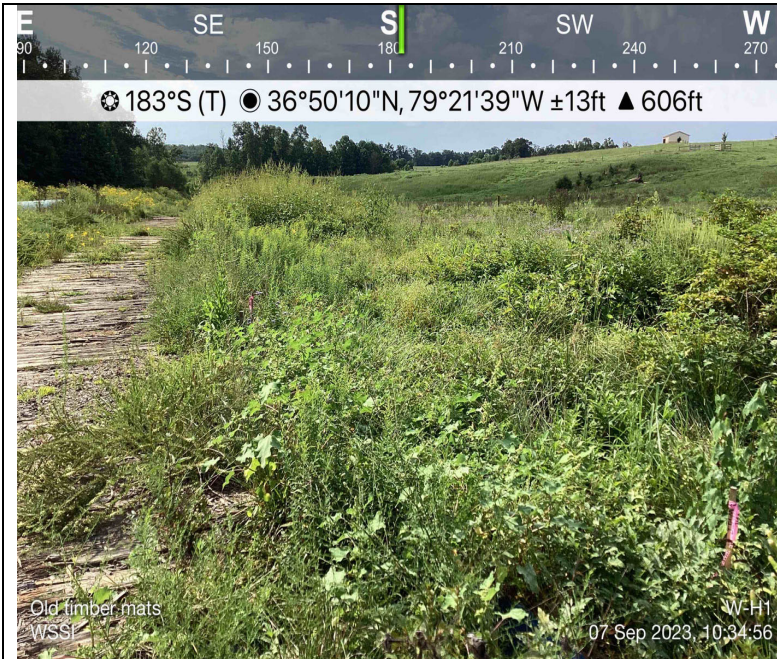
Photo Description: View of permitted resource impact area during pre-construction assessment.

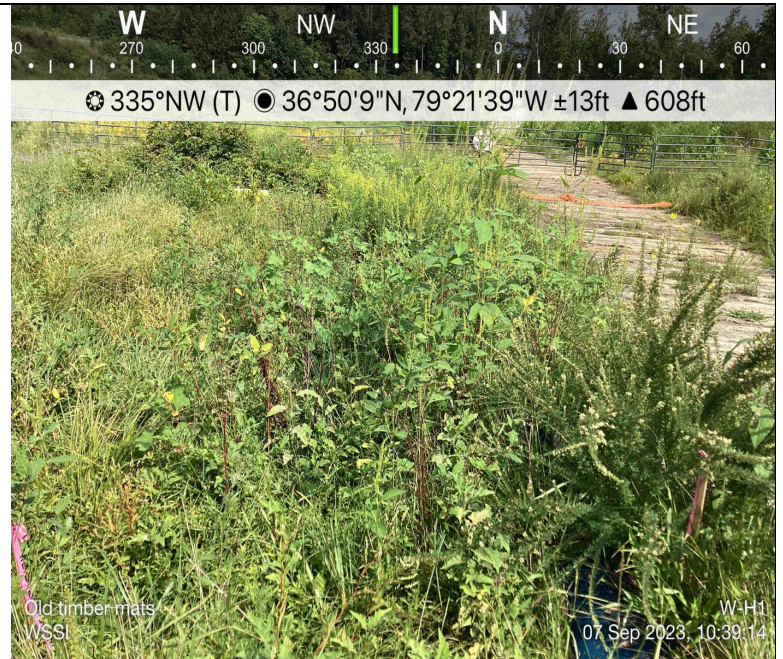
Photo Description: View of area outside delineated wetland boundary during pre-construction assessment.

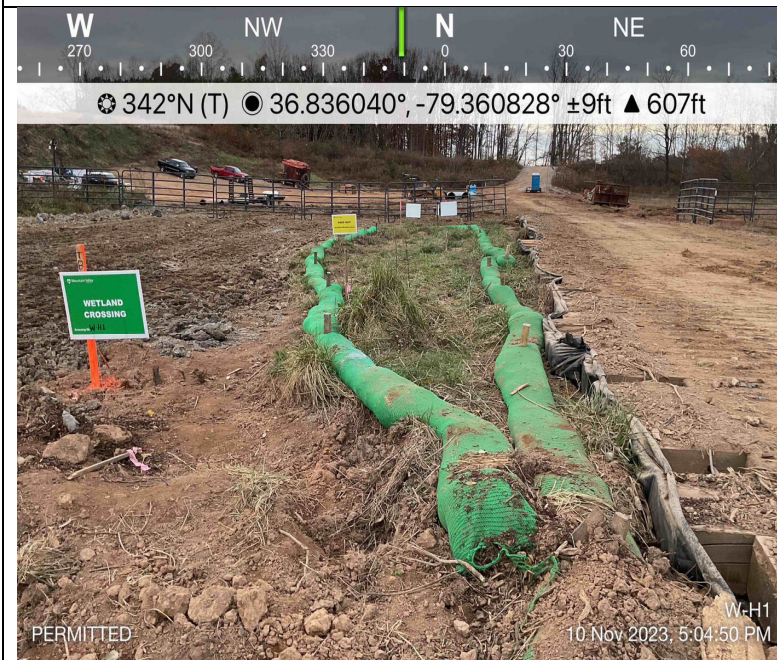
Photo Description: View of permitted resource impact area during post-construction assessment. Impact to resource avoided by construction.

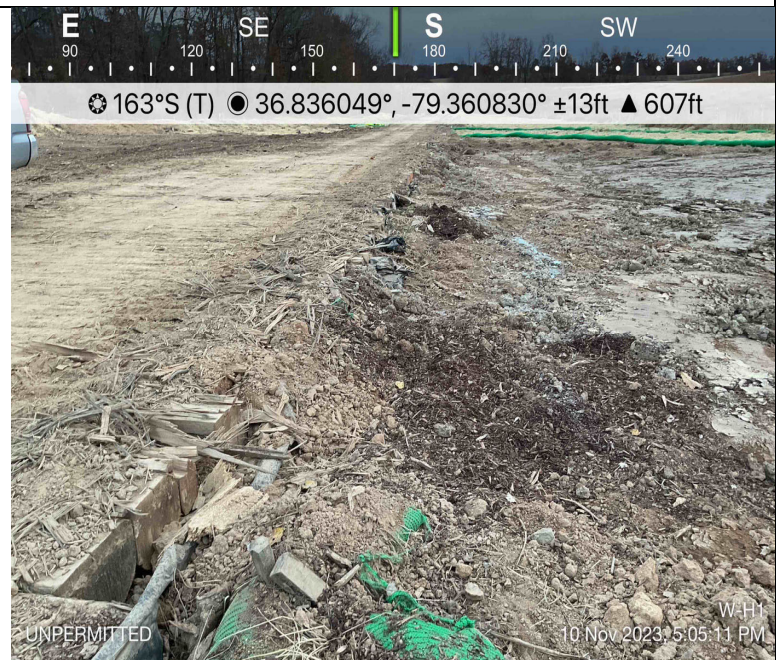
Photo Description: View of area outside delineated wetland boundary during post-construction assessment.

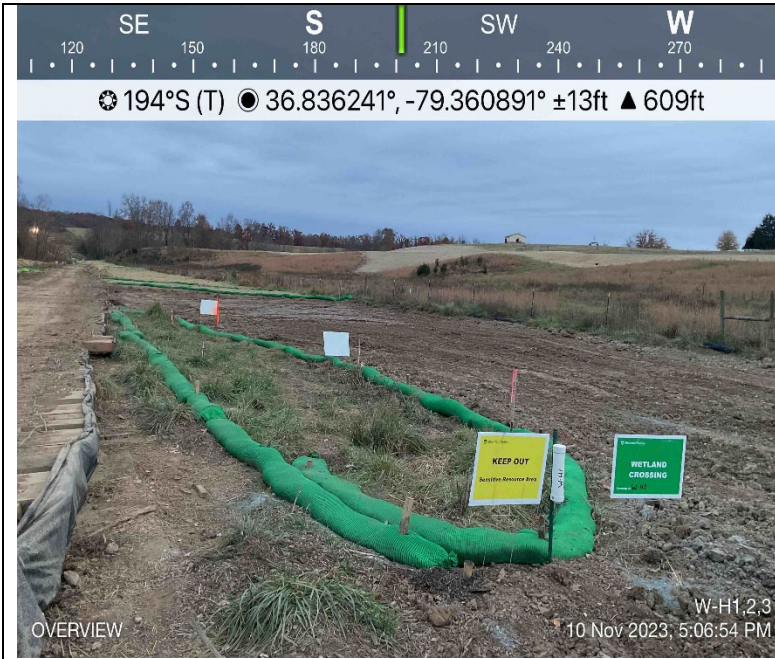
Photo Description: Resource impact avoided by construction.

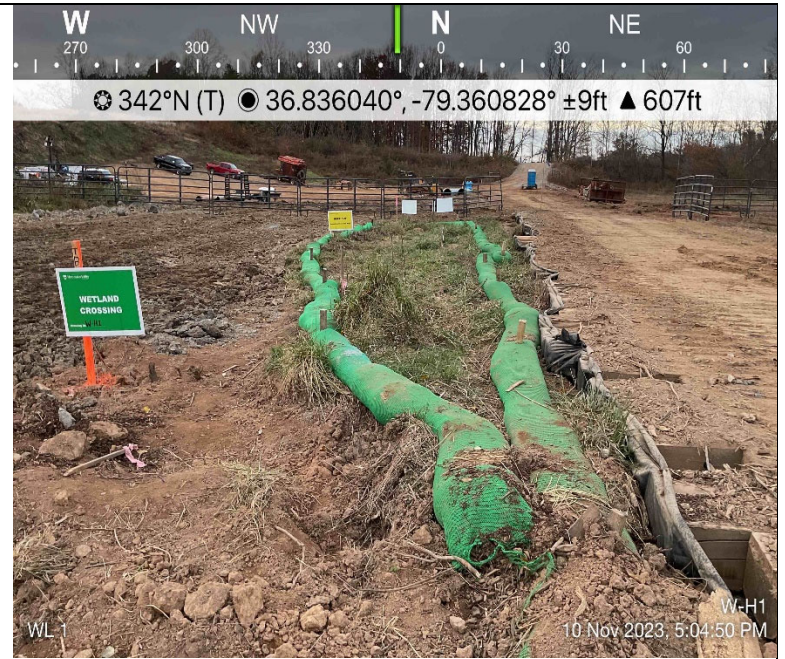
Photo Description: Wetland area avoided by construction.

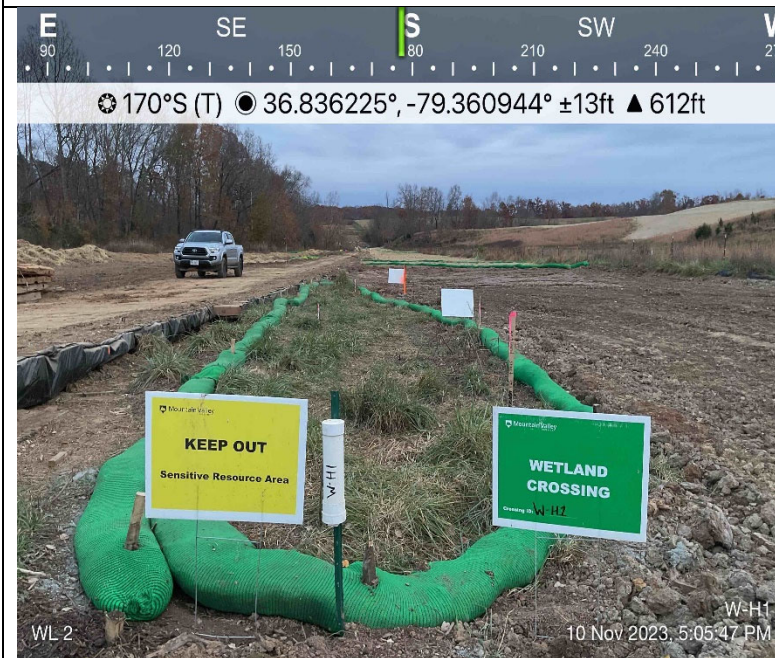
Photo Description: Wetland W-H1 avoided by construction.

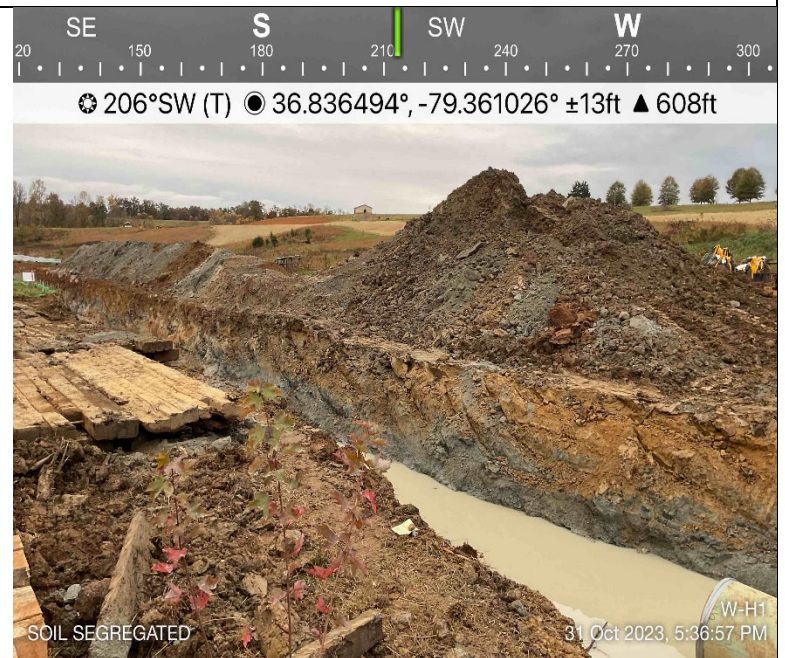
Photo Description: Subsoil segregated during trench excavation. Avoided wetland signage can be seen on left side of photo.
