WETLAND BIOLOGICAL CONDITIONS ENVIRONMENTAL AUDITOR REPORT

Wetland ID: W-H2	Crossing Start Date: 11/01/2023	Crossing Completion Date: 11/10/2023
Milepost: 301.7	Pre-Con Assessment Date: 9/07/2023	Post-Con Assessment Date: 11/10/2023
Station: 15953+68	Cowardin Classification: PEM (PEM, PFO, PSS, POW)	Wetland Impact Area (sq ft.): 34791.37
County: Pittsylvania

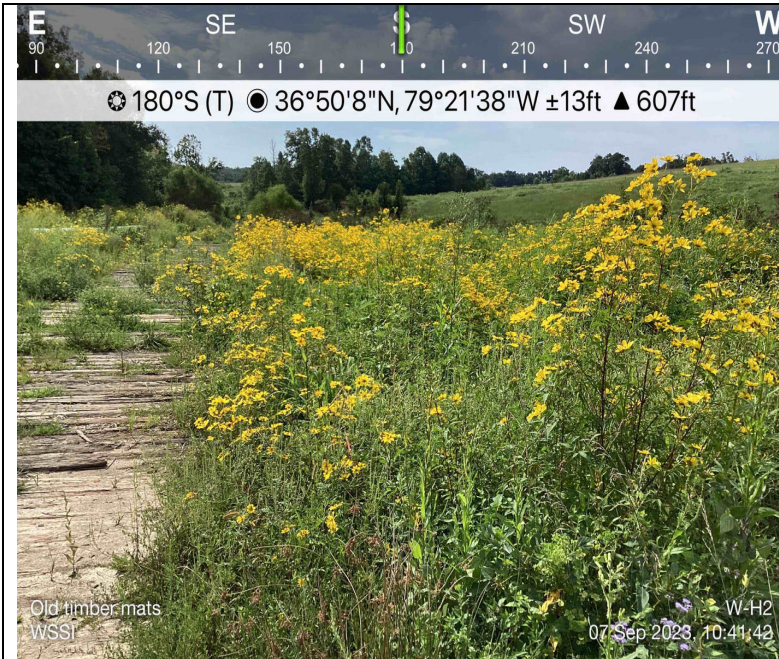
Photo Description: View of permitted resource impact area during pre-construction assessment.

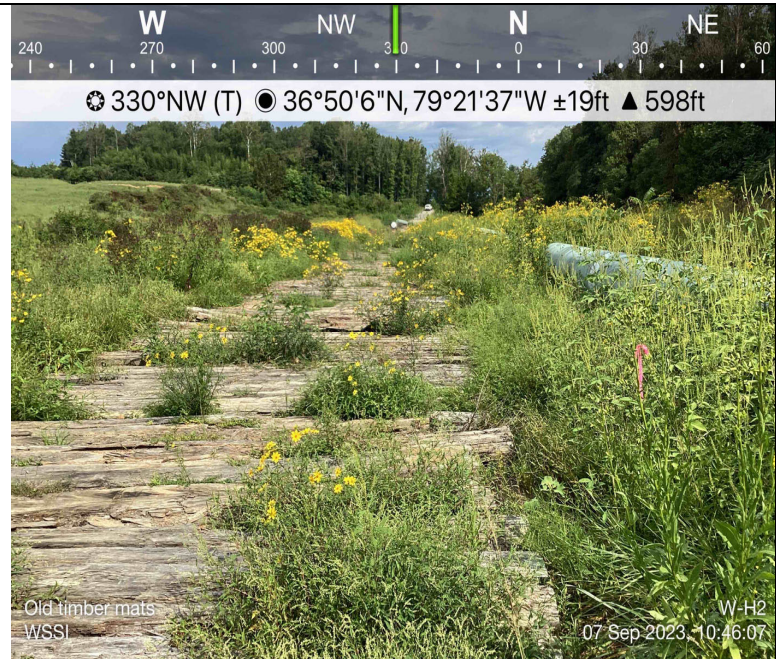
Photo Description: At edge of LOD, view of unpermitted resource area conditions during pre-construction assessment.

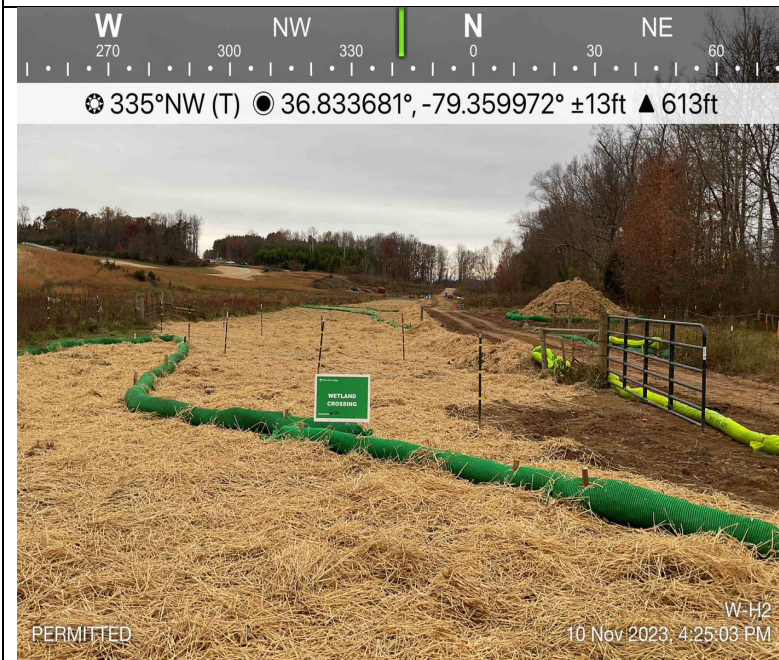
Photo Description: View of permitted resource impact area during post-construction assessment.

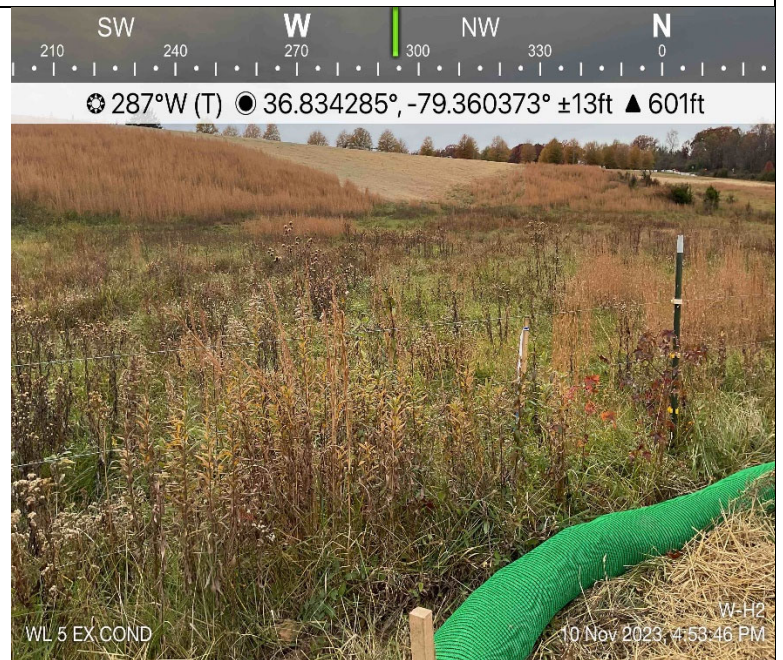
Photo Description: At edge of LOD, view of unpermitted resource area conditions during post-construction assessment.

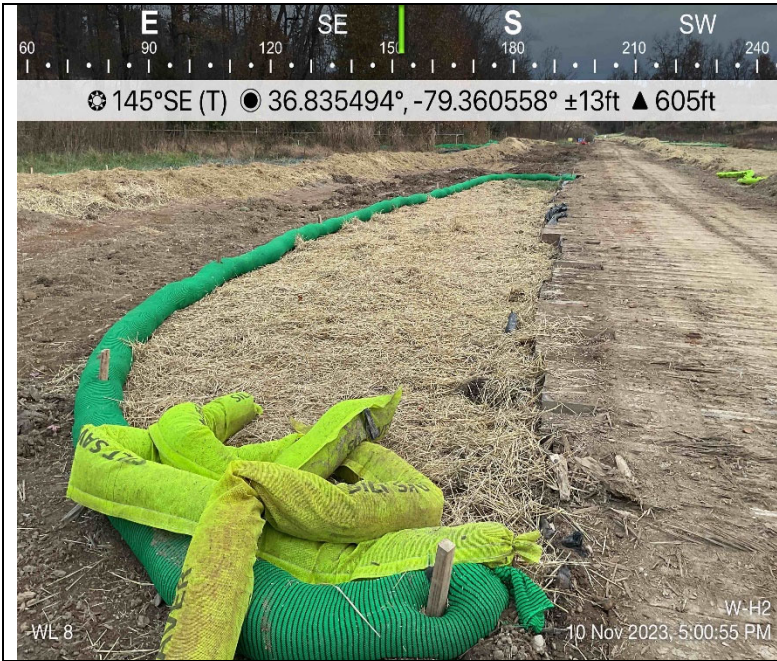
Photo Description: Wetland boundary maintained during restoration, but timber mats remain in place across wetland area to maintain access during completion of upland areas.

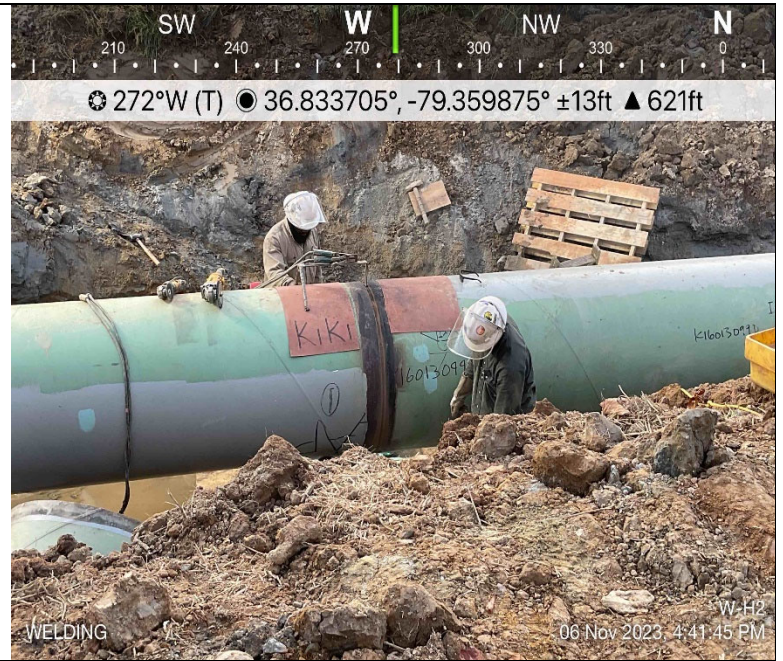
Photo Description: Welding activities within the wetland impact area.

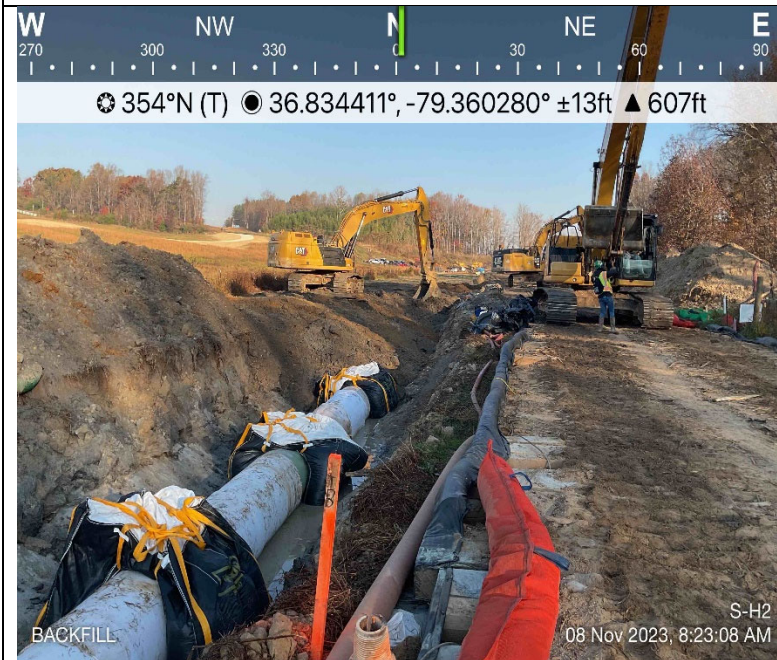
Photo Description: Backfill operations within resource crossing areas. Typo in photo watermark, "W-H2", not "S-H2"

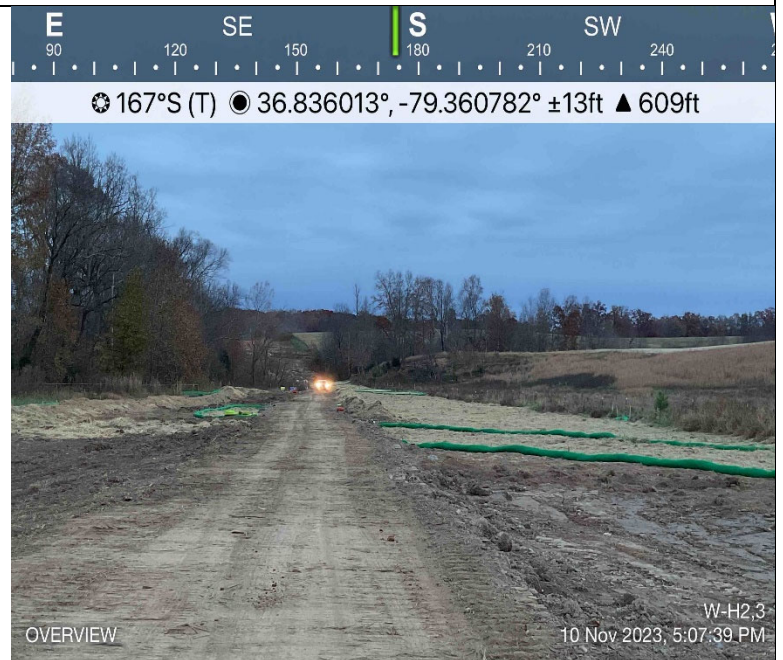
Photo Description: Overview of wetland crossings restored and new ECD's installed.
