# WETLAND BIOLOGICAL CONDITIONS ENVIRONMENTAL AUDITOR REPORT

<b>Wetland ID:</b> W-H3	<b>Crossing Start Date:</b> 11/01/2023	<b>Crossing Completion Date:</b> 11/09/2023
<b>Milepost:</b> 301.7	<b>Pre-Con Assessment Date:</b> 10/28/2023	<b>Post-Con Assessment Date:</b> 11/10/2023
<b>Station:</b> 15960+38	<b>Cowardin Classification:</b> PEM (PEM, PFO, PSS, POW)	<b>Wetland Impact Area (sq ft.):</b> 2217.2
<b>County:</b> Pittsylvania

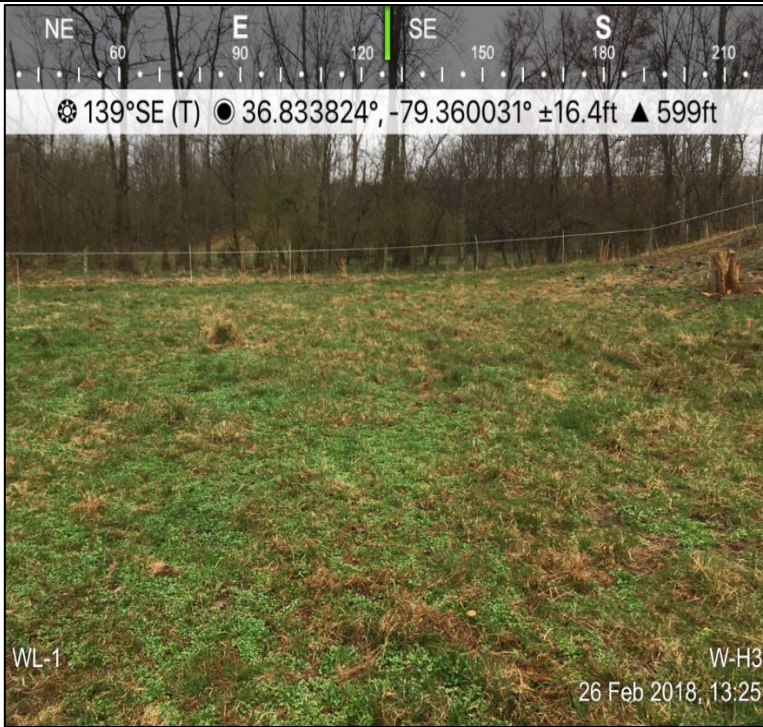
**Photo Description:** View of permitted resource impact area during pre-construction assessment in 2018.

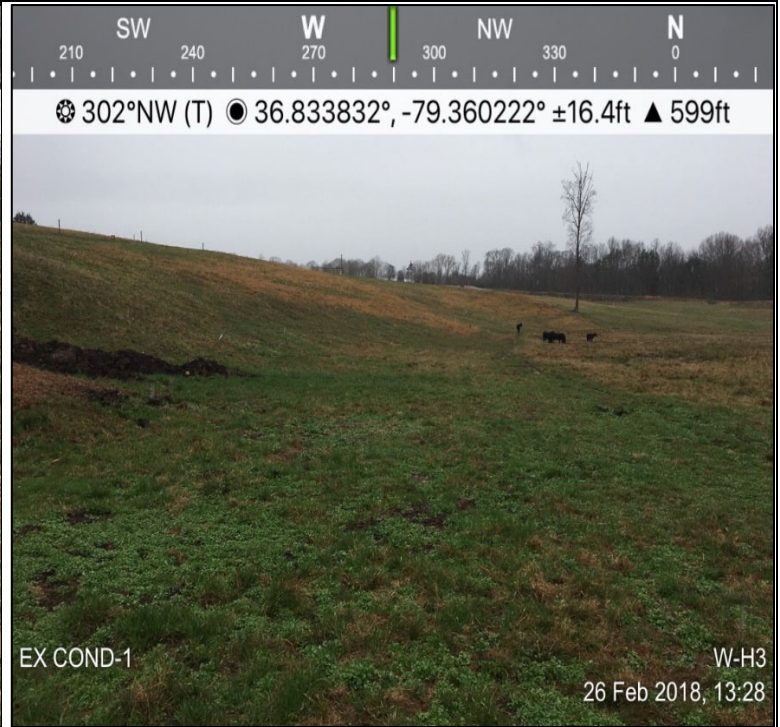
**Photo Description:** At edge of LOD, view of unpermitted resource area conditions during pre-construction assessment in 2018.

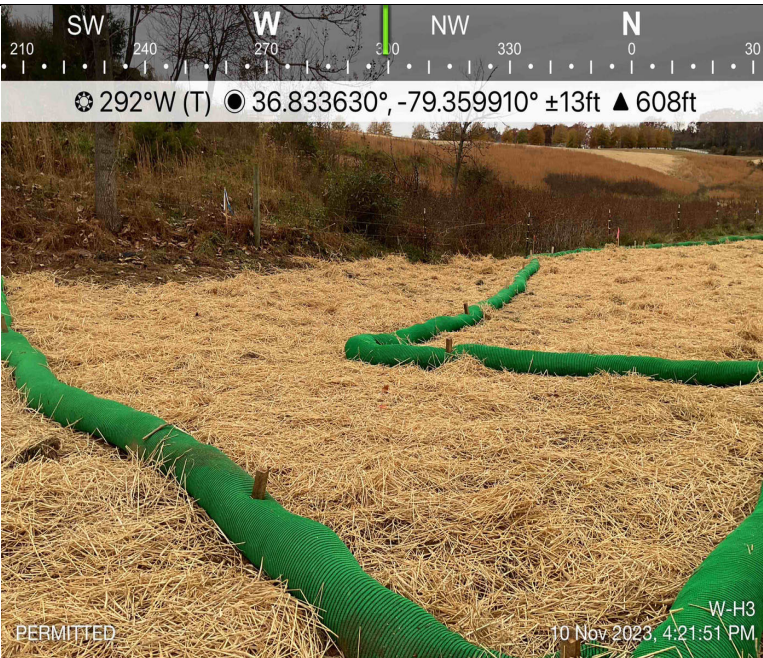
11-09-2023: Completed restoration of W-H3 by reapplying previously stockpiled topsoil, with seed and straw mulch.

**Photo Description:** View of permitted resource impact area during post-construction assessment.

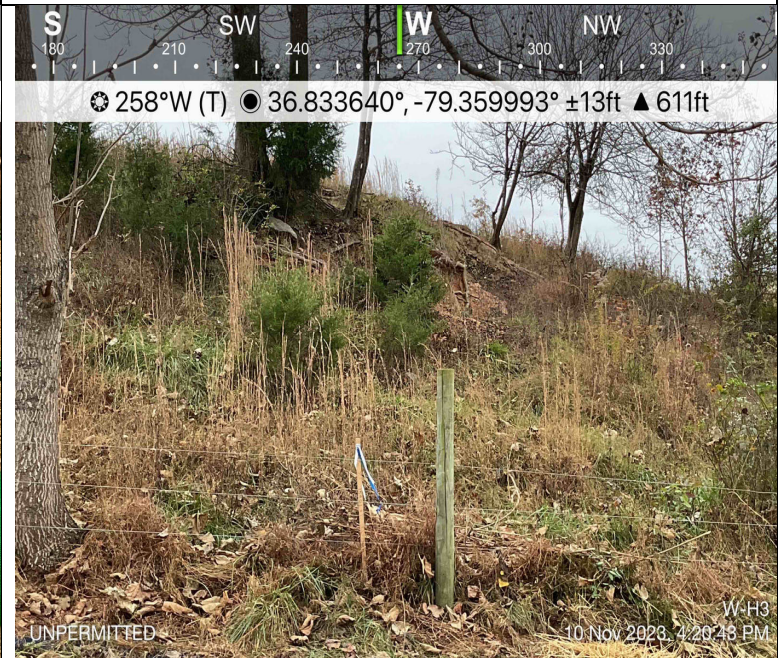
No unauthorized discharges or impacts to biological conditions were observed during the crossing.

**Photo Description:** At edge of LOD, view of unpermitted resource area conditions during post-construction assessment.
