Wetland Biological Conditions EA Report

Project Name	H-600 Pipeline Spread C	A/E	124300131	Spread	H-600 Pipeline Spread C
Contractor	Precision	Report #	144		
Environmental Auditor	Curtis Barbacci			Date/Time	11/30/2023 10:30 PM
Wetland ID	W-H75	Crossing Start Date	11/25/2023	Crossing Completion Date	12/2/2023
Milepost	88.17	Pre-Con Assessment Date	11/25/2023	Post-Con Assessment Date	12/2/2023
Station	4655+29	Cowardin Classification	PEM	Wetland Impact Area(acres)	0.0108
State	WV				
County	Webster

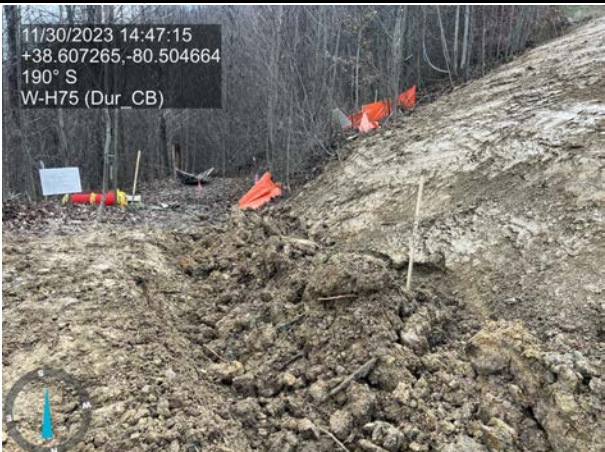
<p>11/30/2023 11:17:33 +38.607060,-80.504682 40° NE W-H75 (Dur_CB)</p>	
GPS Location	See photo	GPS Location	See photo
Description	View of CIS of W-H75 trench breaker near station 4655+49.	Description	View of contractor installing padding dirt within ditch line.

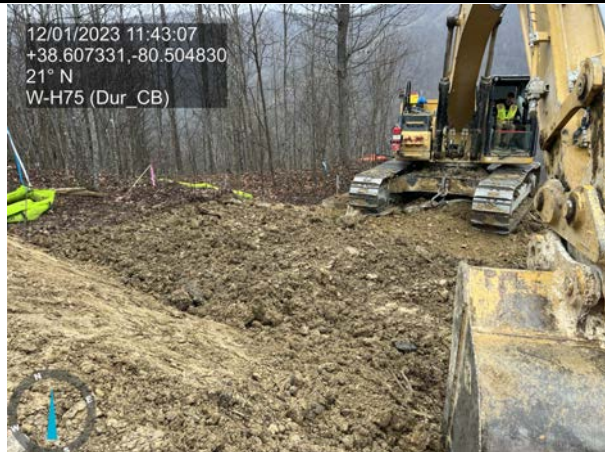
<p>11/30/2023 14:47:15 +38.607265,-80.504664 190° S W-H75 (Dur_CB)</p>

<p>12/01/2023 11:43:07 +38.607331,-80.504830 21° N W-H75 (Dur_CB)</p>	
GPS Location	See photo	GPS Location	See photo
Description	View wetland soils being returned to W-H75.	Description	View of contractor decompacting wetland soils prior to seeding.
  <p>12/02/2023 14:28:09 +38.607385,-80.504781 250° W W-H75 (Dur_CB)</p>		  <p>12/02/2023 16:00:55 +38.607220,-80.504723 336° NW W-H75 (Post_CB)</p>	
GPS Location	See photo	GPS Location	See photo
Description	View from CIS facing towards GAS of contractor applying seed mix to W-H75.	Description	View of erosion control blanket installed adjacent to W-H75.
