WETLAND BIOLOGICAL CONDITIONS ENVIRONMENTAL AUDITOR REPORT

Wetland ID: W-MM3	Crossing Start Date: 10/30/2023	Crossing Completion Date: 11/02/2023
Milepost: 302.1	Pre-Con Assessment Date: 10/28/2023	Post-Con Assessment Date: 11/03/2023
Station: 15976+82	Cowardin Classification: PSS (PEM, PFO, PSS, POW)	Wetland Impact Area (sq ft.): 1481.04
County: Pittsylvania

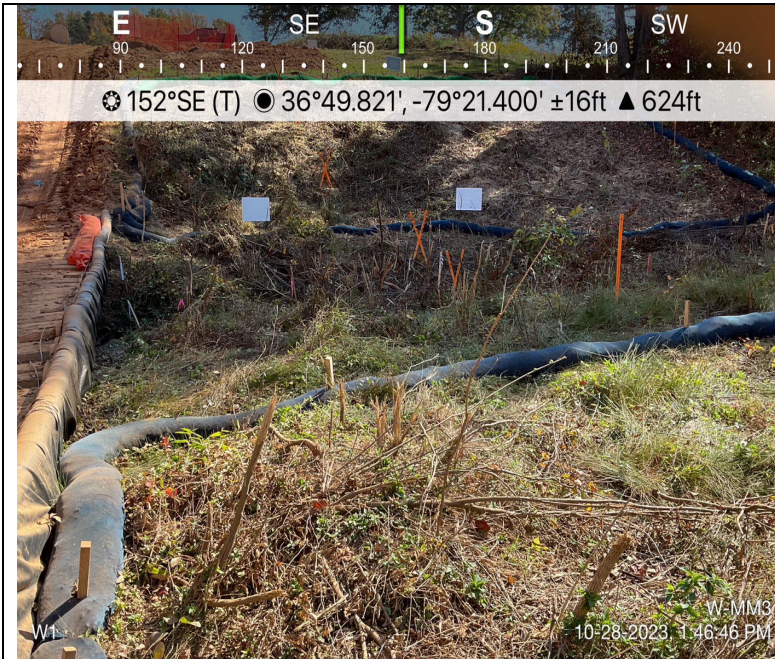
Photo Description: View of permitted resource impact area during pre-construction assessment.

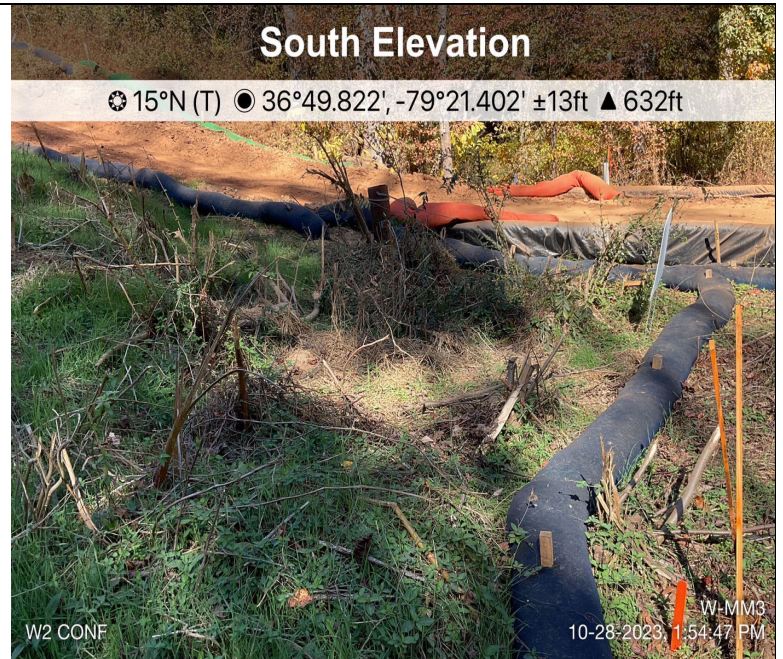
Photo Description: At edge of LOD, view of unpermitted resource area conditions during pre-construction assessment.

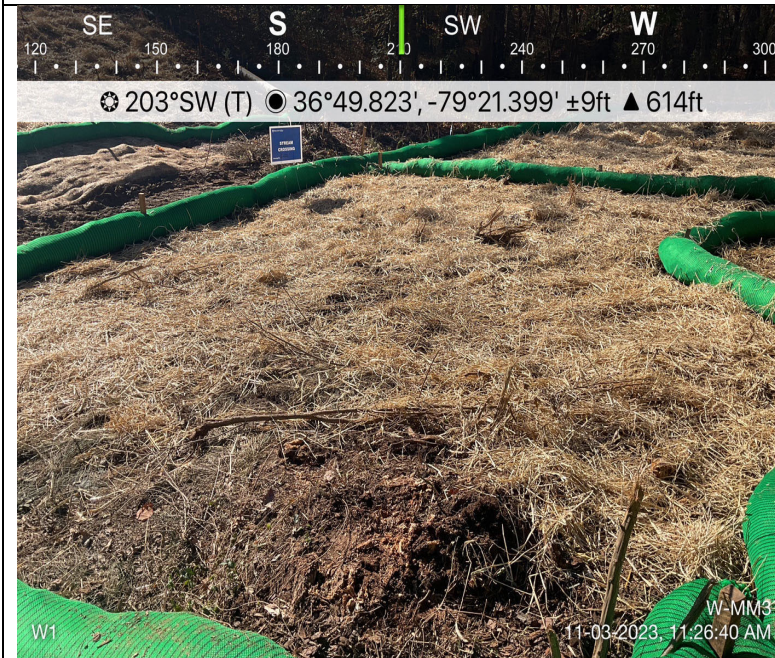
Photo Description: View of permitted resource impact area during post-construction assessment.

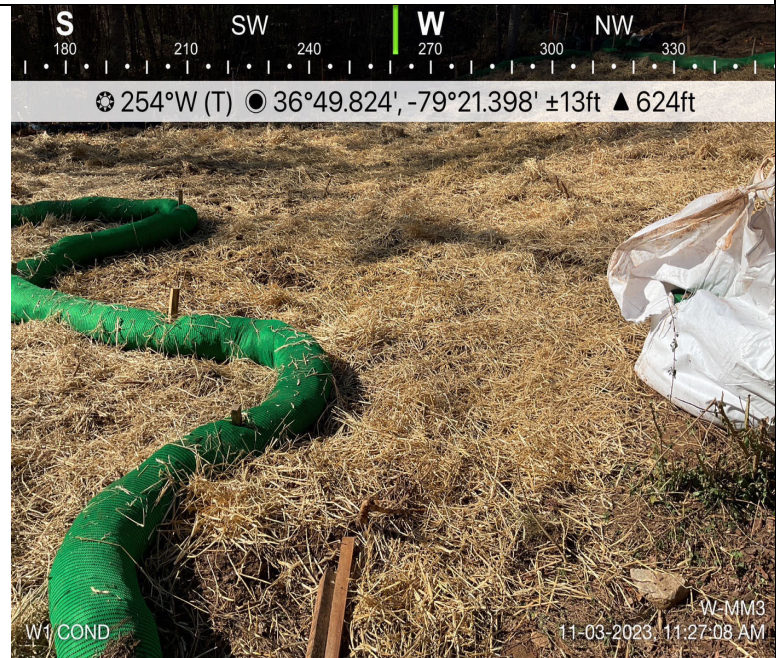
Photo Description: At edge of LOD, view of unpermitted resource area conditions during post-construction assessment.

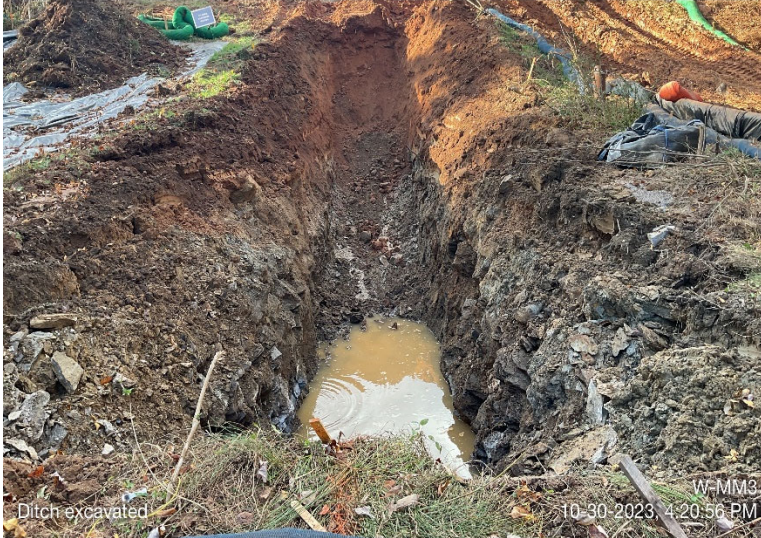
Ditch excavated

Photo Description: Excavation of the trench. The ground water was pumped to the dewatering structure.

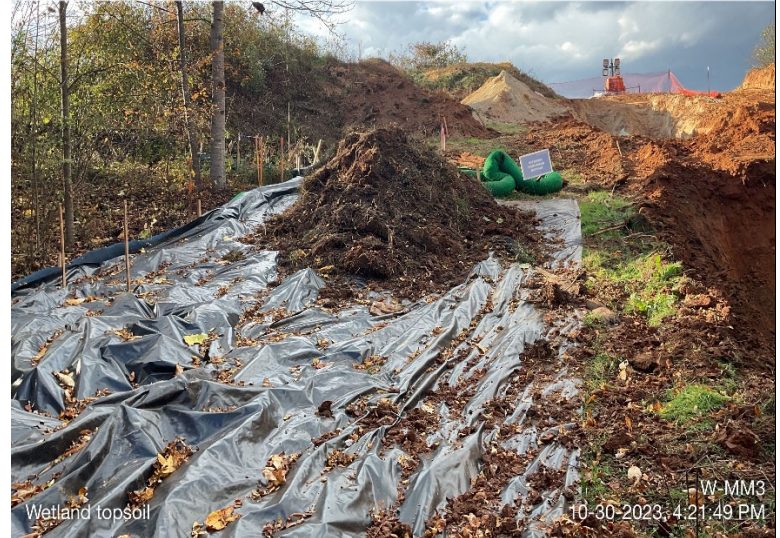
Wetland topsoil

Photo Description: Wetland topsoil was stockpiled and segregated from other soil with a barrier.

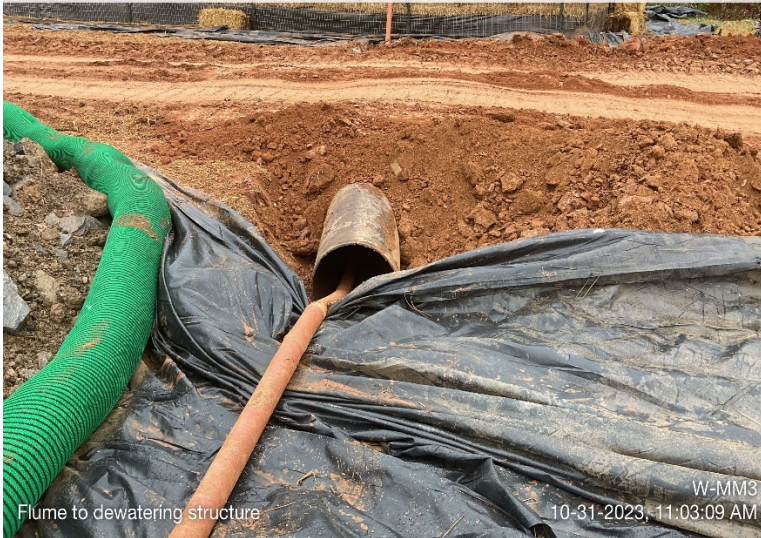
Flume to dewatering structure

Photo Description: The flume is transporting ground water from the trench to the dewatering structure.

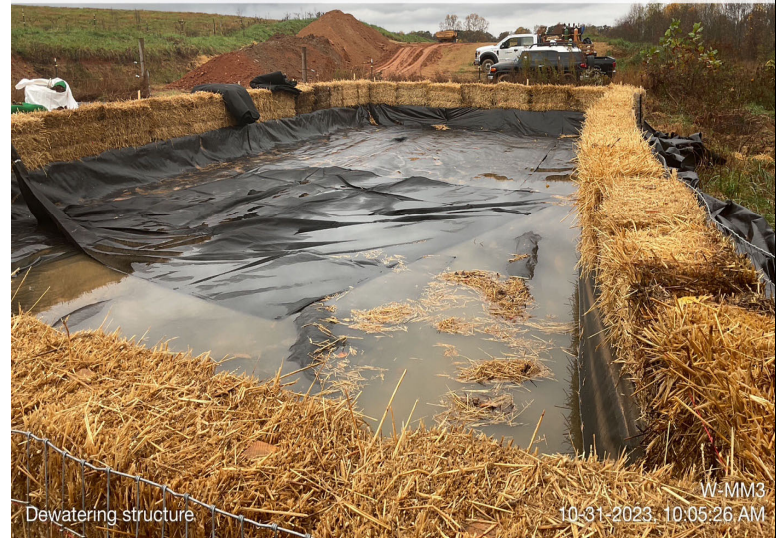
Dewatering structure

Photo Description: An overview of the dewatering structure.
