WETLAND BIOLOGICAL CONDITIONS ENVIRONMENTAL AUDITOR REPORT

Wetland ID: W-MM8-PEM	Crossing Start Date: 11/15/2023	Crossing Completion Date: 11/20/2023
Milepost: 294.9	Pre-Con Assessment Date: 11/11/2023	Post-Con Assessment Date: 11/22/2023
Station: 15598+05	Cowardin Classification: PEM (PEM, PFO, PSS, POW)	Wetland Impact Area (sq ft.): 2408.87
County: Pittsylvania

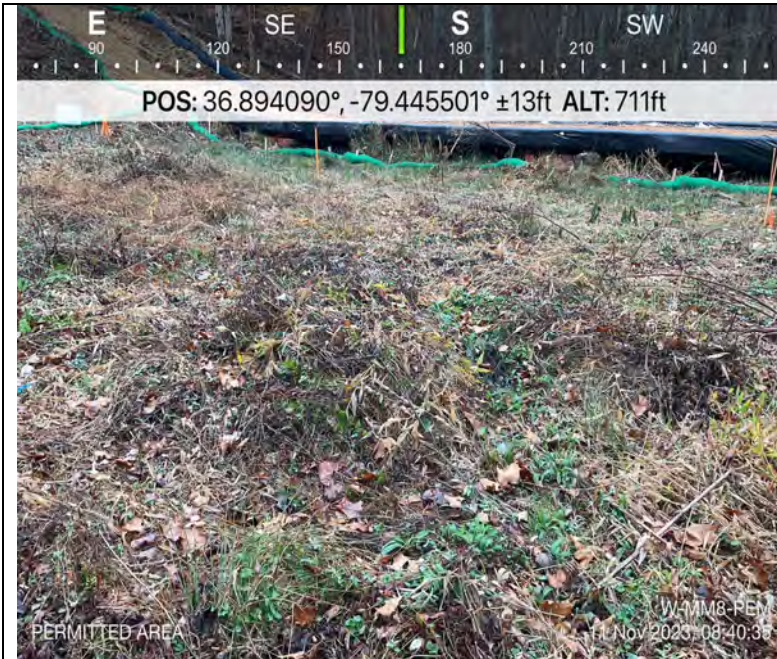
Photo Description: View of permitted resource impact area during pre-construction assessment.

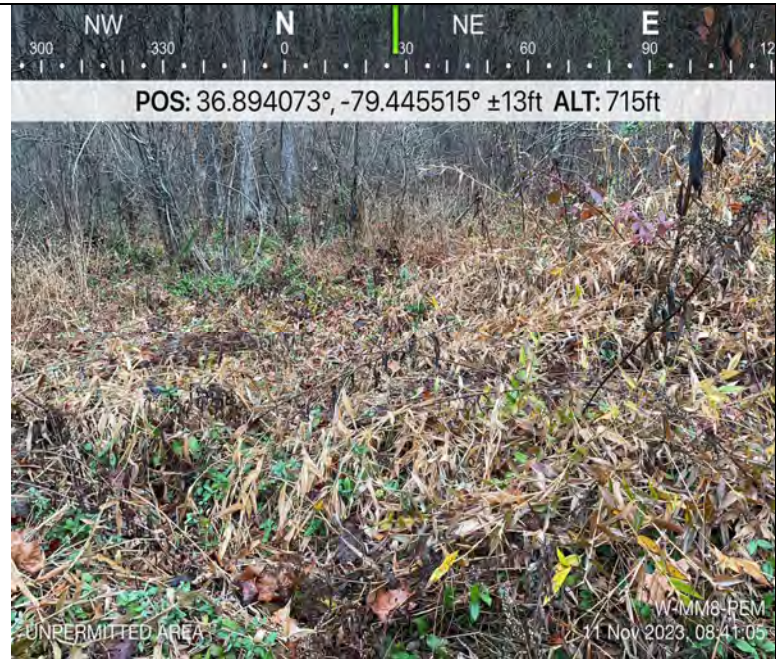
Photo Description: At edge of LOD, view of unpermitted resource area conditions during pre-construction assessment.

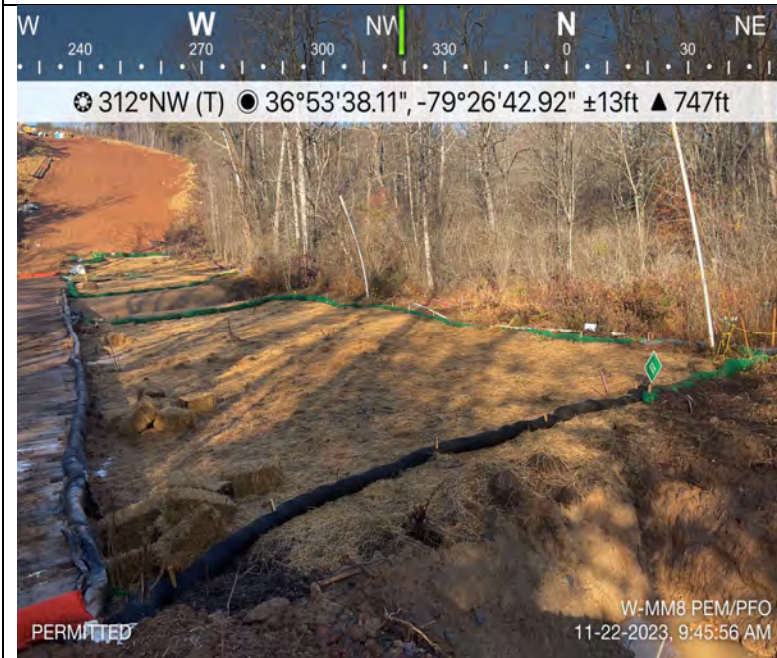
Photo Description: View of permitted resource impact area during post-construction assessment.

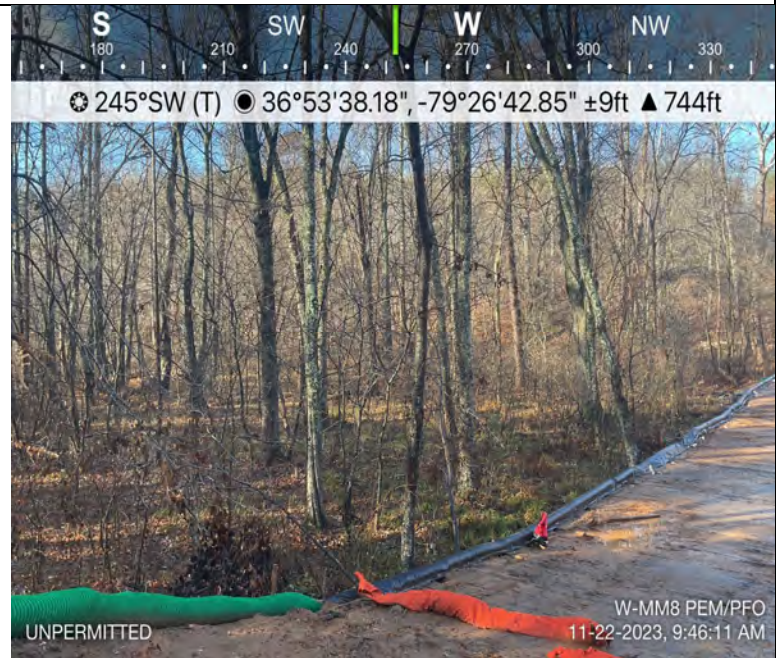
Photo Description: At edge of LOD, view of unpermitted resource area conditions during post-construction assessment.

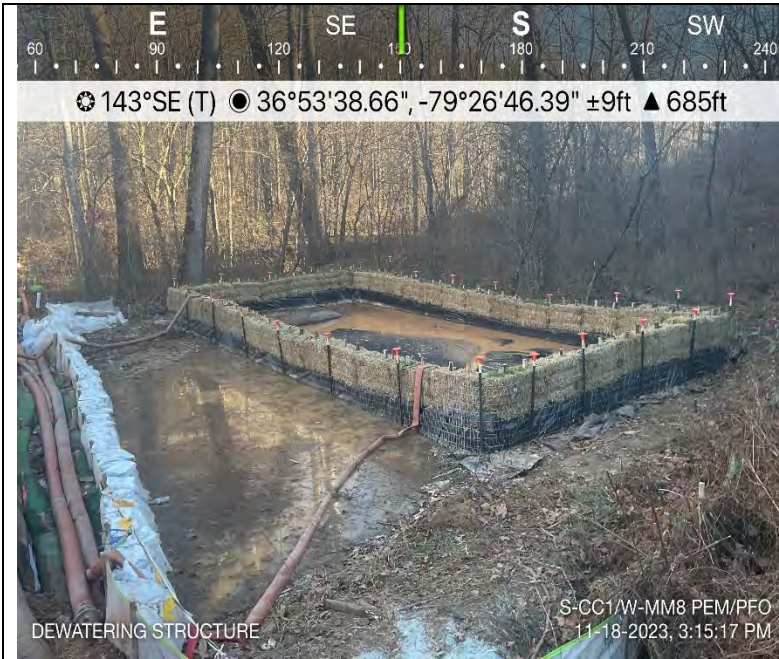
Photo Description: Dewatering structure installed and operational throughout crossing.

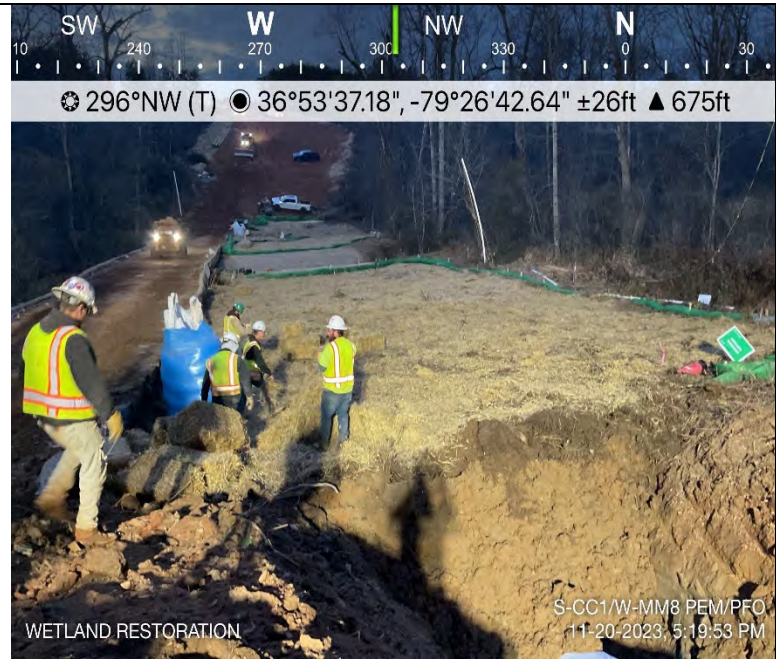
Photo Description: Restoration of seed and straw to the wetland impact area.

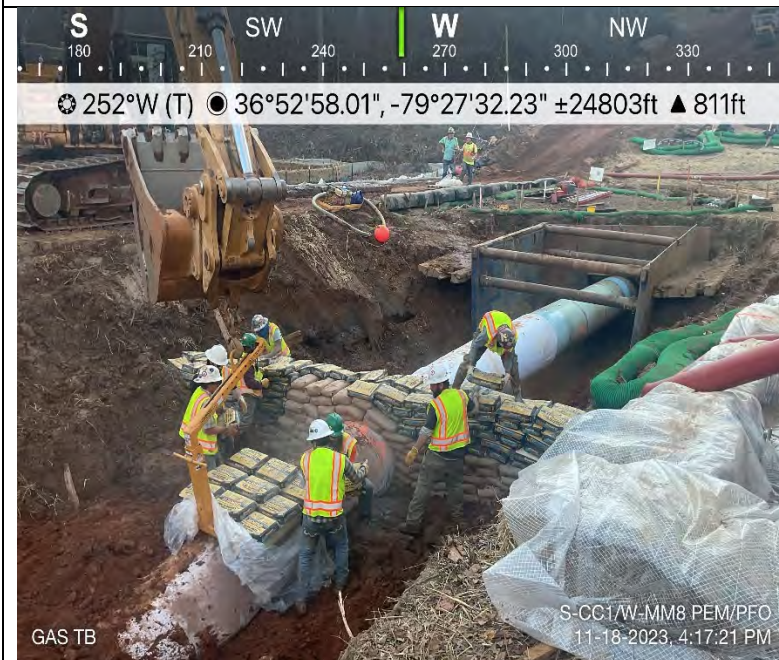
Photo Description: Trenchbreaker installation on the going away side of the resource.

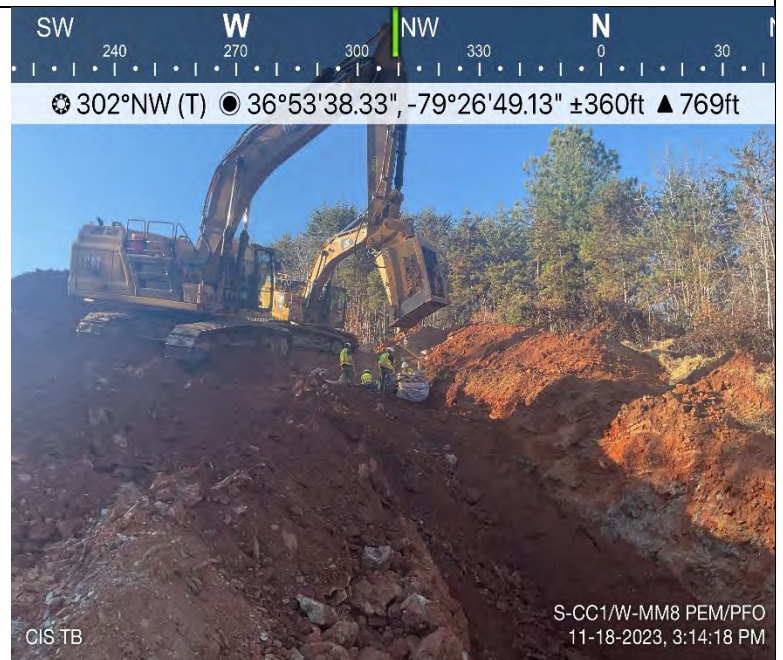
Photo Description: Trenchbreaker installation on the coming in side of the resource, and backfill of soil with padding bucket.
