WETLAND BIOLOGICAL CONDITIONS ENVIRONMENTAL AUDITOR REPORT

Wetland ID: W-MM8-PFO	Crossing Start Date: 11/16/2023	Crossing Completion Date: 11/20/2023
Milepost: 294.9	Pre-Con Assessment Date: 11/11/2023	Post-Con Assessment Date: 11/22/2023
Station: 15596+16	Cowardin Classification: PFO (PEM, PFO, PSS, POW)	Wetland Impact Area (sq ft.): 1833.88
County: Pittsylvania

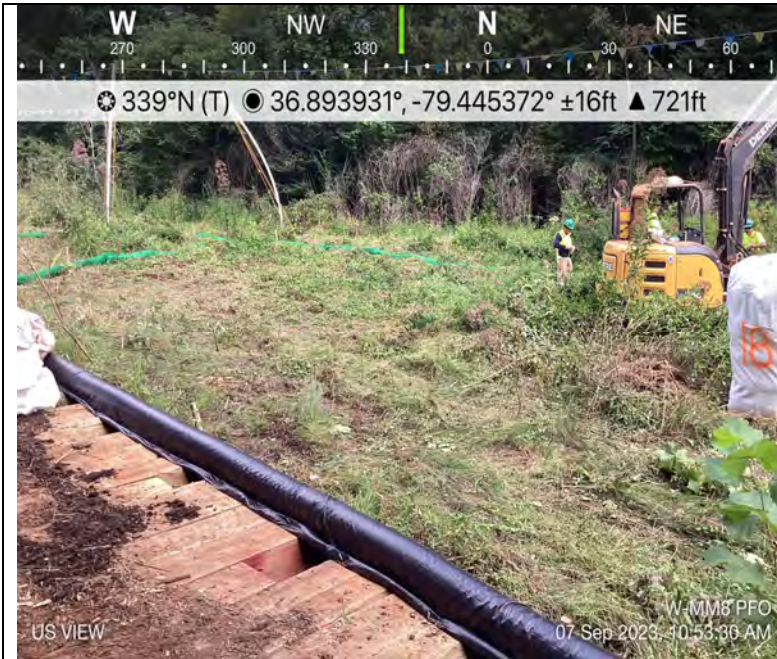
Photo Description: View of permitted resource impact area during pre-construction assessment.

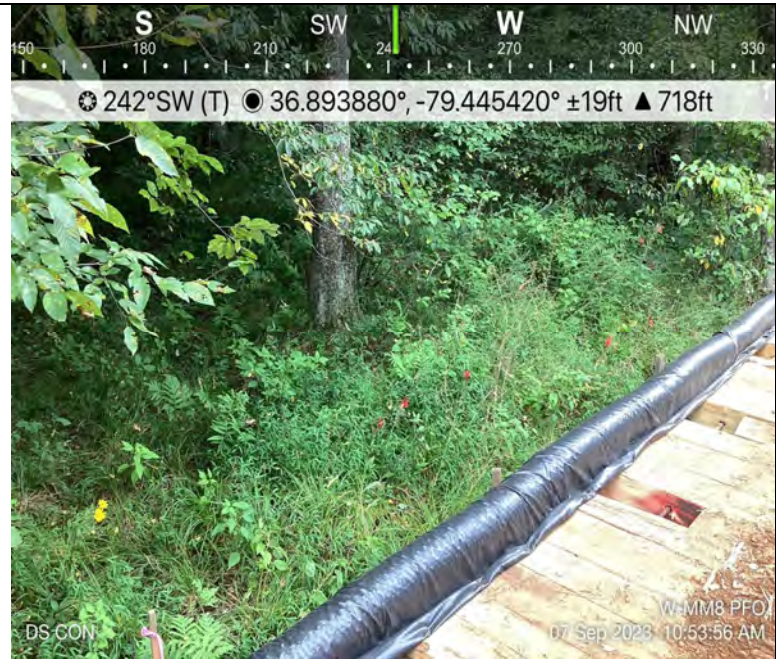
Photo Description: At edge of LOD, view of unpermitted resource area conditions during pre-construction assessment.

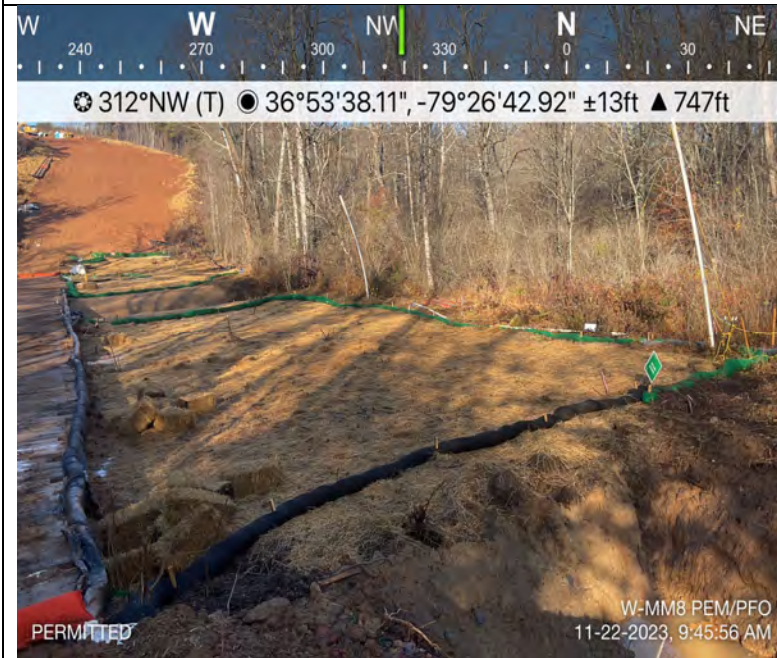
Photo Description: View of permitted resource impact area during post-construction assessment.

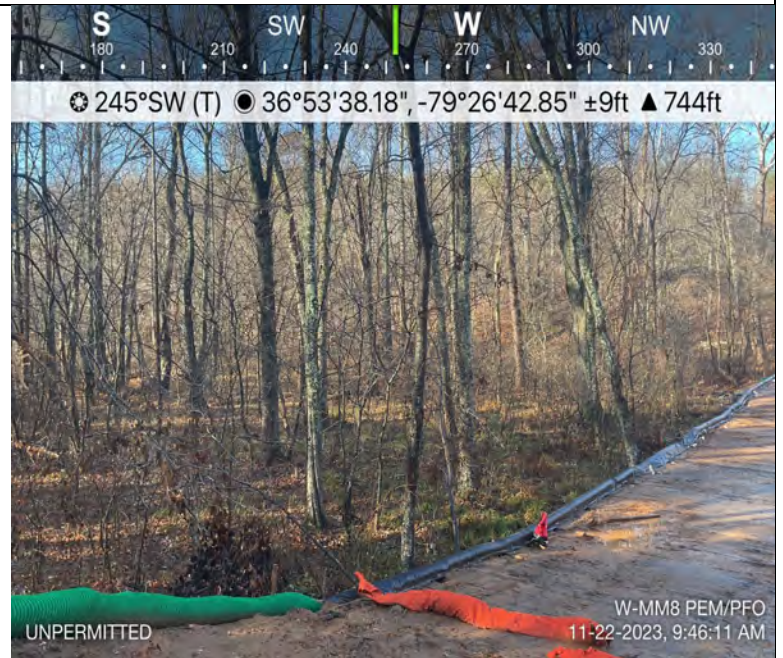
Photo Description: At edge of LOD, view of unpermitted resource area conditions during post-construction assessment.

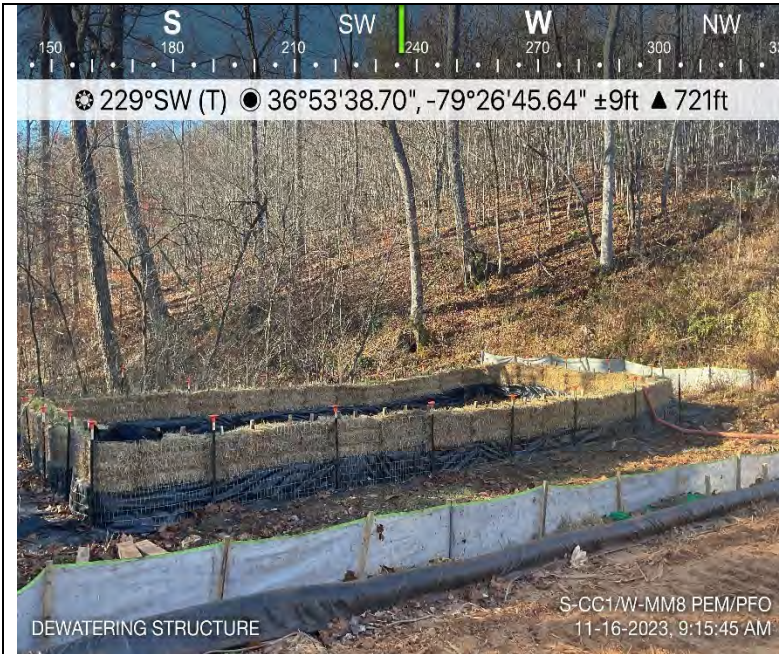
Photo Description: Dewatering structure installed and operational throughout crossing.

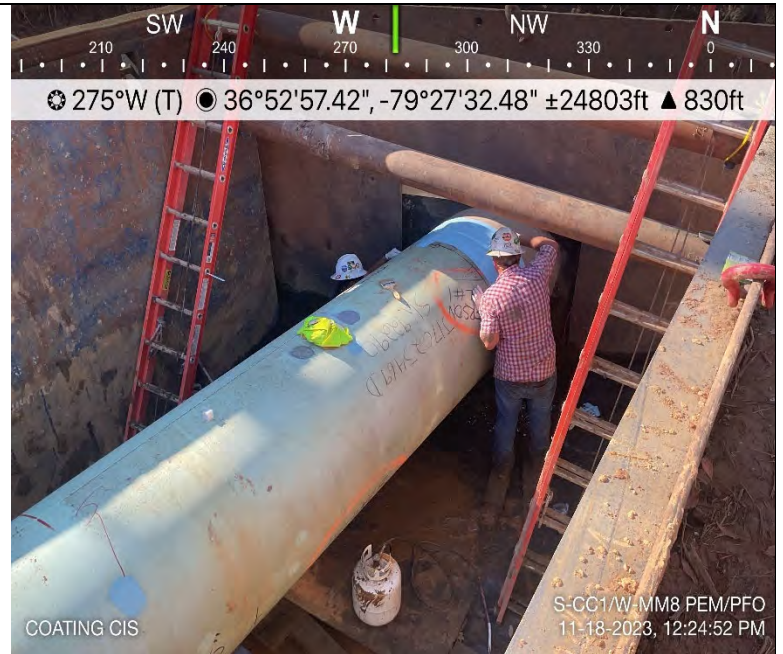
Photo Description: Coating completed for weld on coming in side of the resources after QA/QC of welds.

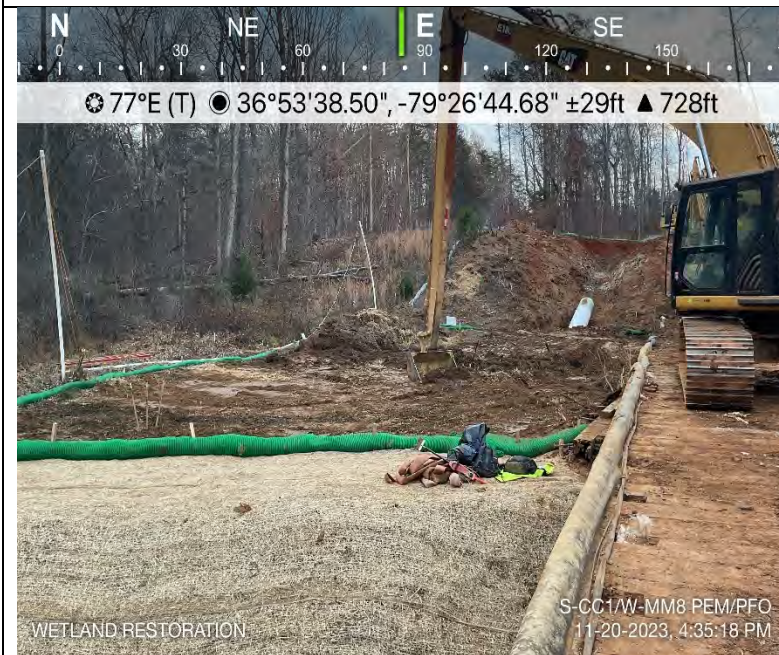
Photo Description: Restoration of soil to the wetland impact area.

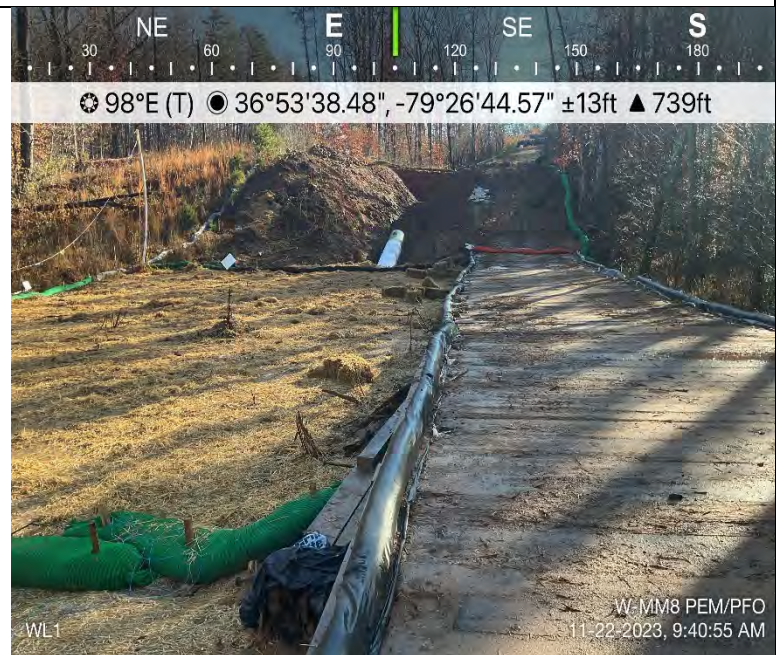
Photo Description: Conditions of wetland area post-restoration. Timber mat bridges remain installed across resources for access to upland areas for project completion.
