# WETLAND BIOLOGICAL CONDITIONS ENVIRONMENTAL AUDITOR REPORT

<b>Wetland ID:</b> W-Q1	<b>Crossing Start Date:</b> 11/29/2023	<b>Crossing Completion Date:</b> 12/01/2023
<b>Milepost:</b> 296.3	<b>Pre-Con Assessment Date:</b> 11/08/2023	<b>Post-Con Assessment Date:</b> 11/08/2023
<b>Station:</b> 15670+80	<b>Cowardin Classification:</b> PEM (PEM, PFO, PSS, POW)	<b>Wetland Impact Area (sq ft.):</b> 635.98
<b>County:</b> Pittsylvania

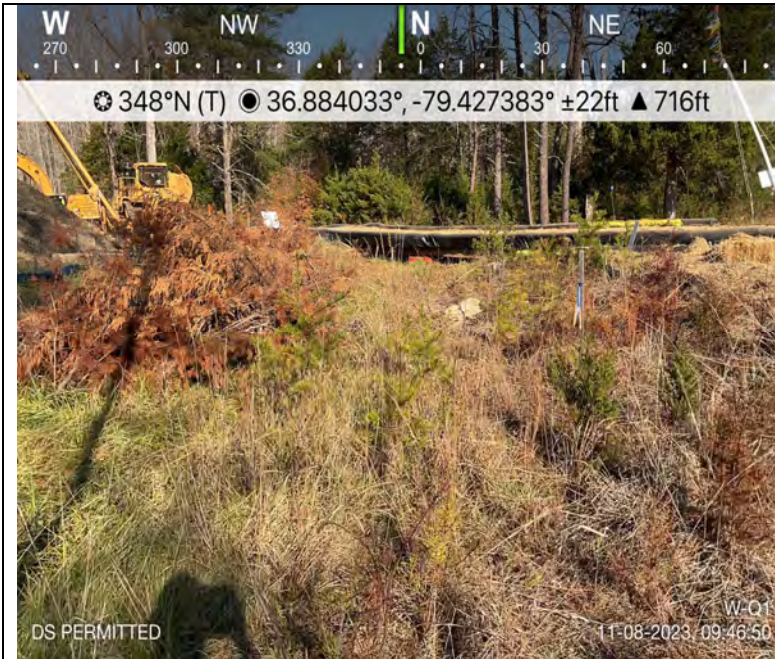
**Photo Description:** View of permitted resource impact area during pre-construction assessment.

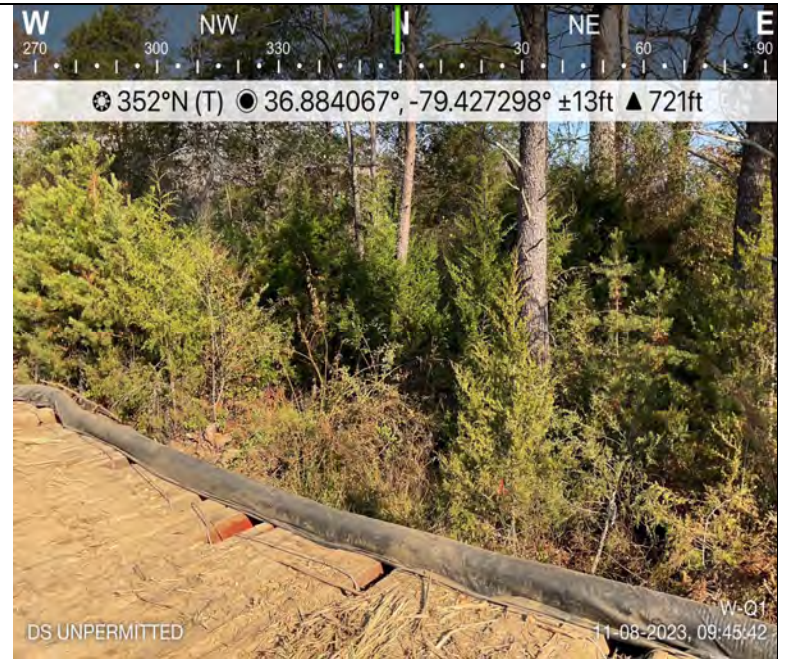
**Photo Description:** At edge of LOD, view of unpermitted resource area conditions during pre-construction assessment.

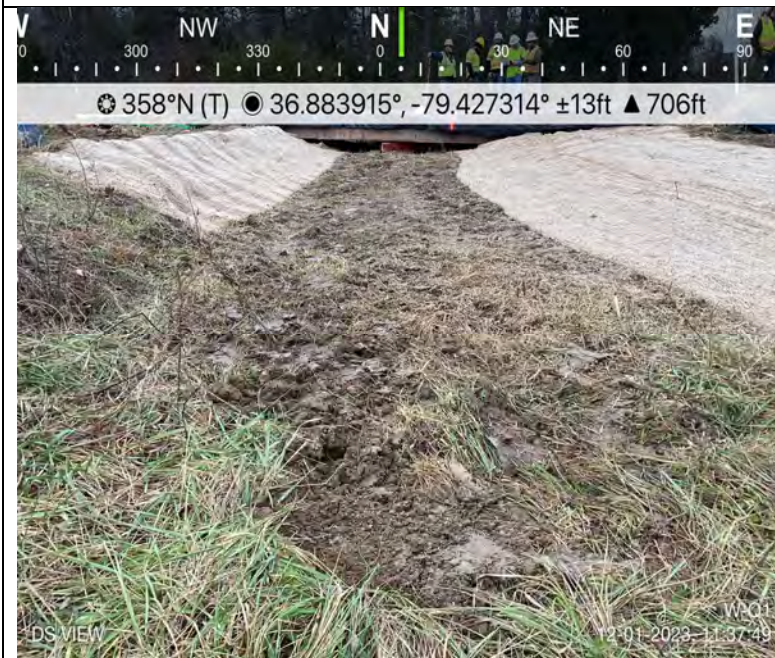
**Photo Description:** View of permitted resource impact area during post-construction assessment.

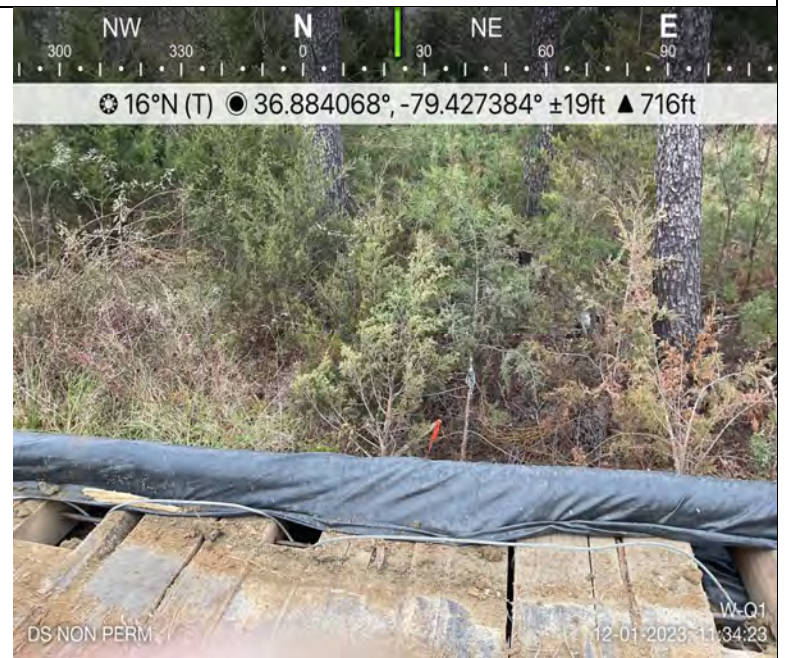
**Photo Description:** At edge of LOD, view of unpermitted resource area conditions during post-construction assessment.

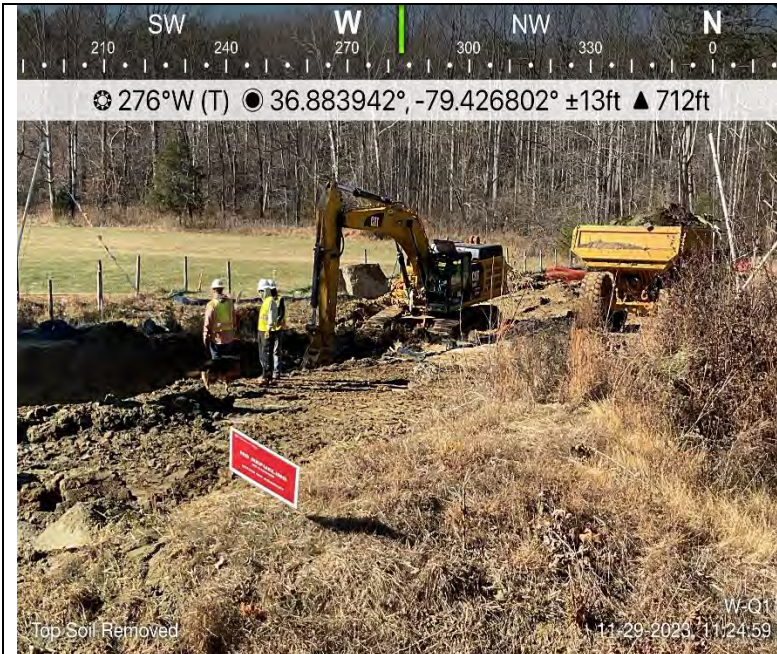
**Photo Description:** Topsoil being excavated from the trench.

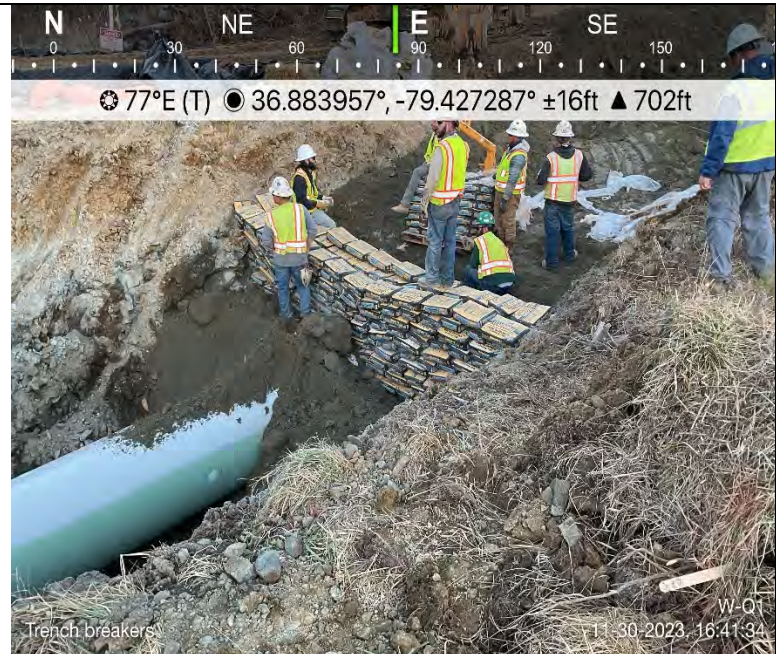
**Photo Description:** A trench breaker being installed within the trench.

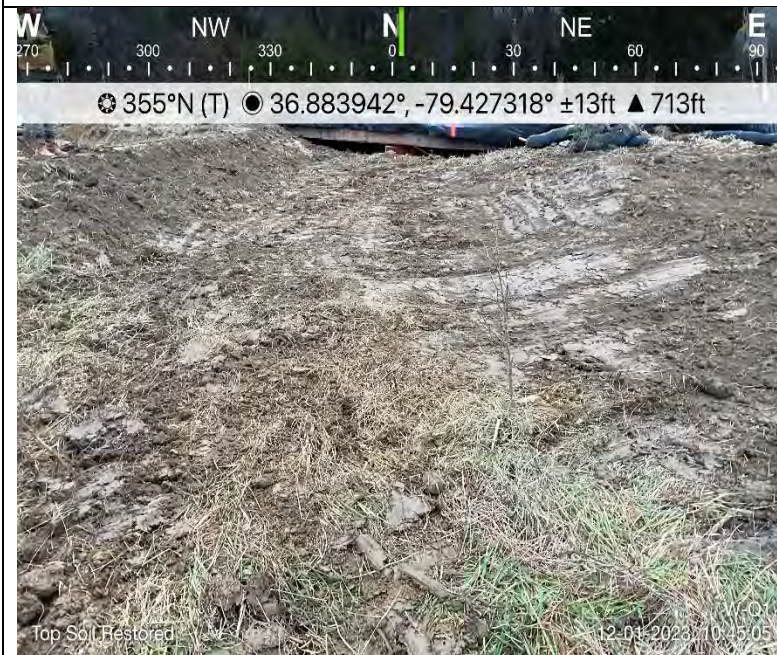
**Photo Description:** Topsoil restored within the resource.

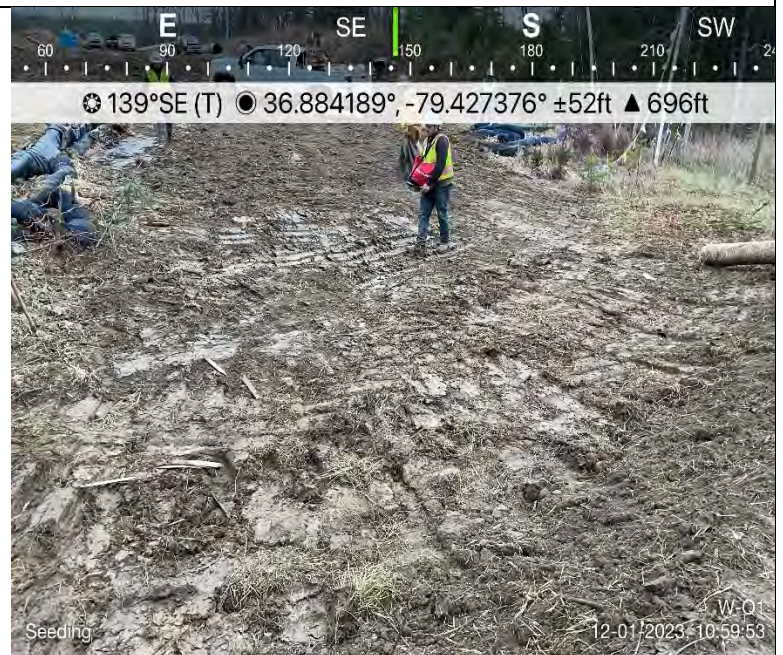
**Photo Description:** Seed being applied after restoration of the topsoil.
