**Mountain Valley Pipeline Project
Environmental Auditor
Quarterly Reports for Q4 2023
January 15, 2024**

Mountain Valley Pipeline Project – Spread G

Environmental Auditor Quarterly Report for Q4 2023

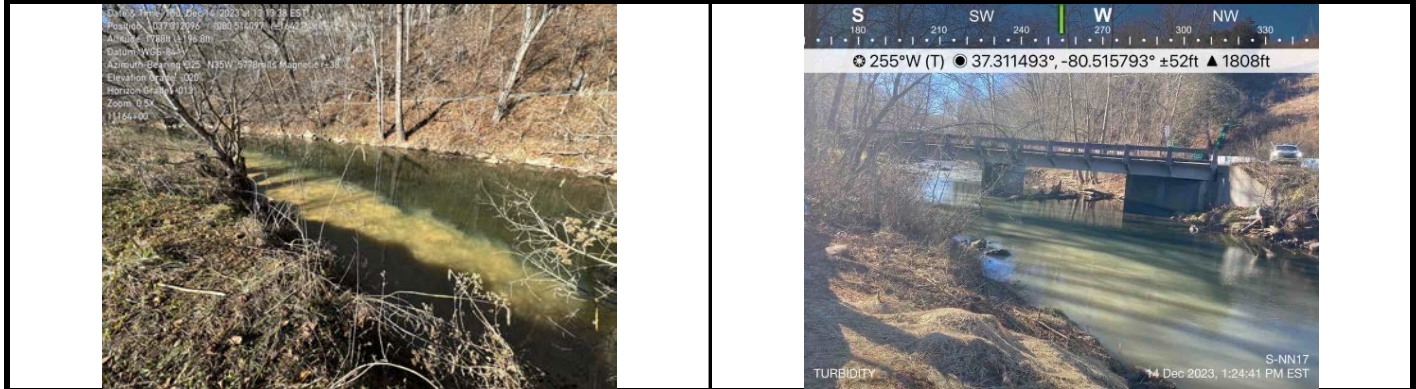
GPS Location	See Photo	GPS Location	See Photo
Field Station#	11158+68	Field Station#	11158+68

AFE	124300137	Date/Time	12/14/2023 2:38 PM	Report #	784
Waterbody/wetland affected			Yes		
If yes, name of waterbody/wetland affected			Sinking Creek S-NN17		
If no, distance to nearest waterbody/wetland					
Description of Corrective Actions			<p>Incorrect filter was installed in the filtration system pods causing water to bypass filtration process before being released into dewatering structure. This resulted in muddy/turbid water reaching the stream S-NN17 causing the sediment impact.</p> <p>EI on site notified crew of Impact and issued a stop work until a solution to the issue was found.</p> <p>Crews plan to insert correct filters and resume pumping.</p>		
Date Corrective Actions Started			12/14/2023		
Completed by MVP Environmental Coordinator					
Additional Corrective Actions					
Date Corrective Actions Completed					
Date Agency Response Completed

Pic 1 Desc.	Stream impact	Pic 2 Desc.	Stream impact
--------------------	---------------	--------------------	---------------

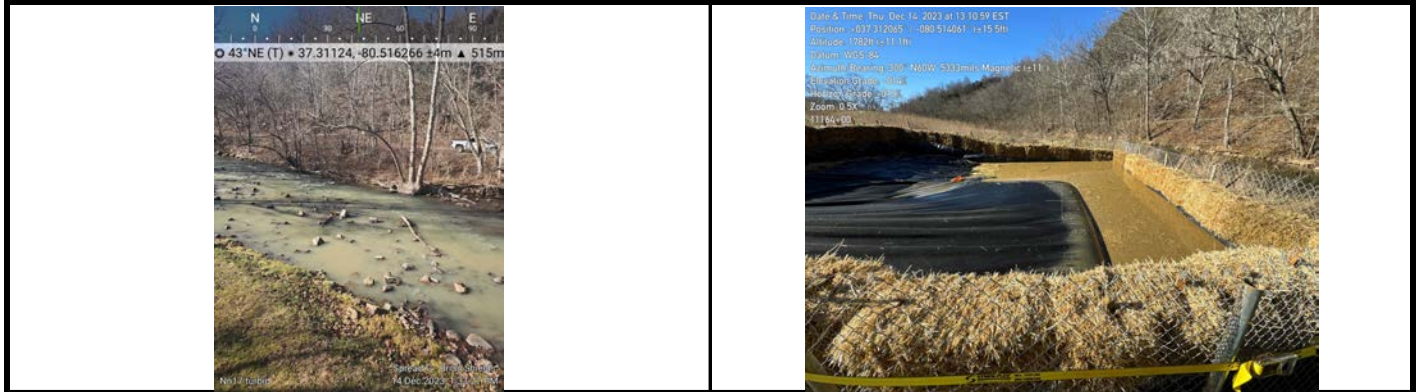
GPS Location	See Photo	GPS Location	See Photo
Field Station#	11158+68	Field Station#	11158+68

Pic 3 Desc.	Entire Stream impacted	Pic 4 Desc.	Turbid water being pumped to dewatering structure
--------------------	------------------------	--------------------	---

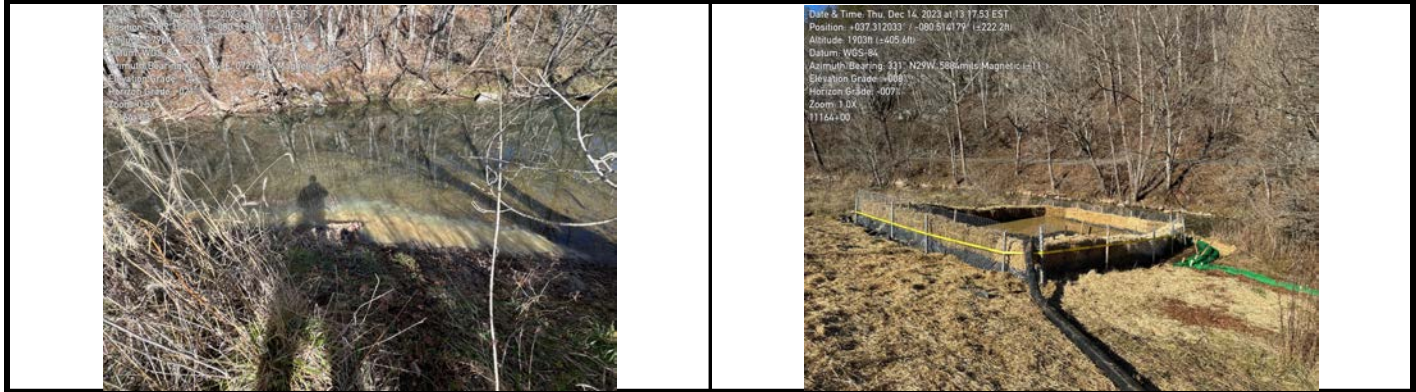
GPS Location	See Photo	GPS Location	See Photo
Field Station#	11158+68	Field Station#	11158+68

Pic 5 Desc.	Turbid water entering stream	Pic 6 Desc.	Dewatering structure
--------------------	------------------------------	--------------------	----------------------
