# STREAM BIOLOGICAL CONDITIONS ENVIRONMENTAL AUDITOR REPORT

<b>Stream ID:</b> S-A19-H26	<b>Crossing Start Date:</b> 12/29/2023	<b>Crossing Completion Date:</b> 01/09/2024
<b>Milepost:</b> 278.8	<b>Pre-Con Assessment Date:</b> 12/22/2023	<b>Post-Con Assessment Date:</b> 01/11/2024
<b>Station:</b> 14727+62	<b>Stream Classification:</b> Intermittent (Perennial, Intermittent, Ephemeral)	<b>Bankfull Width (ft.):</b> 7
<b>County:</b> Franklin	<b>303(d) Impairment Listing:</b> Not Impaired	<b>Riffle:Pool Complexes Present?</b> No

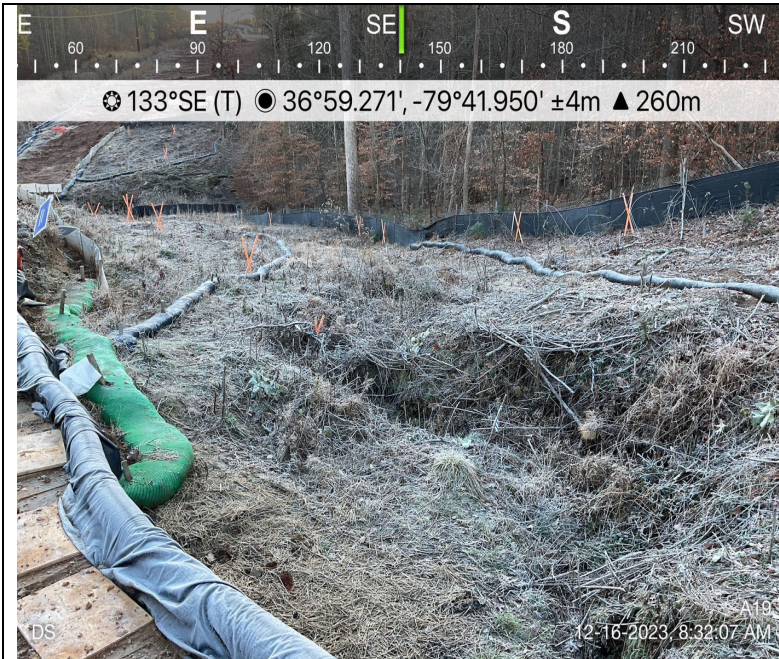
**Photo Description:** Downstream view of permitted impact area during pre-construction assessment.

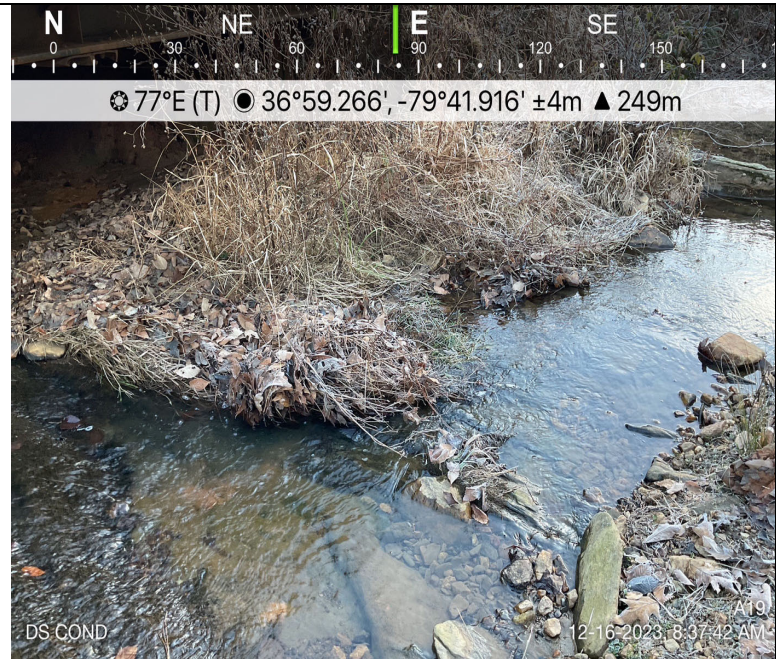
**Photo Description:** Conditions of the downstream area outside the ROW during pre-construction assessment. S-A19-H26 converges with S-A20 within the permitted impact area.

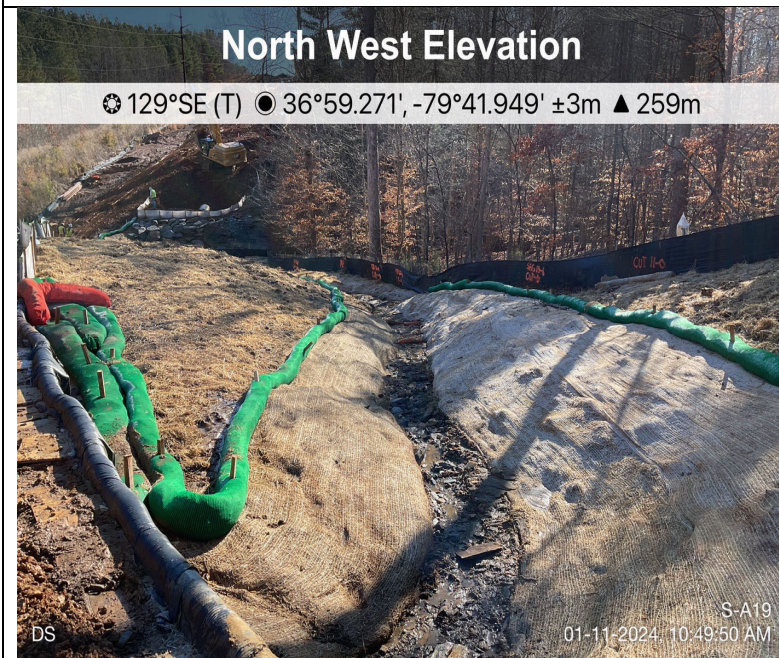
**Photo Description:** Downstream view of permitted impact area during post-construction assessment.

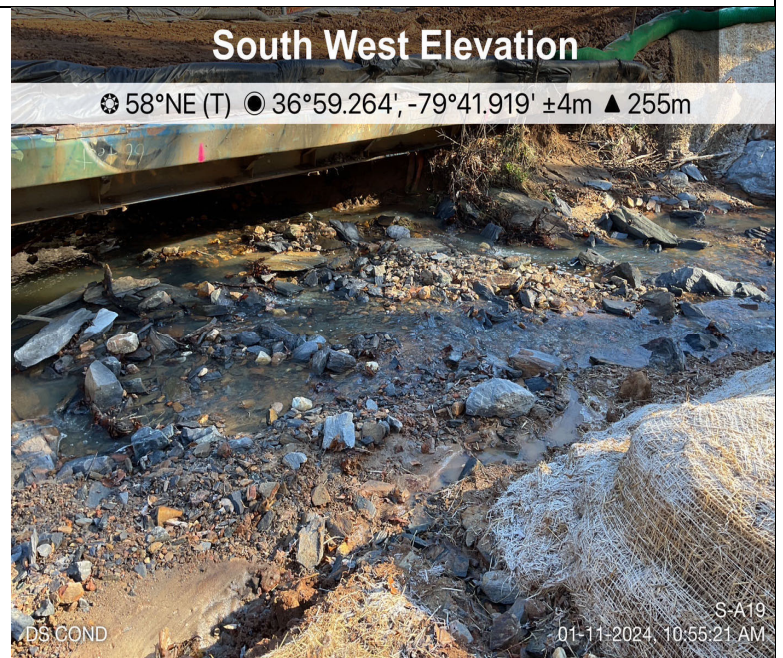
**Photo Description:** Conditions of the downstream area outside the ROW during post-construction assessment. S-A19-H26 converges with S-A20 within the permitted impact area.

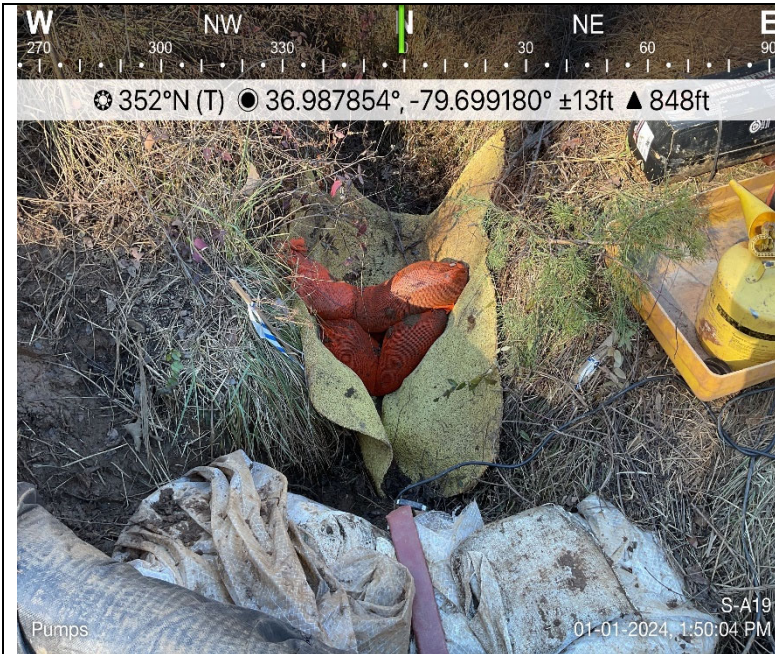
**Photo Description:** The dam was installed and the pump around was functioning as designed.

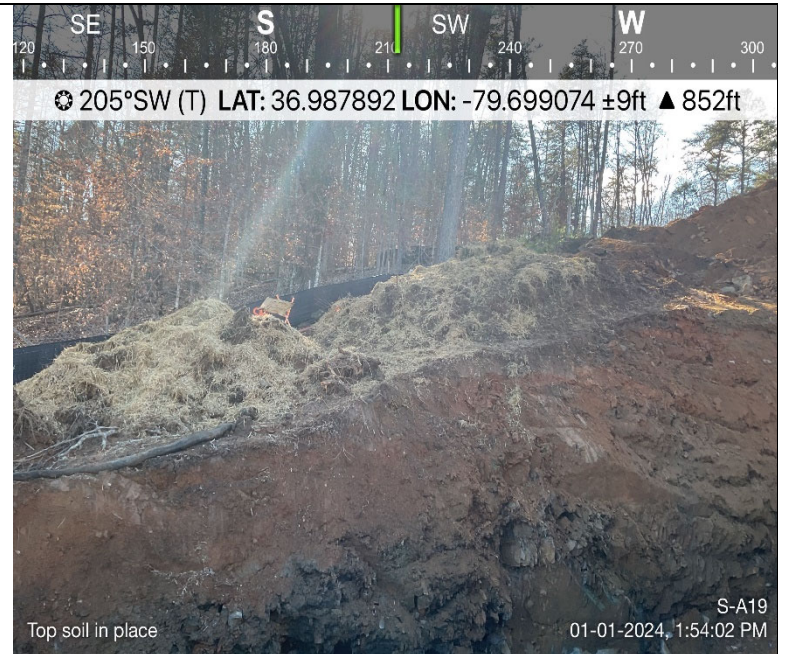
**Photo Description:** The topsoil was stockpiled and stabilized with straw mulch.

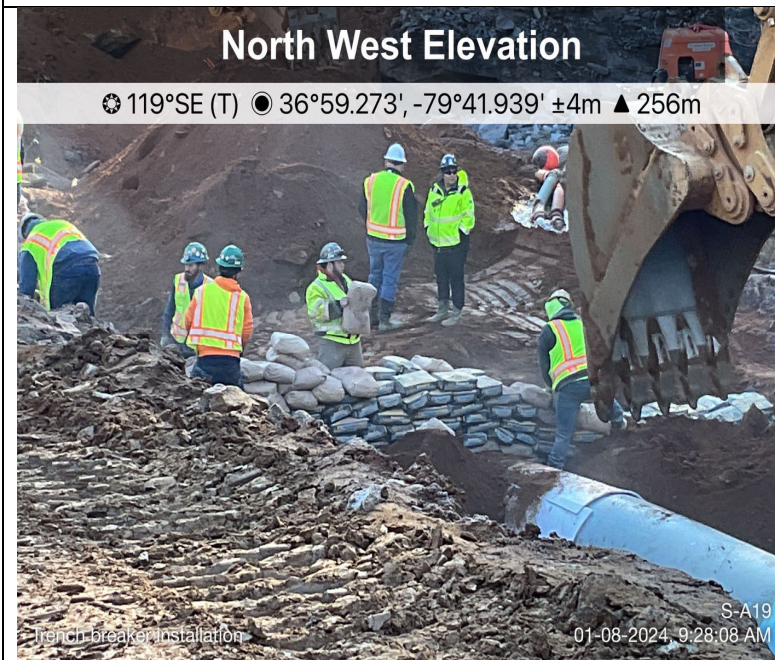
**Photo Description:** Trench breaker installation.

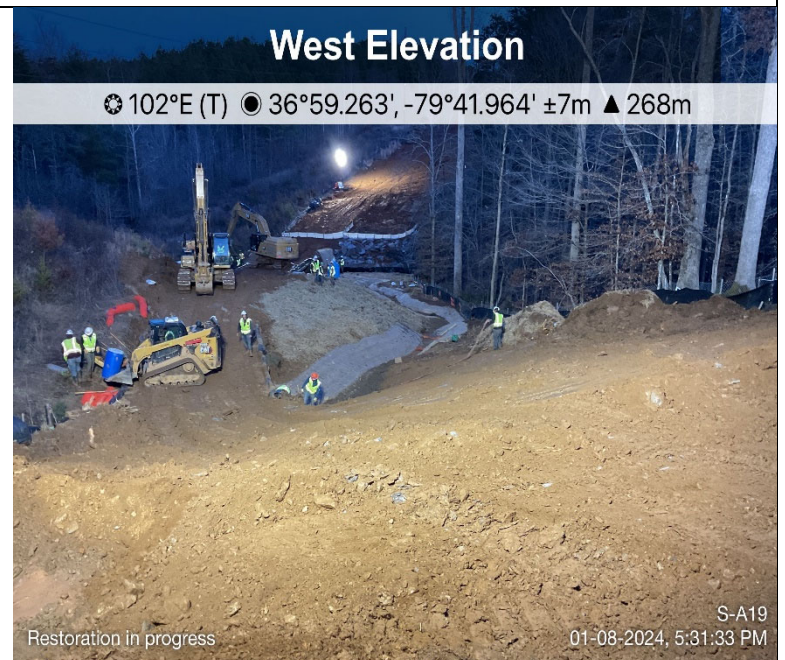
**Photo Description:** An overview of the site restoration. Crews installing new ESCs, applying riparian seed, stabilization matting, and straw.
