STREAM BIOLOGICAL CONDITIONS ENVIRONMENTAL AUDITOR REPORT

Stream ID: S-A20	Crossing Start Date: 01/02/2024	Crossing Completion Date: 01/09/2024
Milepost: 278.8	Pre-Con Assessment Date: 01/02/2024	Post-Con Assessment Date: 01/11/2024
Station: 14729+62	Stream Classification: Perennial (Perennial, Intermittent, Ephemeral)	Bankfull Width (ft.): 7
County: Franklin	303(d) Impairment Listing: Not Impaired	Riffle:Pool Complexes Present? No

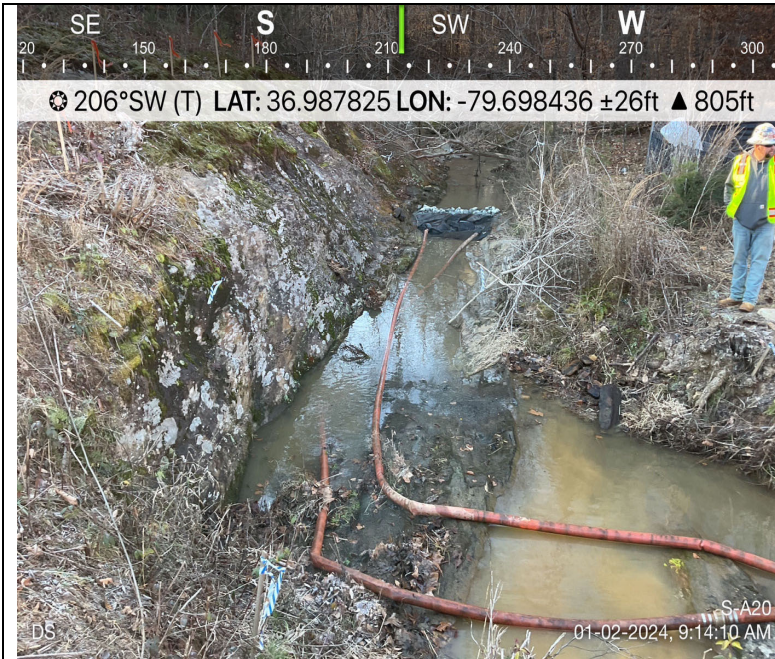
Photo Description: Downstream view of permitted impact area during pre-construction assessment.

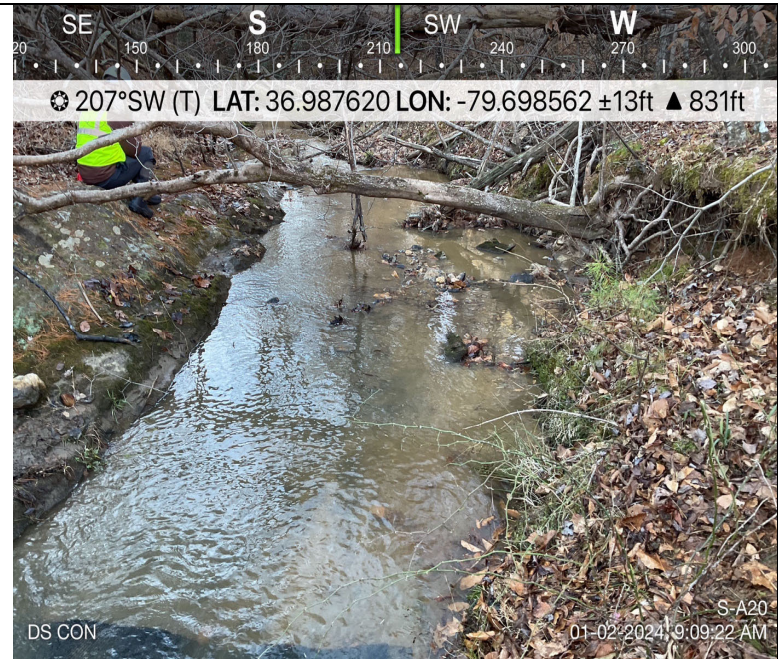
Photo Description: Conditions of the downstream area outside the ROW during pre-construction assessment.

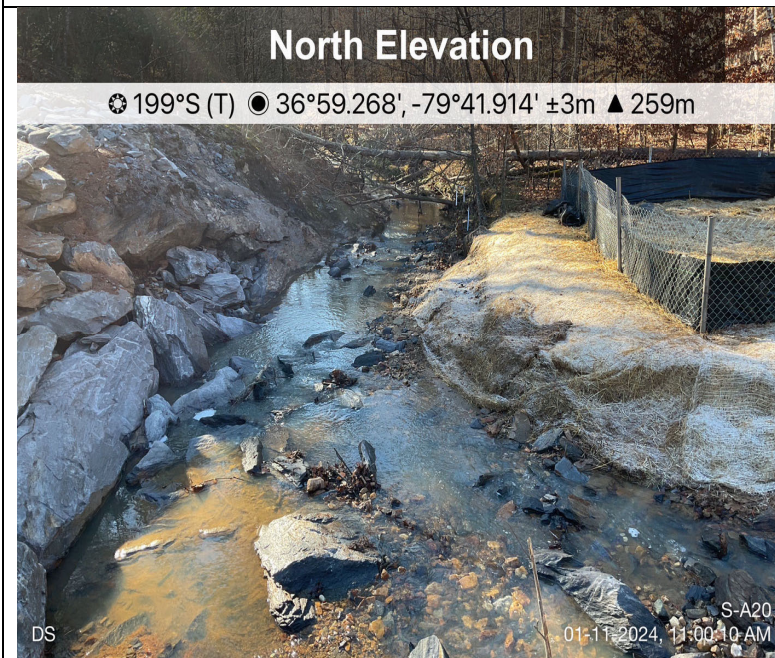
Photo Description: Downstream view of permitted impact area during post-construction assessment.

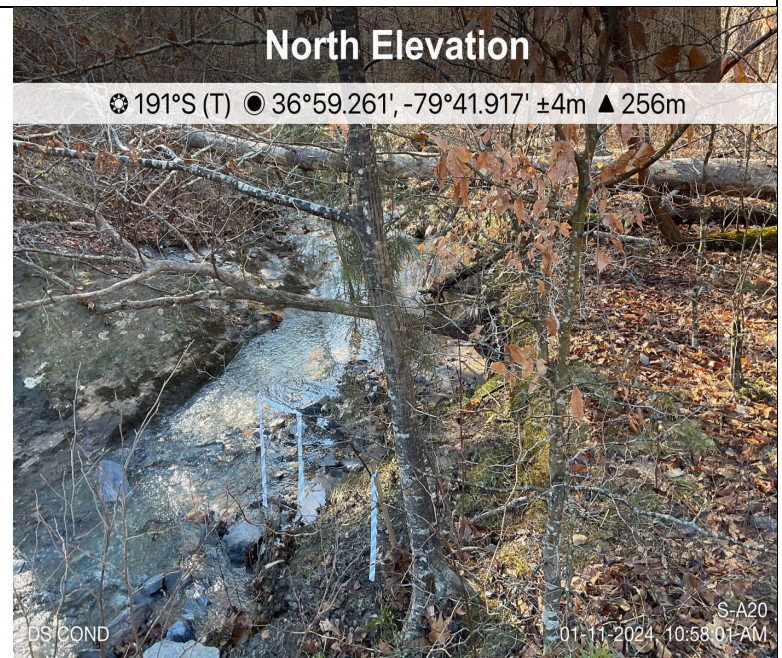
Photo Description: Conditions of the downstream area outside the ROW during post-construction assessment.

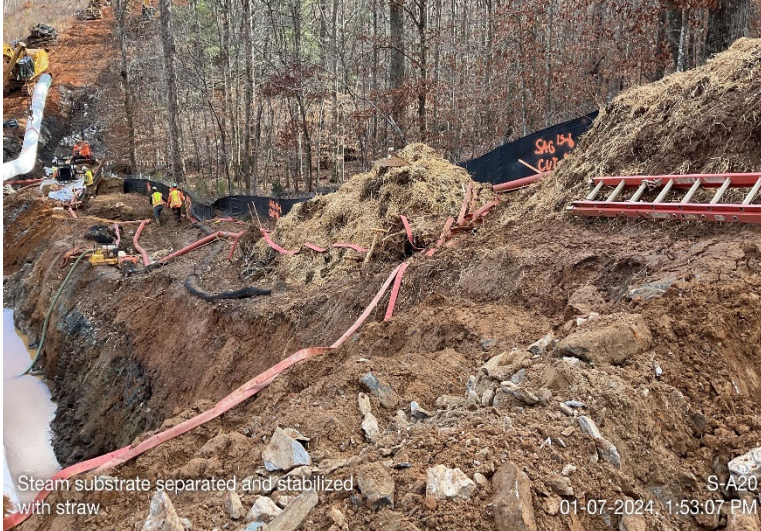
Stream substrate separated and stabilized with straw

Photo Description: The stream substrate was excavated, segregated, stockpiled, and stabilized with straw mulch.

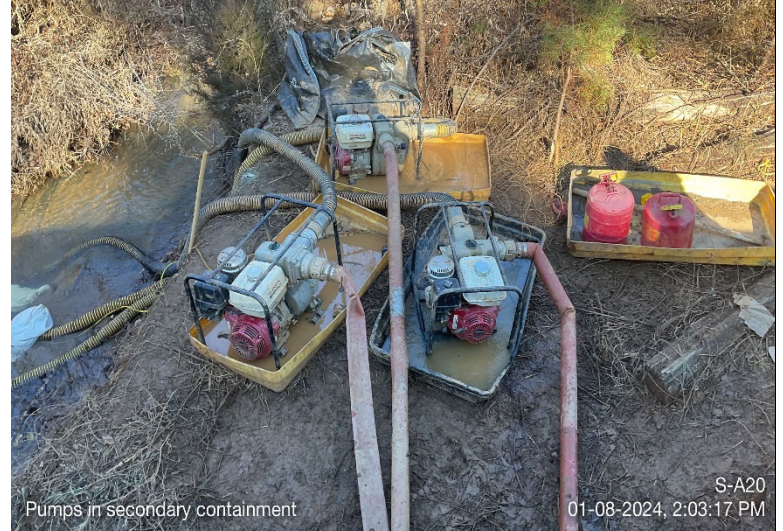
Pumps in secondary containment

Photo Description: The pumps utilized for the pump around were placed in secondary containment.

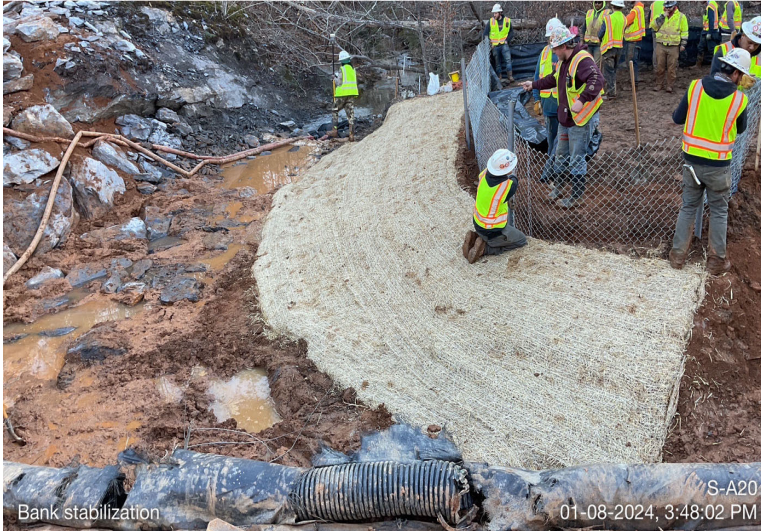
Bank stabilization

Photo Description: Straw matting was installed to stabilize the stream banks.

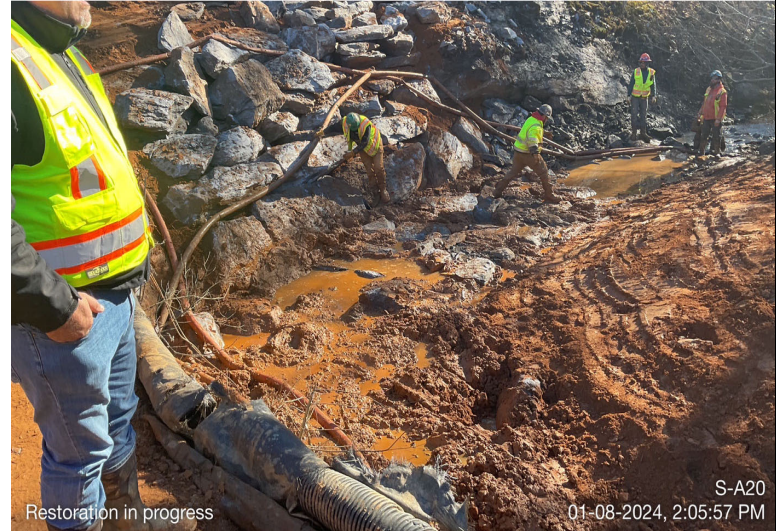
Restoration in progress

Photo Description: Restoration of the resource after pipe backfill.
