STREAM BIOLOGICAL CONDITIONS ENVIRONMENTAL AUDITOR REPORT

Stream ID: S-A33	Crossing Start Date: 11/30/2023	Crossing Completion Date: 12/22/2023
Milepost: 205.4	Pre-Con Assessment Date: 11/20/2023	Post-Con Assessment Date: 12/22/2023
Station: 10763+97	Stream Classification: Ephemeral (Perennial, Intermittent, Ephemeral)	Bankfull Width (ft.): 7
County: Giles	303(d) Impairment Listing: Not Impaired	Riffle:Pool Complexes Present? No

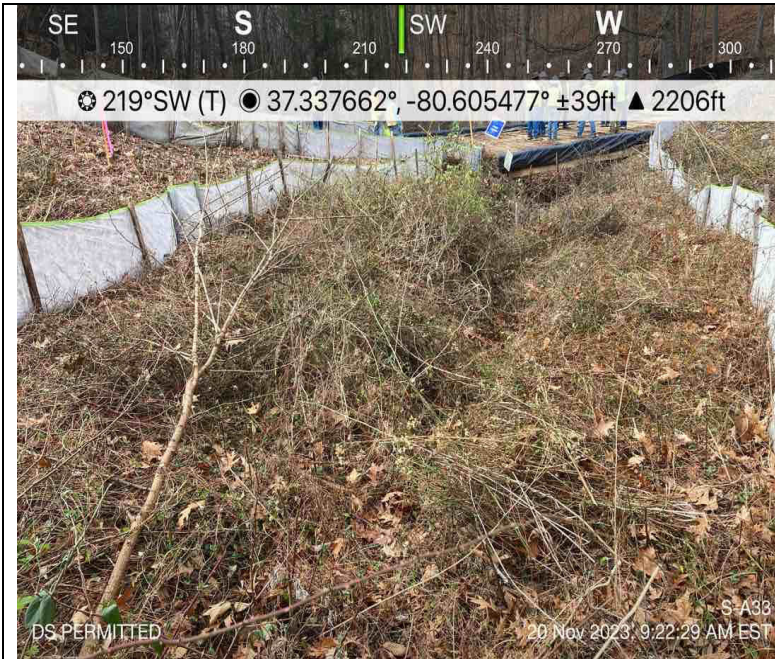
Photo Description: Downstream view of permitted impact area during pre-construction assessment.

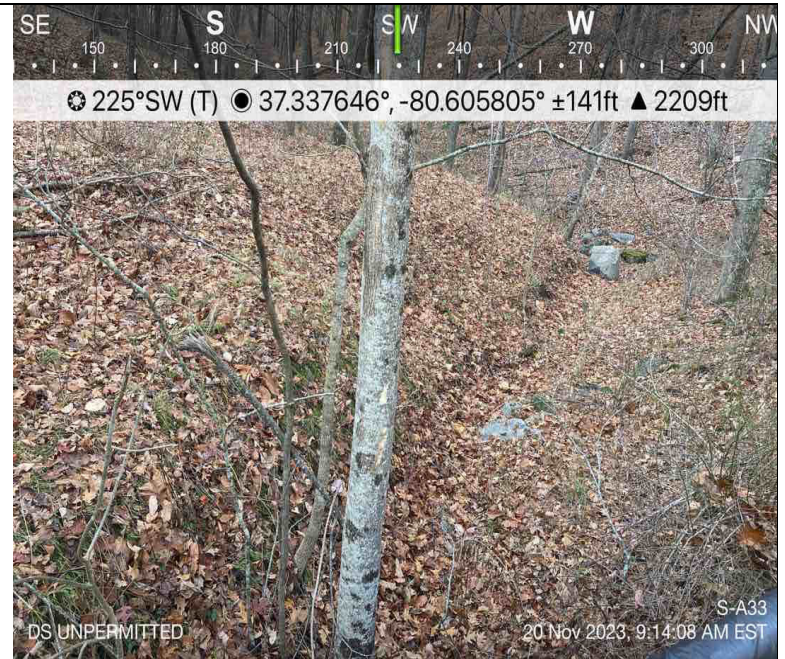
Photo Description: Conditions of the downstream area outside the ROW during pre-construction assessment.

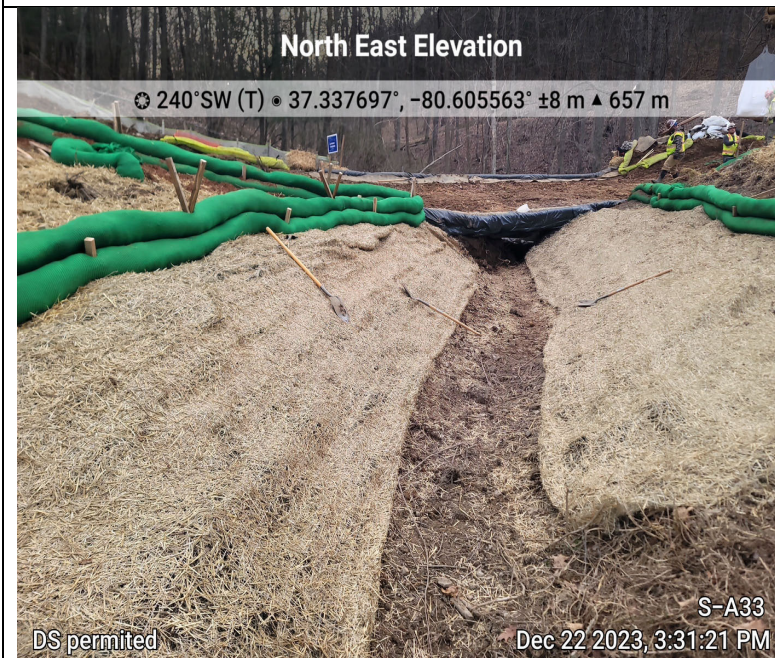
Photo Description: Downstream view of permitted impact area during post-construction assessment.

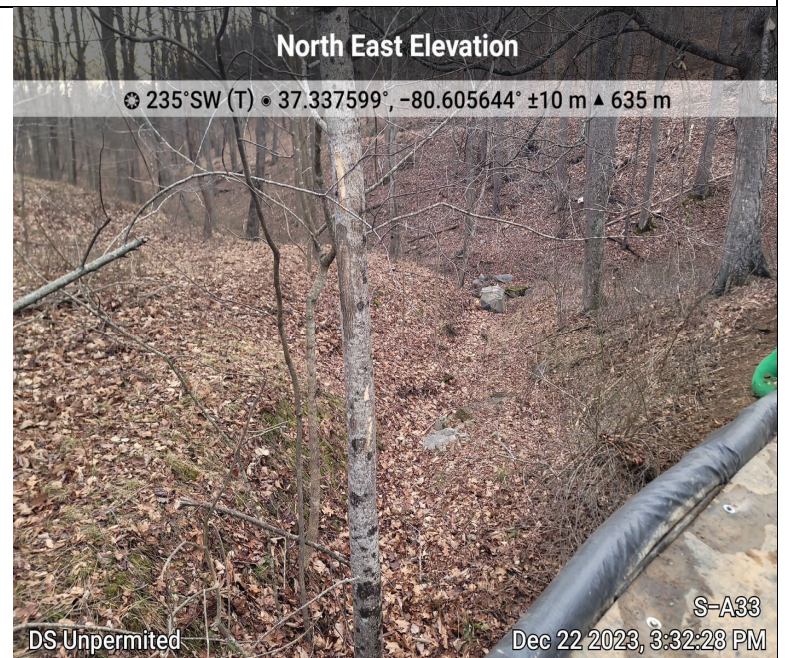
Photo Description: Conditions of the downstream area outside the ROW during post-construction assessment.

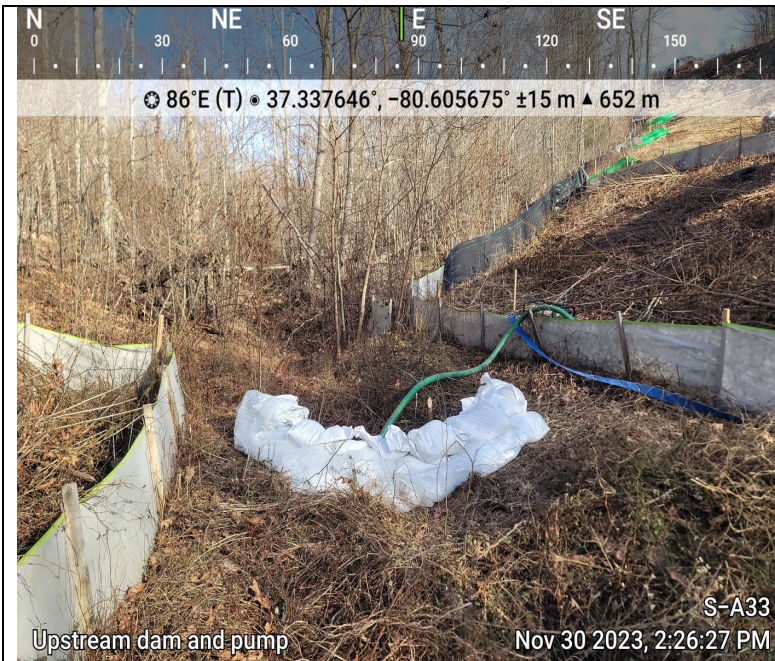
Photo Description: Dam and pump installed and operational throughout crossing.

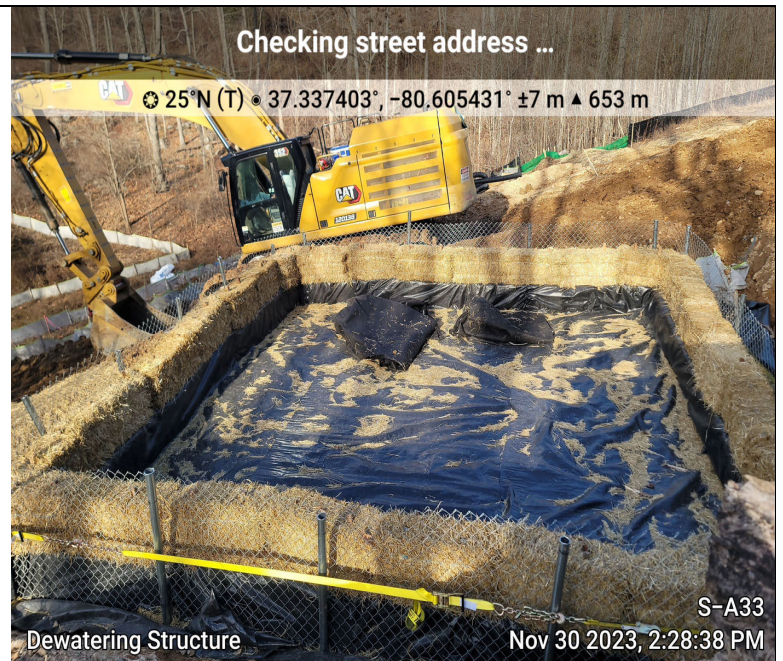
Photo Description: Dewatering structure installed and available throughout crossing.

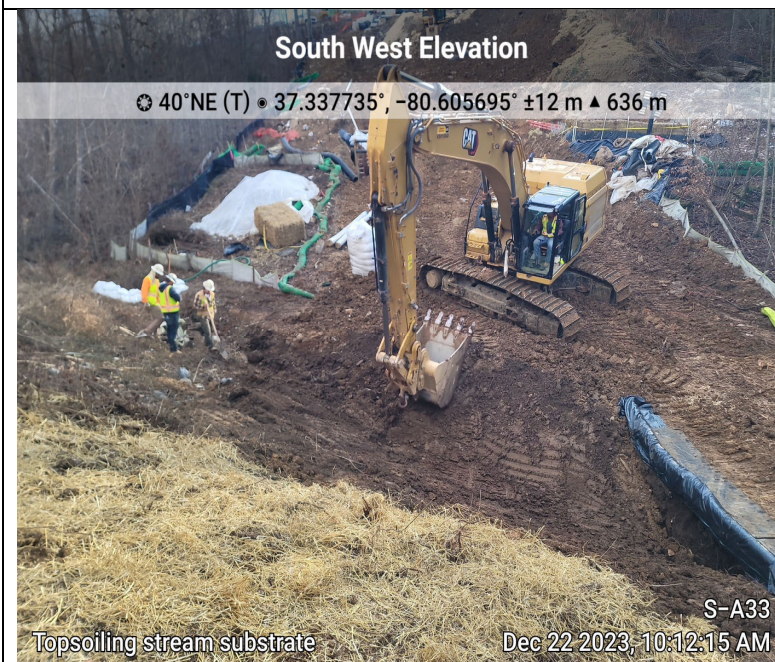
Photo Description: Stream substrate restoration with survey team on-site.

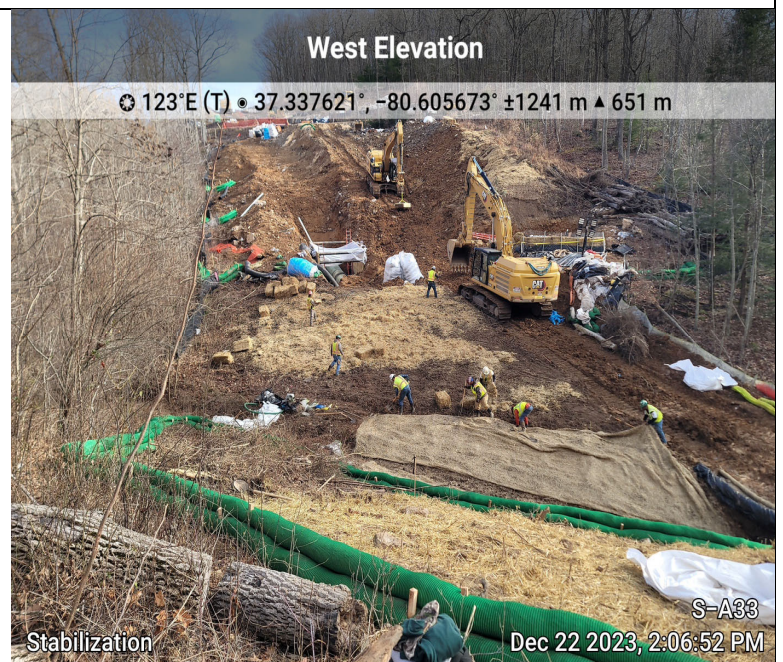
Photo Description: Stabilization applied by environmental crews.
