# STREAM BIOLOGICAL CONDITIONS ENVIRONMENTAL AUDITOR REPORT

<b>Stream ID:</b> S-A34	<b>Crossing Start Date:</b> 11/30/2023	<b>Crossing Completion Date:</b> 12/22/2023
<b>Milepost:</b> 205.4	<b>Pre-Con Assessment Date:</b> 11/20/2023	<b>Post-Con Assessment Date:</b> 12/22/2023
<b>Station:</b> 10762+63	<b>Stream Classification:</b> Ephemeral (Perennial, Intermittent, Ephemeral)	<b>Bankfull Width (ft.):</b> 7
<b>County:</b> Giles	<b>303(d) Impairment Listing:</b> Not Impaired	<b>Riffle:Pool Complexes Present?</b> No

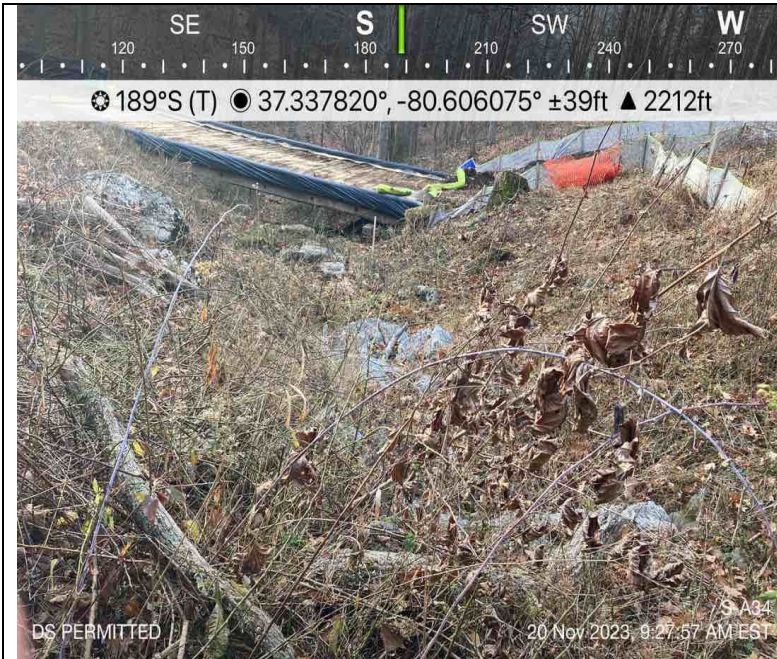
**Photo Description:** Downstream view of permitted impact area during pre-construction assessment.

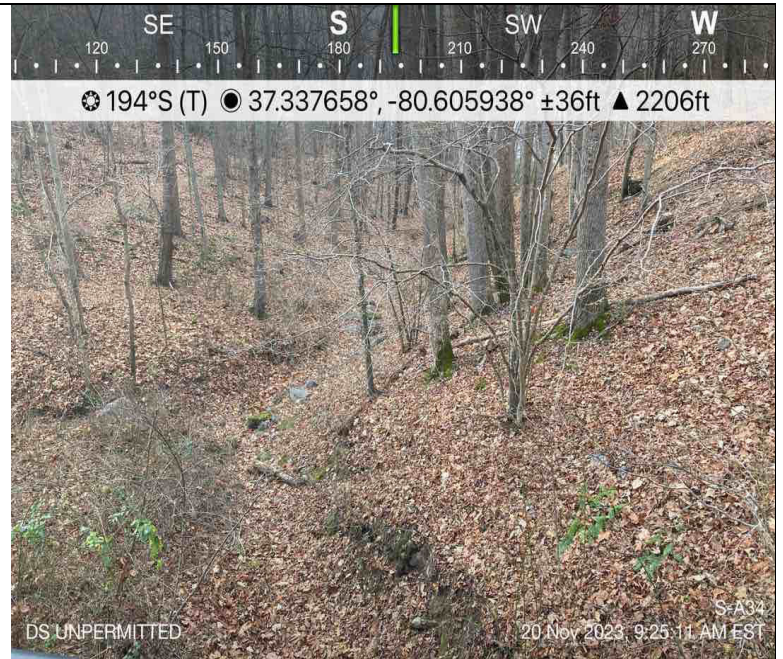
**Photo Description:** Conditions of the downstream area outside the ROW during pre-construction assessment.

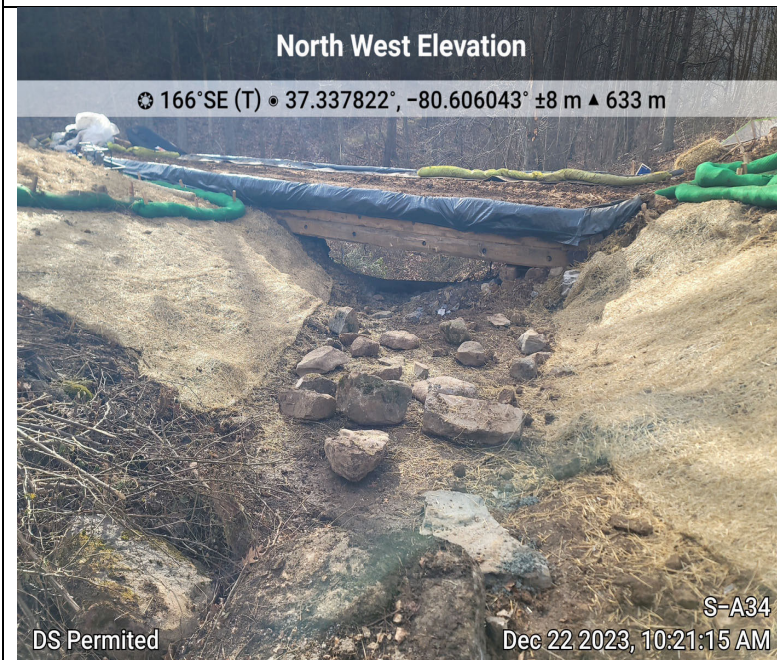
**Photo Description:** Downstream view of permitted impact area during post-construction assessment.

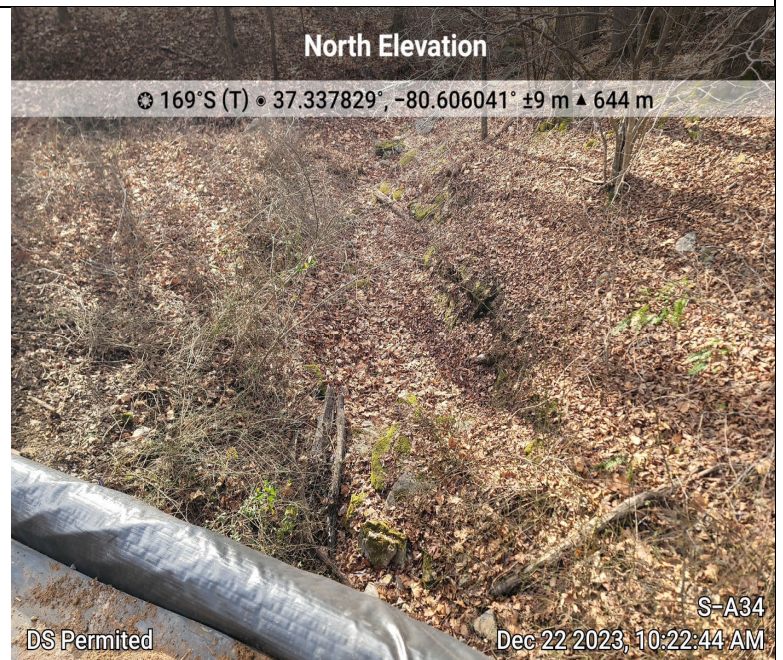
**Photo Description:** Conditions of the downstream area outside the ROW during post-construction assessment.

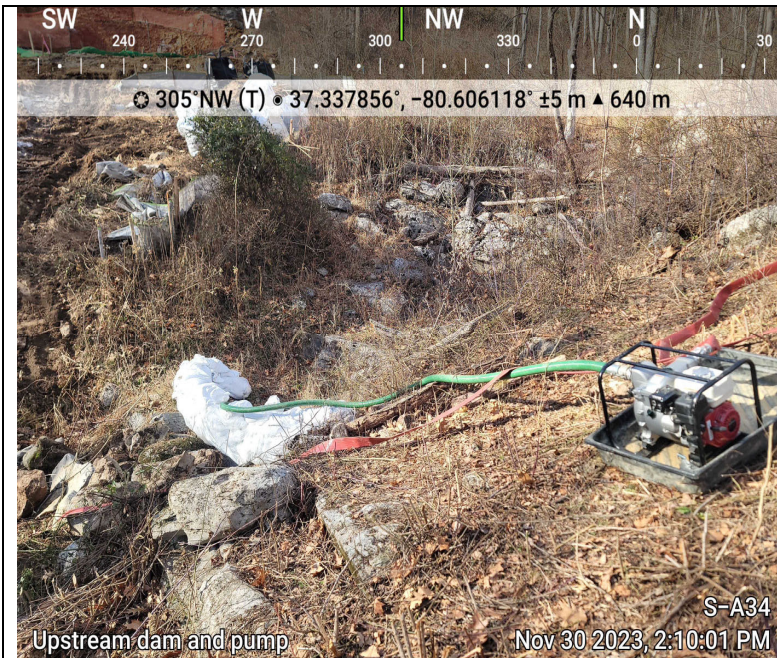
**Photo Description:** Dam and pump installed and functional throughout crossing.

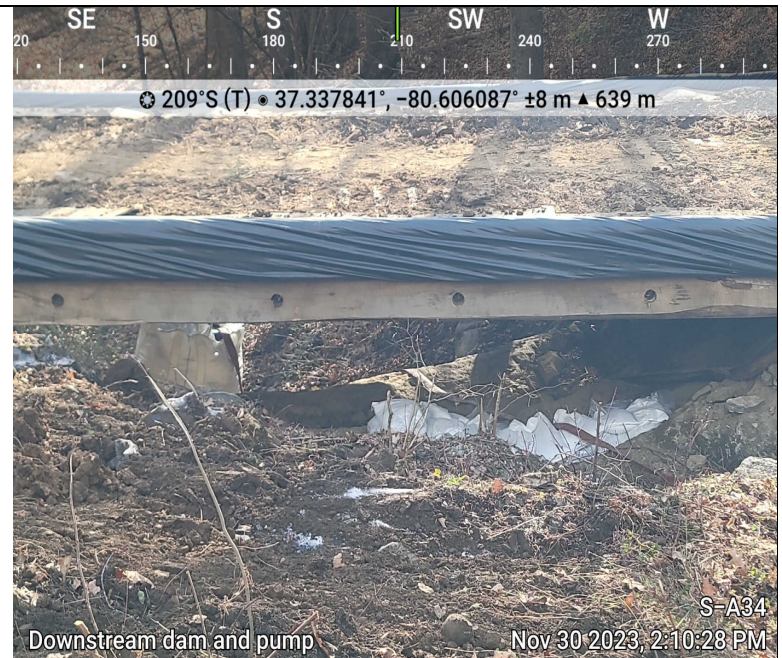
**Photo Description:** Downstream dam and energy dissipator.

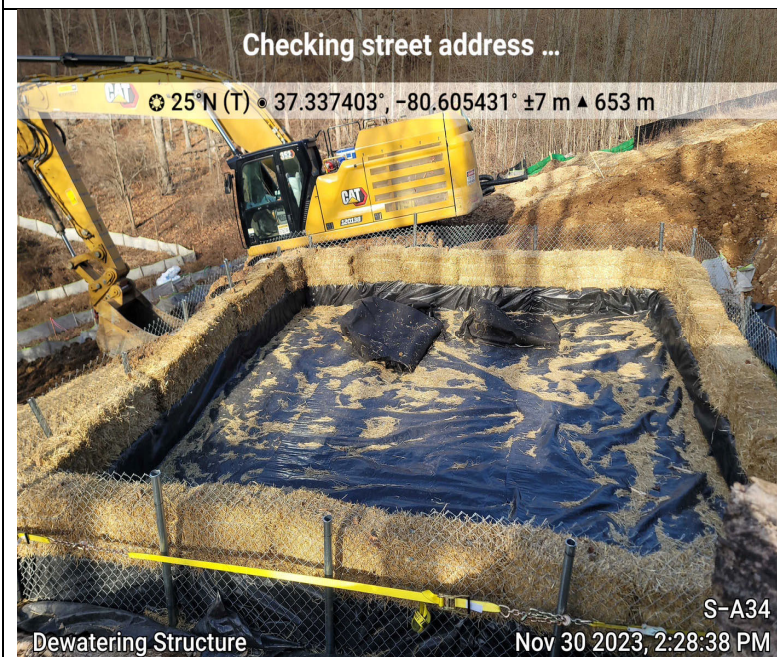
**Photo Description:** Dewatering structure installed and functional throughout crossing.

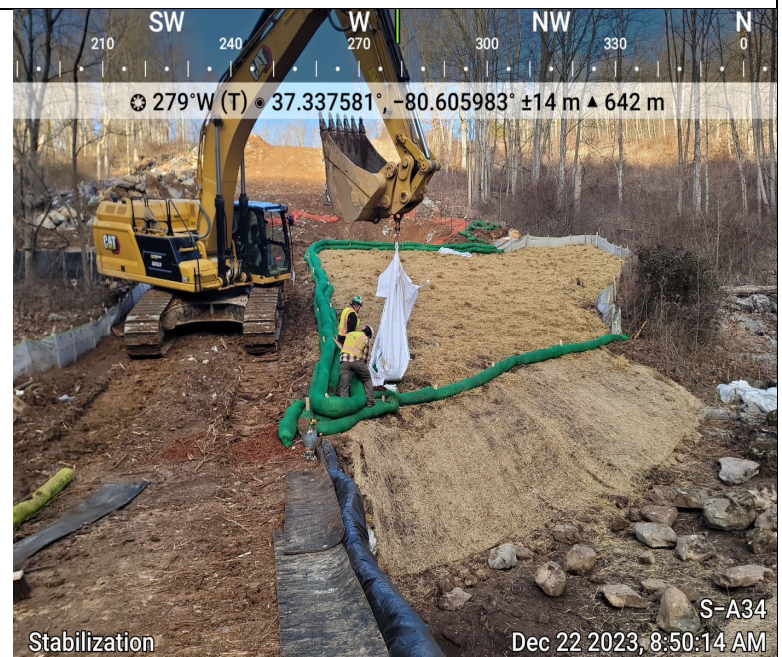
**Photo Description:** Stabilization being applied by environmental crews.
